# **TECHNICAL MEMORANDUM 10-1**

## **Visual Quality on Federal Land**

### **Yuba River Development Project FERC Project No. 2246**

July 2012

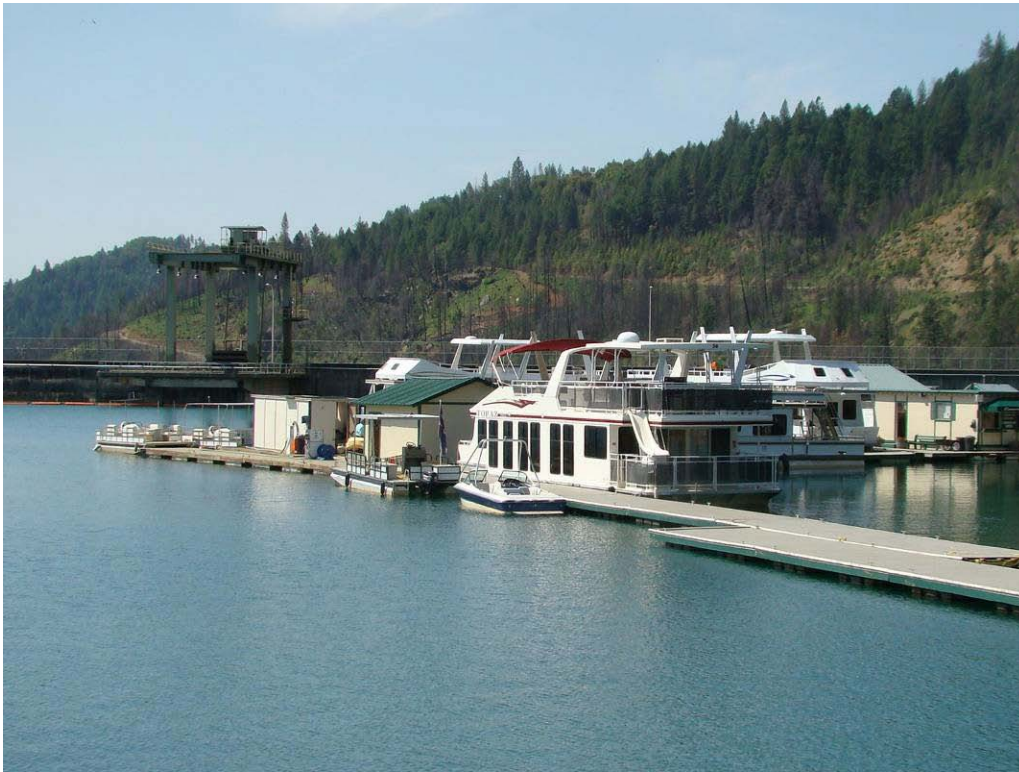
On land owned by YCWA at New Bullards Bar Reservoir, the Emerald Cove Marina and moored houseboats do not meet visual direction due to visual contrast from the white and lightly colored docks, buildings, boats, and rental house boats. The visual contrast of these facilities is expected and is considered part of normal recreation management for a reservoir like New Bullards Bar Reservoir. In addition, New Bullards Bar Dam, which is visible from Sunset Vista Point and Bullards Bar Trail on NFS land, does not meet LRMP visual direction due to visual contrast.

**Figure 13. KOP 9B: View from Cottage Creek Boat Launch looking at Emerald Cove Marina to the south (05/18/12).**

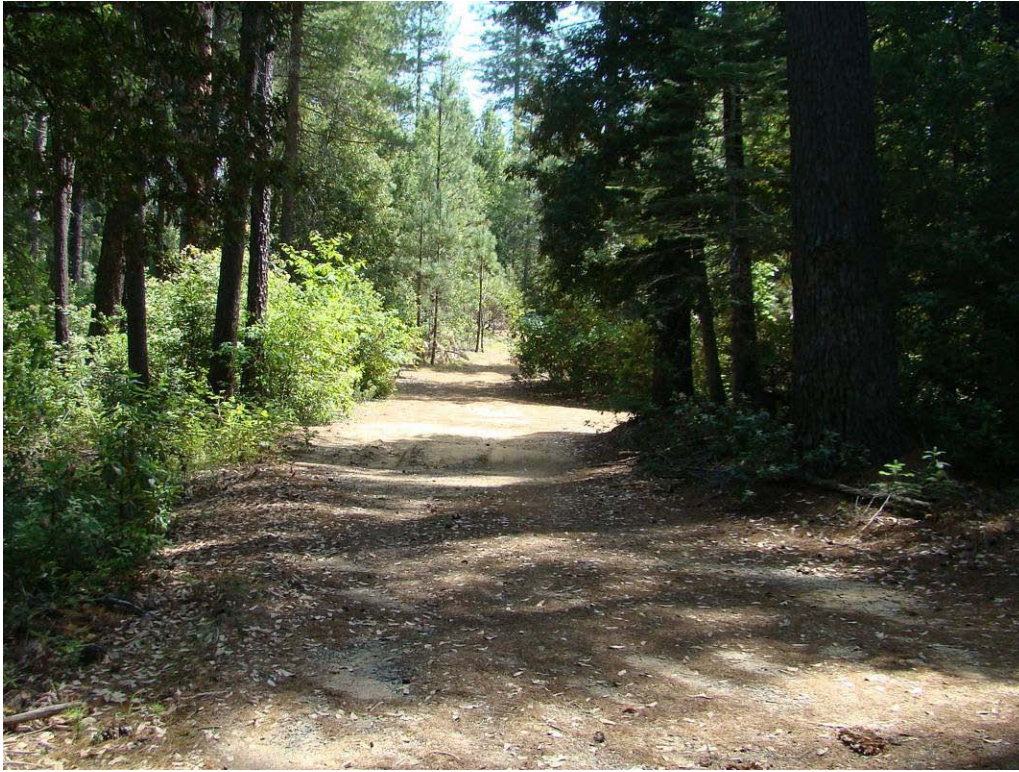
Burnt Bridge Campground	PP 3	R	No view of reservoir (NA)	Yes	NFS	Burnt Bridge Campground has been closed for many years. No visual analysis was conducted because there are no views of the reservoir or facilities from this closed campground. One picture was taken from the campground loop closest to the reservoir to demonstrate the local views of vegetation and the lack of views of the reservoir.
Schoolhouse Campground	PP 4	R	No view of reservoir (NA)	Yes	NFS	Schoolhouse Campground provides overnight camping for families arranged with single camping spurs and is located adjacent to the reservoir. No visual analysis was conducted because there were no views of the reservoir or facilities from this campground. Dense forest vegetation blocks the view. One picture was taken from Campsite No. 23, the closest to the reservoir and facing the reservoir, to demonstrate the local views of vegetation and the lack of views of the reservoir. No EVC evaluation was conducted due to lack of views.

**Figure 21. PP 3: View from Burnt Bridge Campground (decommissioned) at the point closest to the reservoir looking north east (05/18/12).**

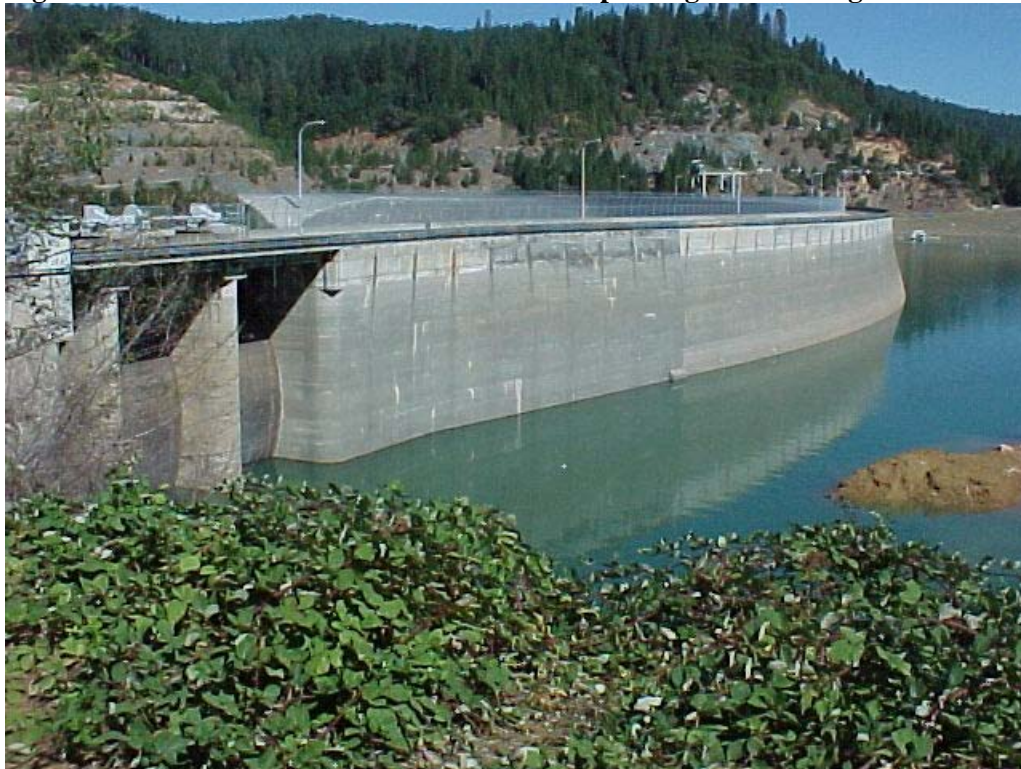
On NFS land, all of the Project facilities and features meet the PNF's and TNF's LRMP visual direction with the exception of the land exposed by seasonal drawdown around New Bullards Bar Reservoir. The contrast increases as the reservoir is drawn down through the summer and fall. The broad band of exposed, mostly reddish soils with no plant growth and tree stumps is an

apparent visual feature to the public and most recreation users, and contrasts to the surrounding continuous native forest cover. The drawdown zone does not meet LRMPs visual direction, which is mostly Retention and Partial Retention VQOs. However, recreation users know to expect a significant drawdown to the reservoir over the summer and continue to recreate at the reservoir. For a multiple-use reservoir like New Bullards Bar, drawdown is an expected outcome from managing the reservoir.

**Figure 24. Archive photograph showing drawdown at the New Bullards Bar Dam.**

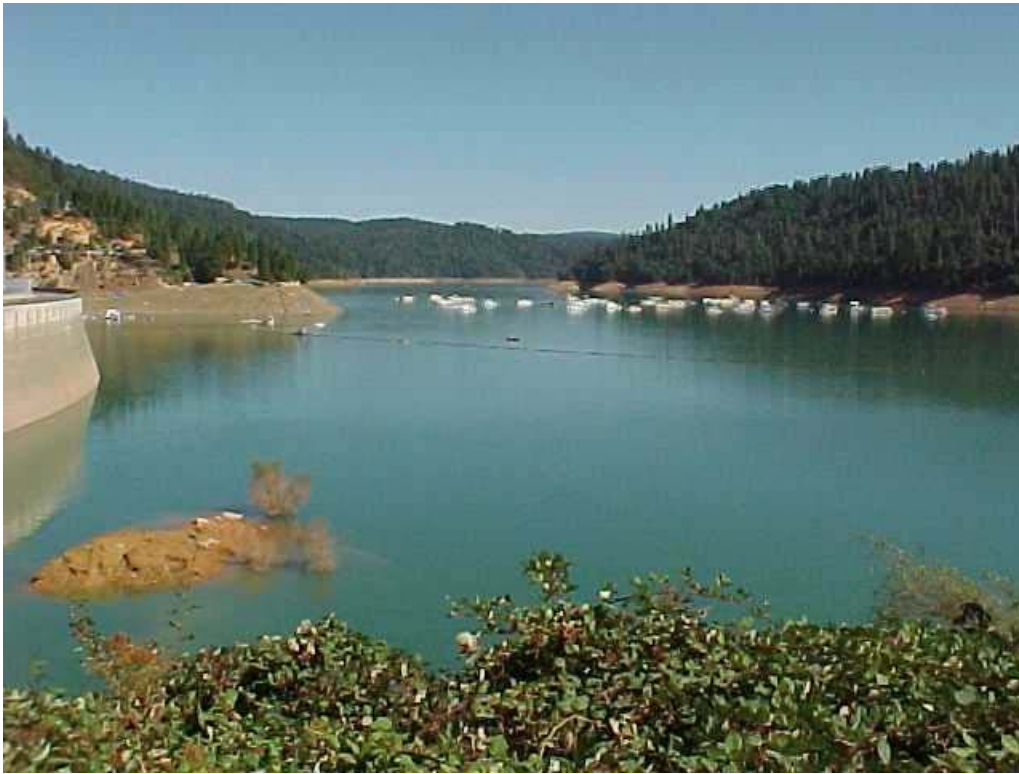
**Figure 25. Archive photograph showing typical drawdown along the shore of New Bullards Bar Reservoir.**
