SUBJECT: Yuba River Development Project
FERC Project No. 2246-058
Yuba Salmon Forum Fish Passage Study Report

YUBA SALMON FORUM

FISH PASSAGE STUDY REPORT

February 2012

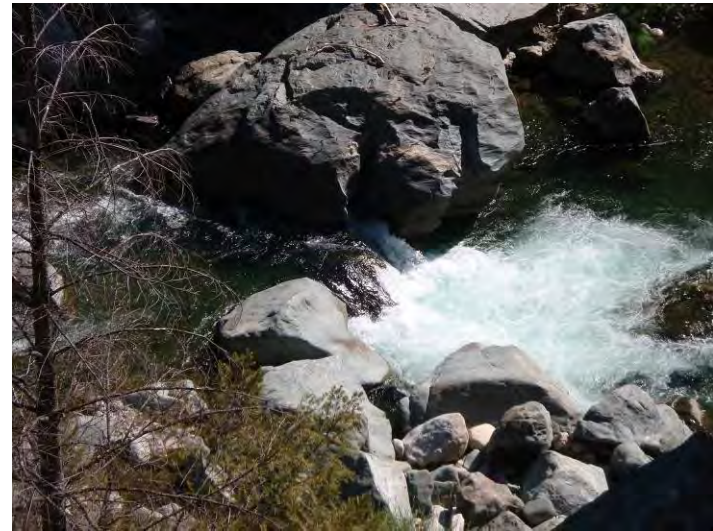
Photo 26. North Yuba R. feature 3a farthest downstream falls

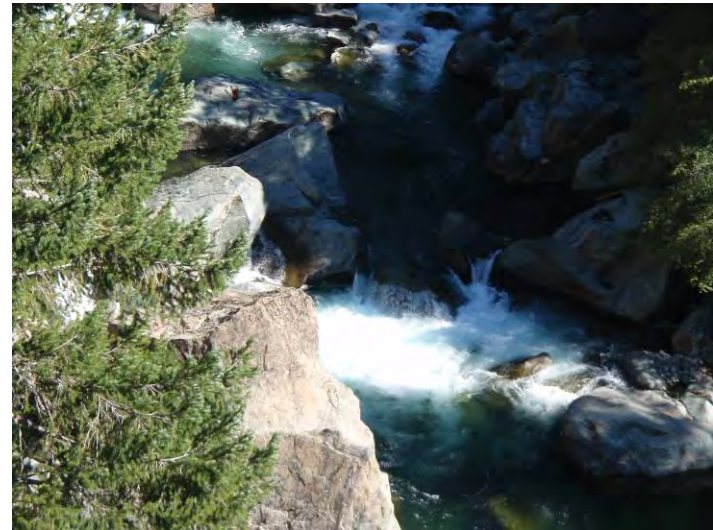
Photo 28. North Yuba R. feature 3c middle falls

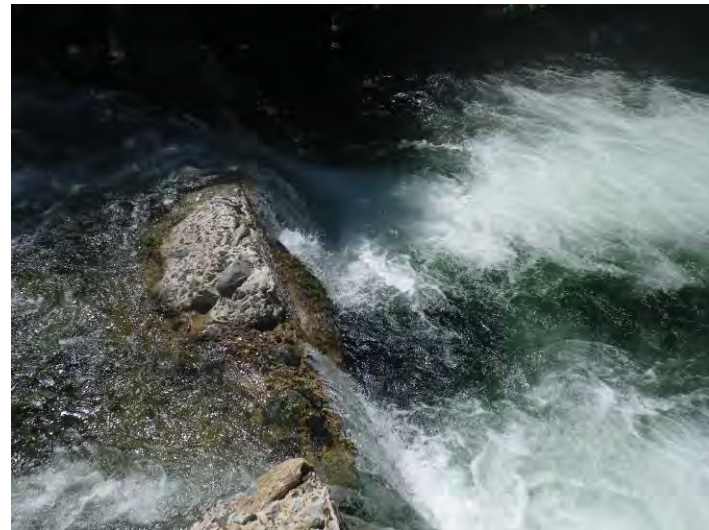
Photo 32. North Yuba R. feature 6a Gillespie Dam

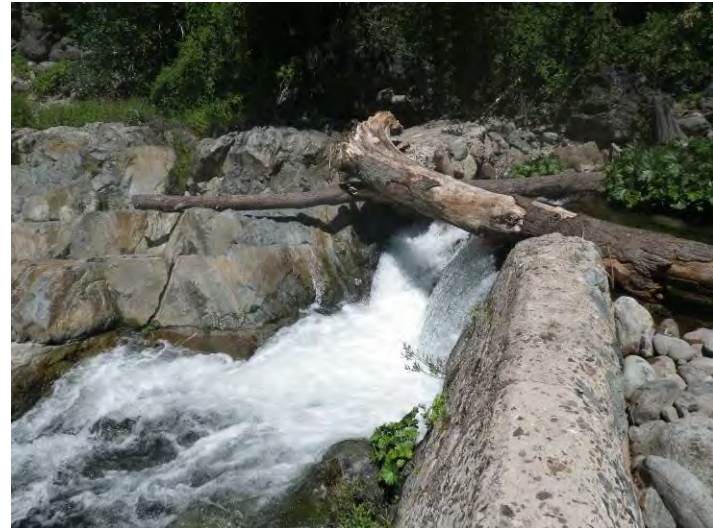
Photo 34. North Yuba R. feature 6c Gillespie Dam

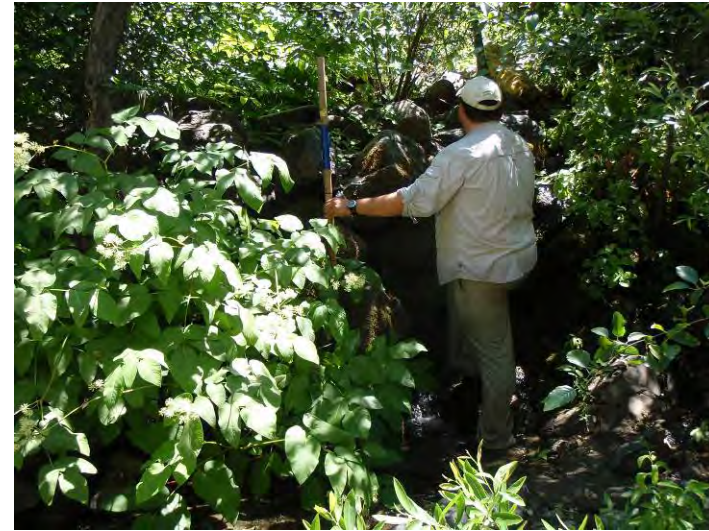
Photo 39. St. Catherine Cr. barrier 1

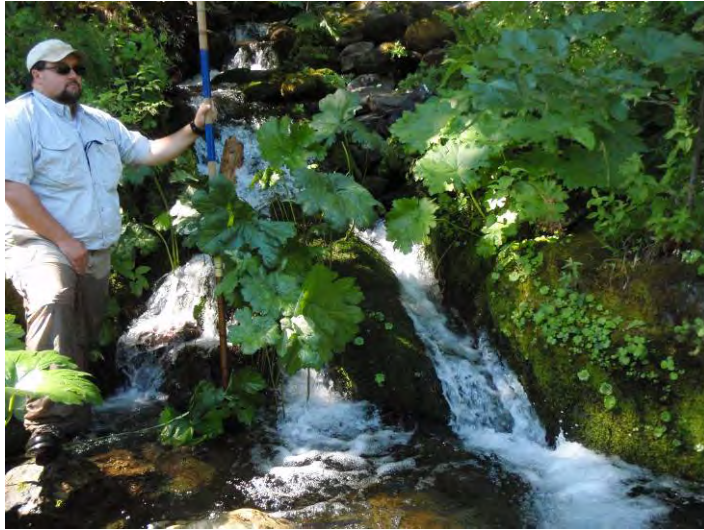
Photo 58. Secret Canyon barrier 1

Secret Canyon				
Stream/ Tributary: N. Yuba / Secret Canyon		Crew: RA, CV	Temp (C°): 10.4	Date : 8/18/11
Estimated Discharge (cfs): 3.0		UTM Start/Description: 0690788 E / 4380361 N	UTM End/Description: 0690788 E / 4380361 N	
Comments: Additional falls that qualify as barriers were observed 200 ft. upstream of Point ID 1.

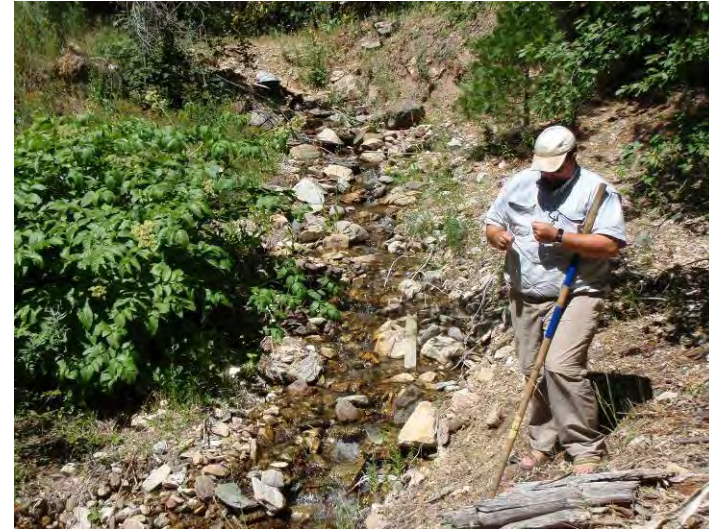
Photo 63. Gold Point Ravine looking upstream of Hwy 49

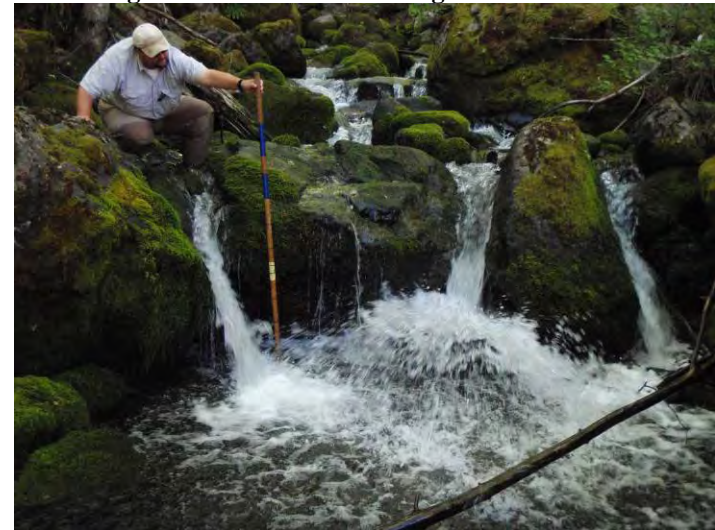
Photo 69. Big Avalanche Ravine barrier 1

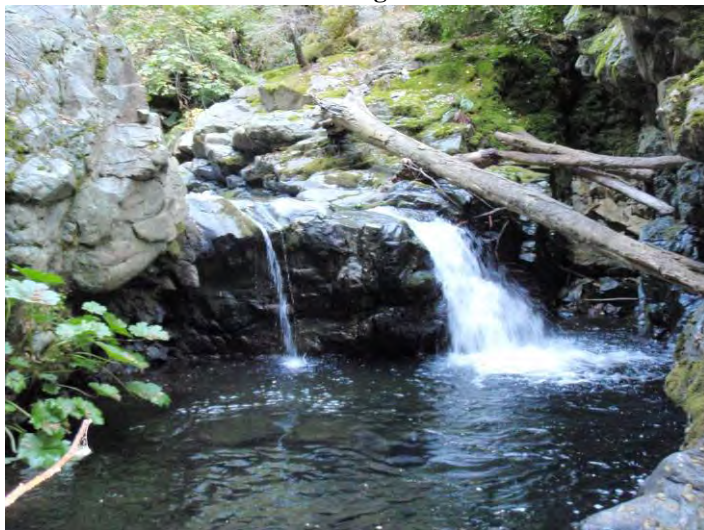
Photo 76. Cherokee Cr. barrier 1

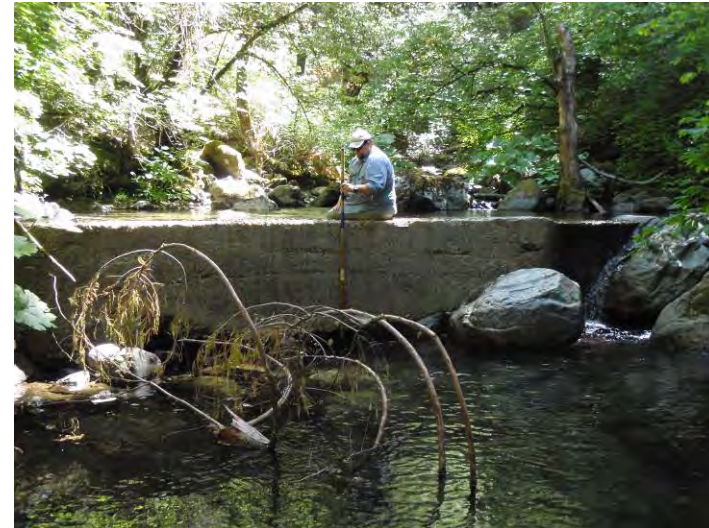
Photo 83. Rock Cr. barrier 1a

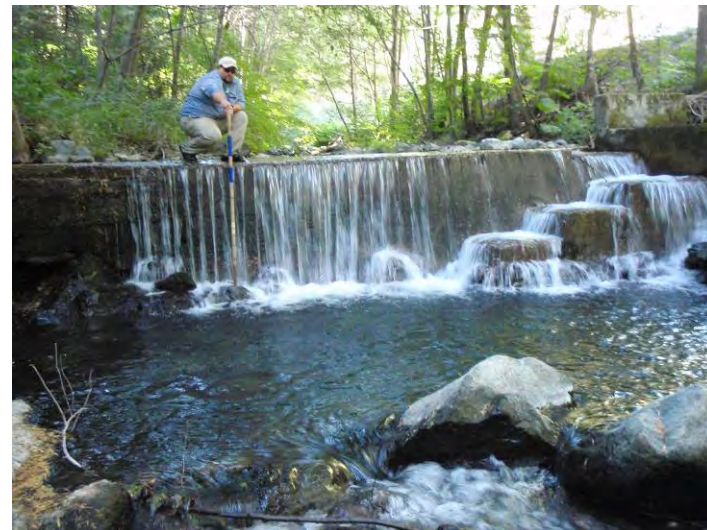
Photo 89. Woodruff Cr. barrier 2a

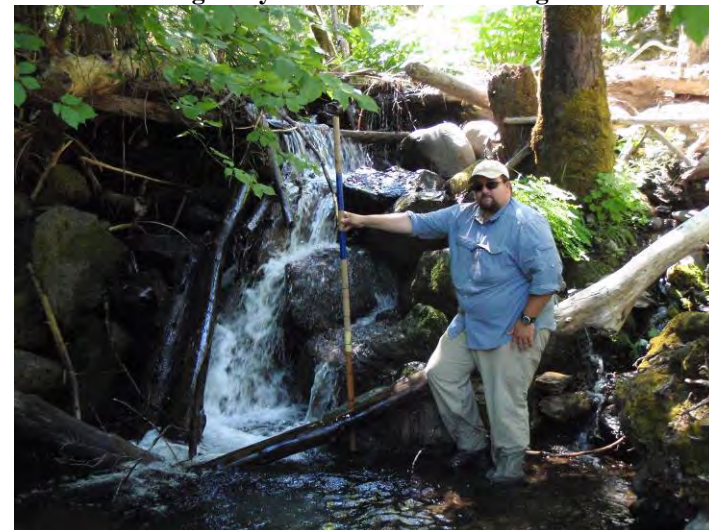
Photo 93. Slug Canyon barrier 1

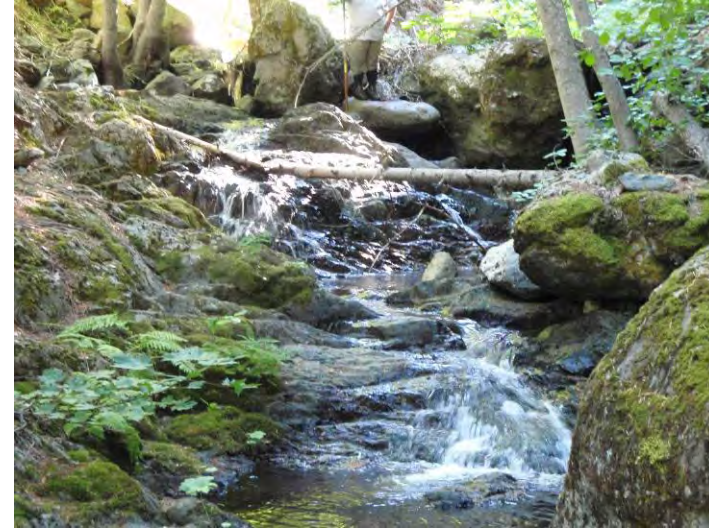
Photo 101. Hackmans Ravine barrier 2

Stream/ Tributary: N. Yuba / Hackmans Ravine	Crew: RA, CV	Temp (C°): 10.6	Date: 9/23/11
Estimated Discharge (cfs): 1.5	UTM Start/Description: 0703640 E / 4382125 N	UTM End/Description: 0703749 E / 4382000 N	
Comments: Boulder delta disperses flow and would block passage at current flow. At current flow no anadromous habitat due to numerous low flow leaping barriers and overall high gradient. Average 4% near confluence and picks up to 8-10% after Point ID #1. Overall, no good habitat due to low flow and high gradient. Fry observed below Point ID #1.

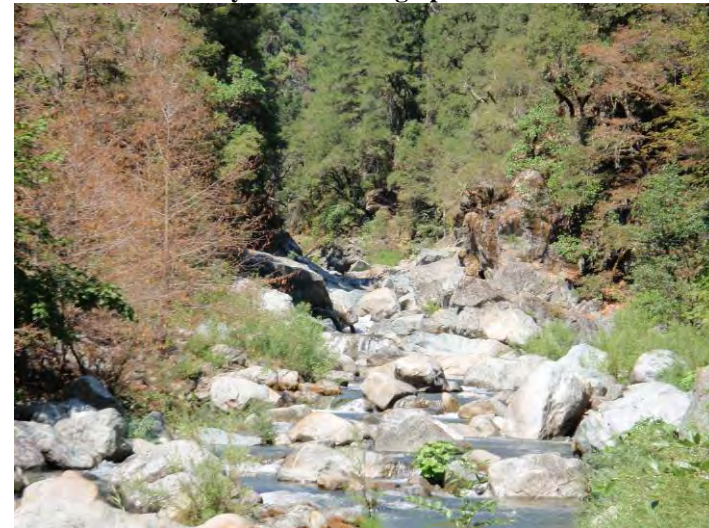
Photo 106. Canyon Cr. Typical habitat and additional falls looking upstream of barrier 1

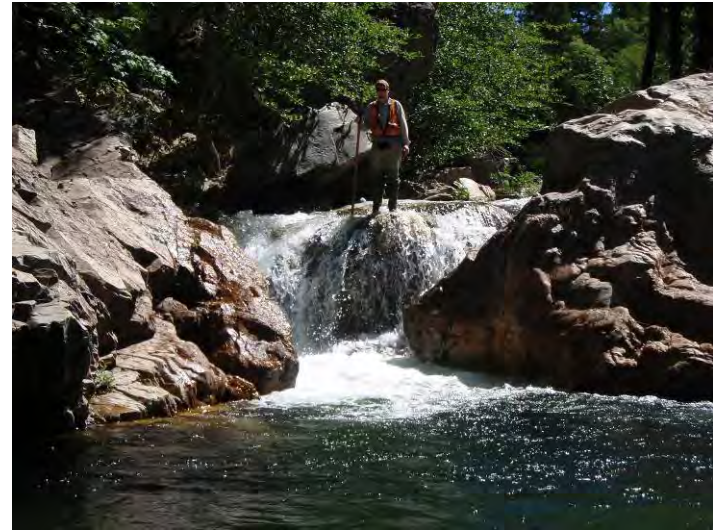
Photo 127. Haypress Cr. barrier 1a

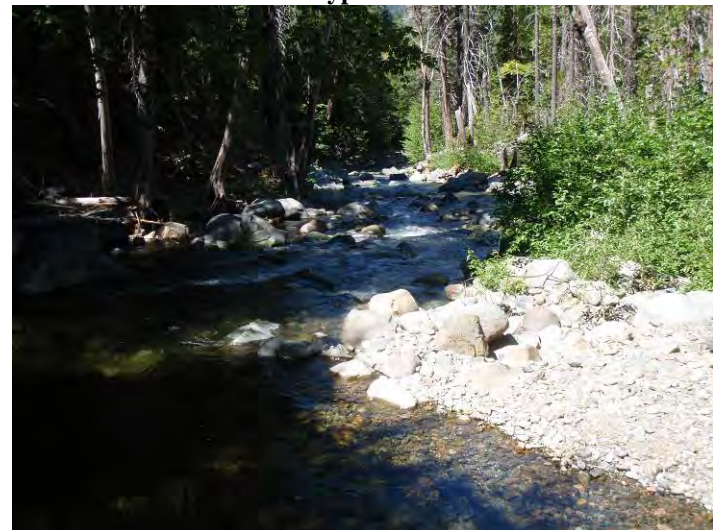
Photo 129. Haypress Cr. looking downstream at end point
