Streambed Monitoring Below Englebright Dam Plan

**Yuba River Development Project
FERC Project No. 2246**

December 2014

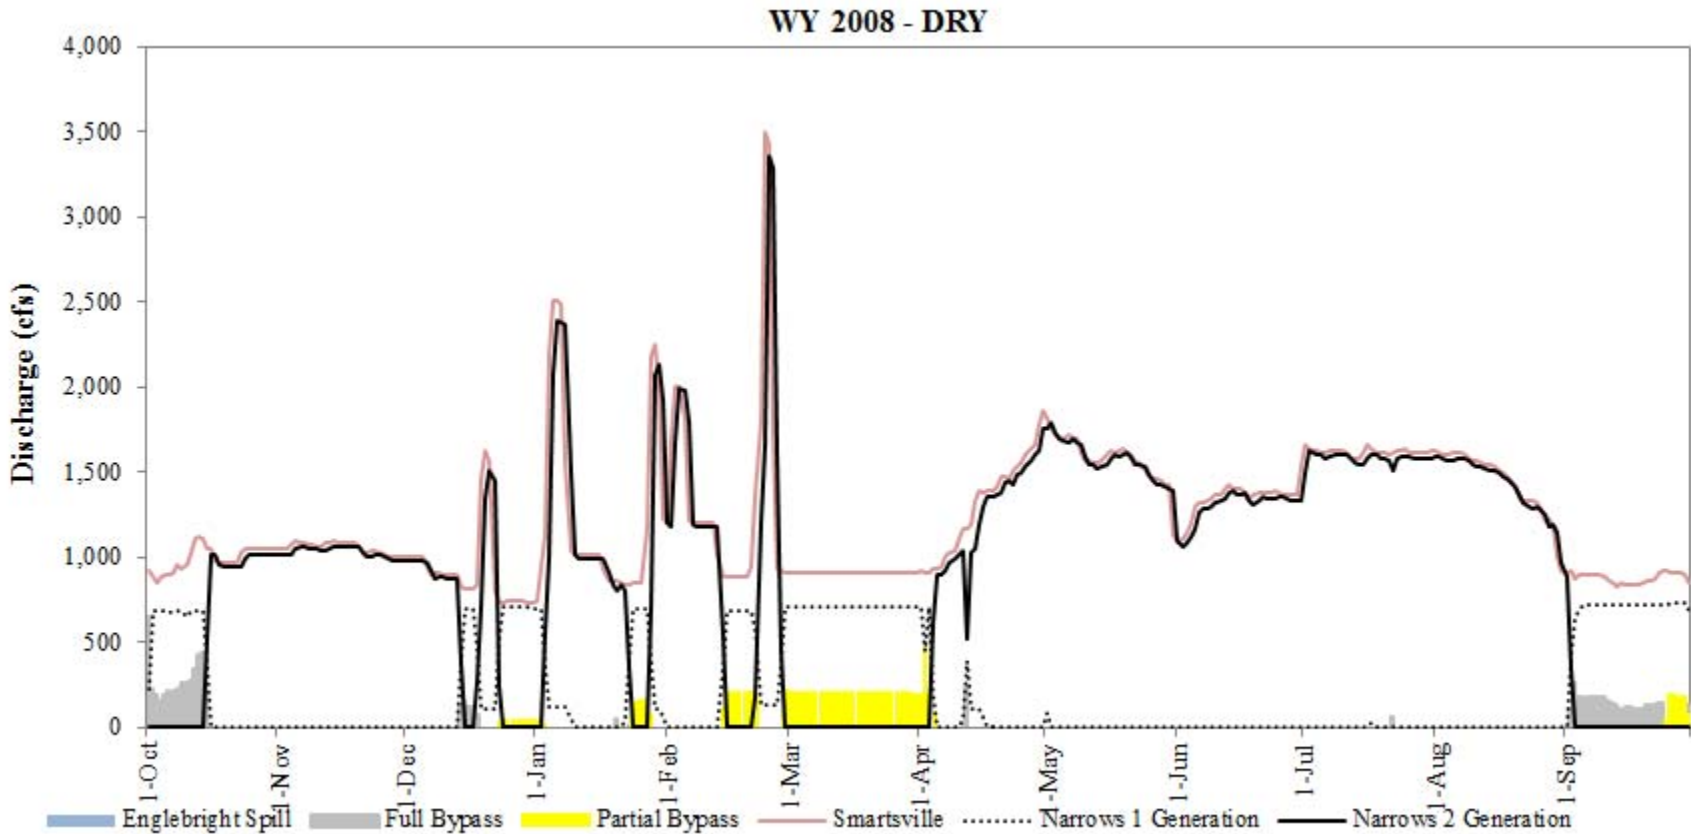
Figure 2.2-6. Mean daily discharges from Narrows 1 Powerhouse, Narrows 2 facilities, and the Smartsville gage in WY 2008. Englebright Dam did not spill in Water Year 2008.¹⁹

¹⁹ In this figure, Narrows 1 Powerhouse and Smartsville gage data are from PG&E, and the Partial and Full bypasses data are estimated by YCWA based on flow data from the Narrows 2 Penstock AVM and information in YCWA Operators' log books.

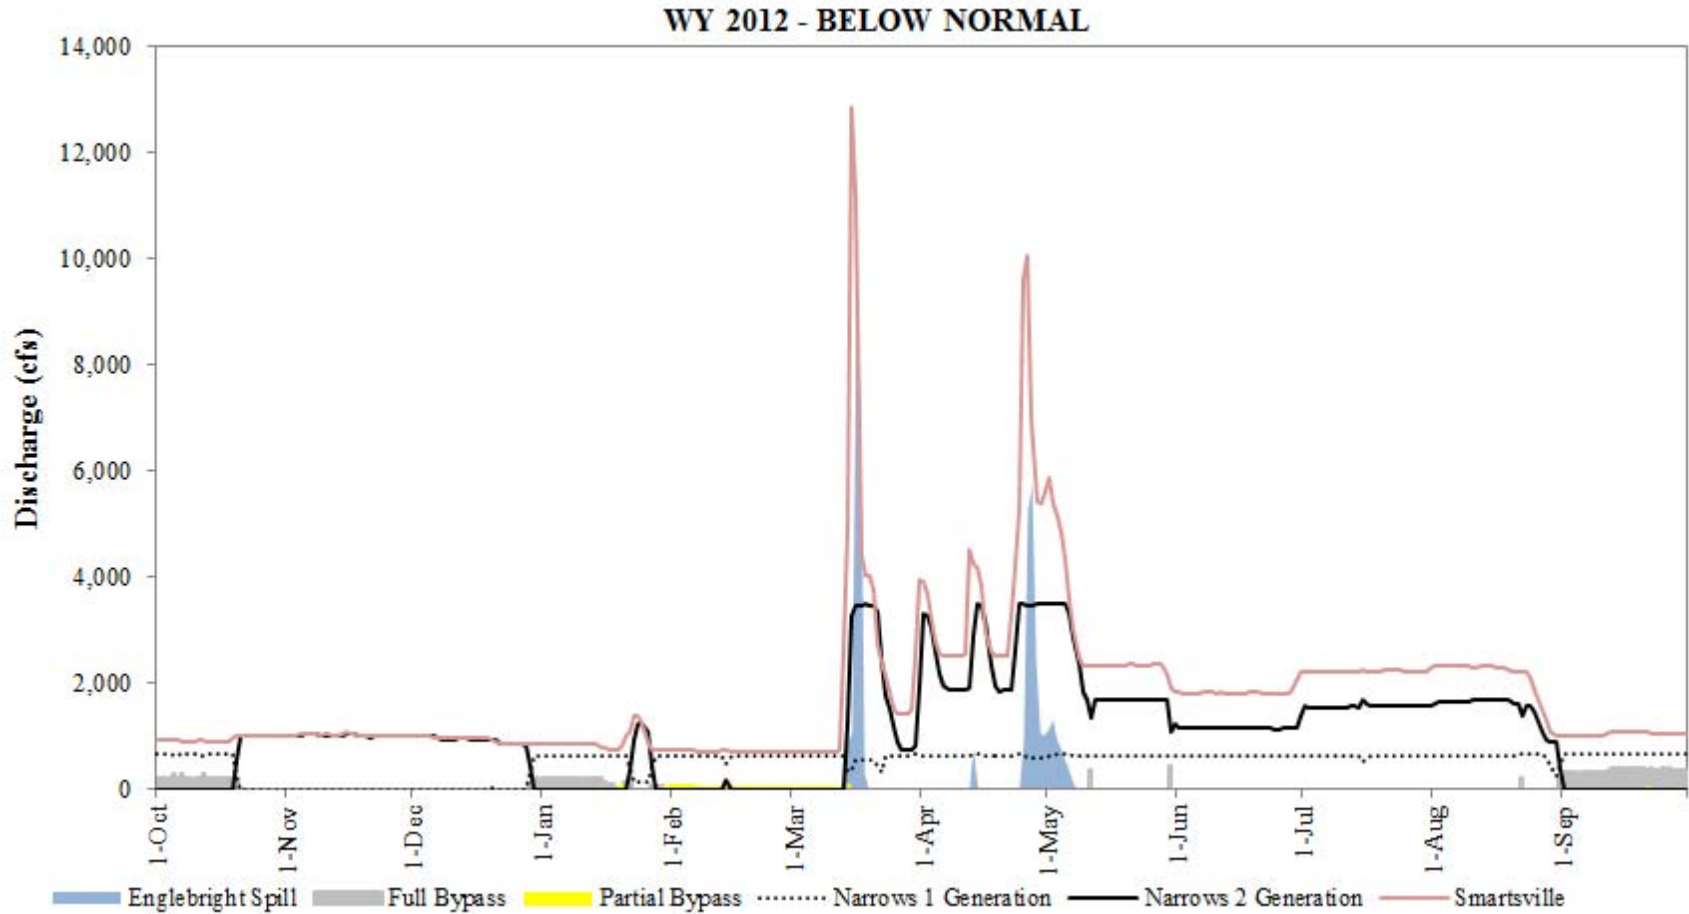
Figure 2.2-10. Mean daily discharges from Narrows 1 Powerhouse, Narrows 2 Facilities, the Smartsville gage, and Englebright Dam spill in Water Year 2012.²³

²³ In this figure, Narrows 1 Powerhouse and Smartsville gage data are from PG&E, and the Partial and Full bypasses data are estimated by YCWA based on flow data from the Narrows 2 Penstock AVM and information in YCWA Operators’ log books.

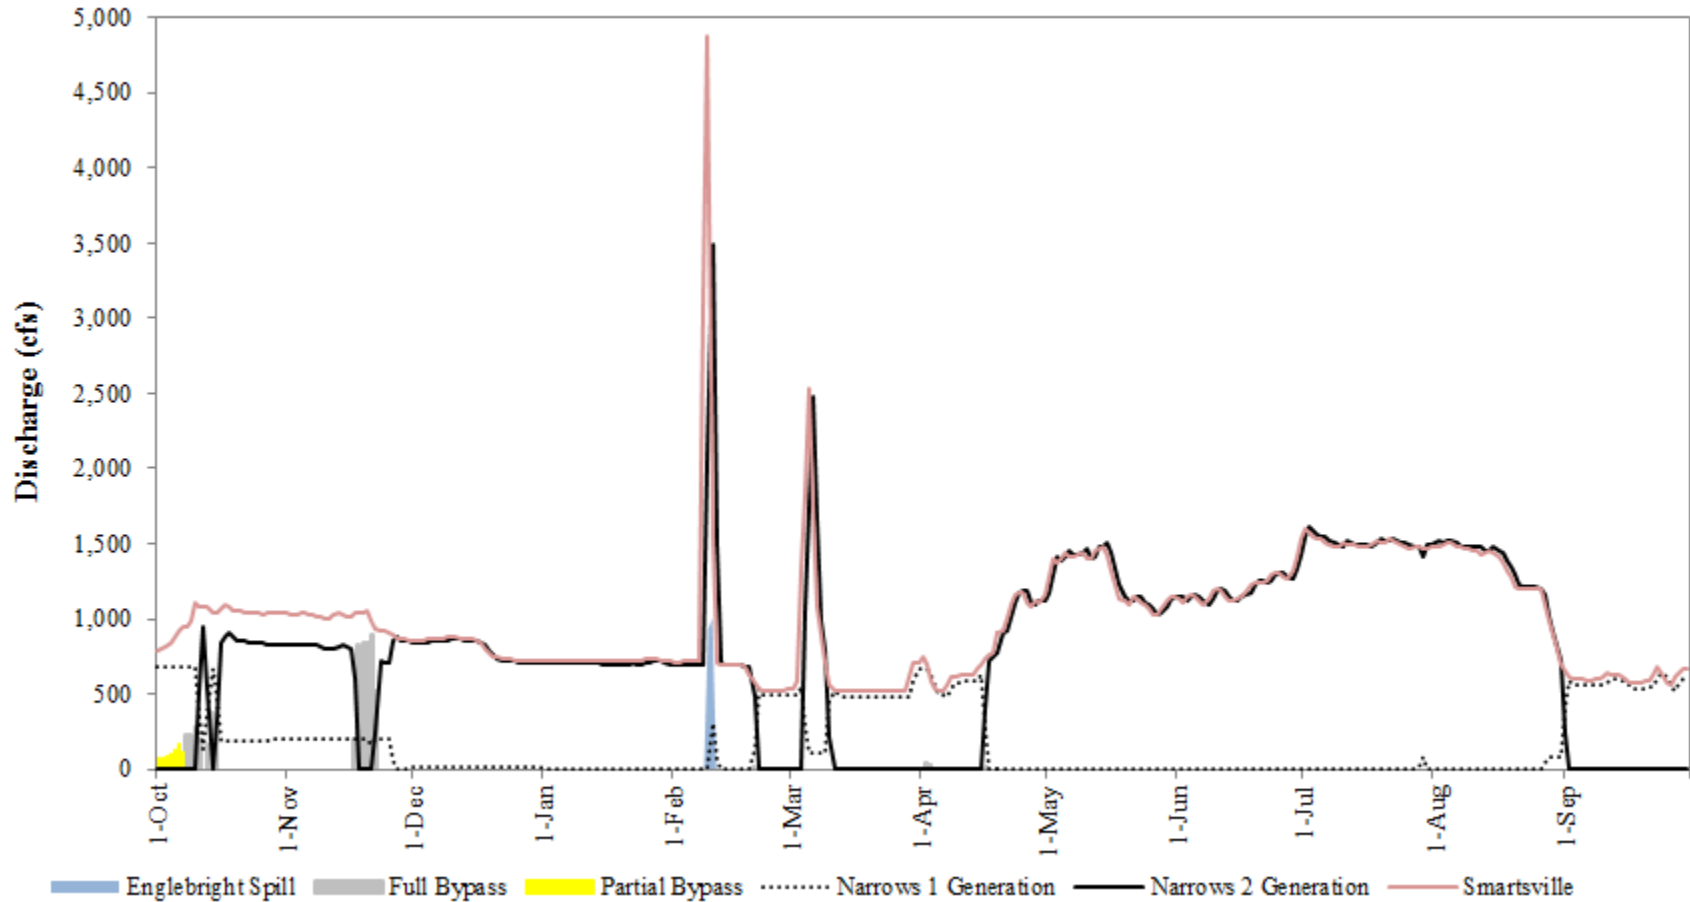
WY 2014 - CRITICALLY DRY

Figure 2.2-12. Mean daily discharges from Narrows 1 Powerhouse, Narrows 2 Facilities, the Smartsville gage, and Englebright Dam spill in Water Year 2014.²⁵

²⁵ In this figure, Narrows 1 Powerhouse and Smartsville gage data are from PG&E, and the Partial and Full bypasses data are estimated by YCWA based on flow data from the Narrows 2 Penstock AVM and information in YCWA operators' log books.

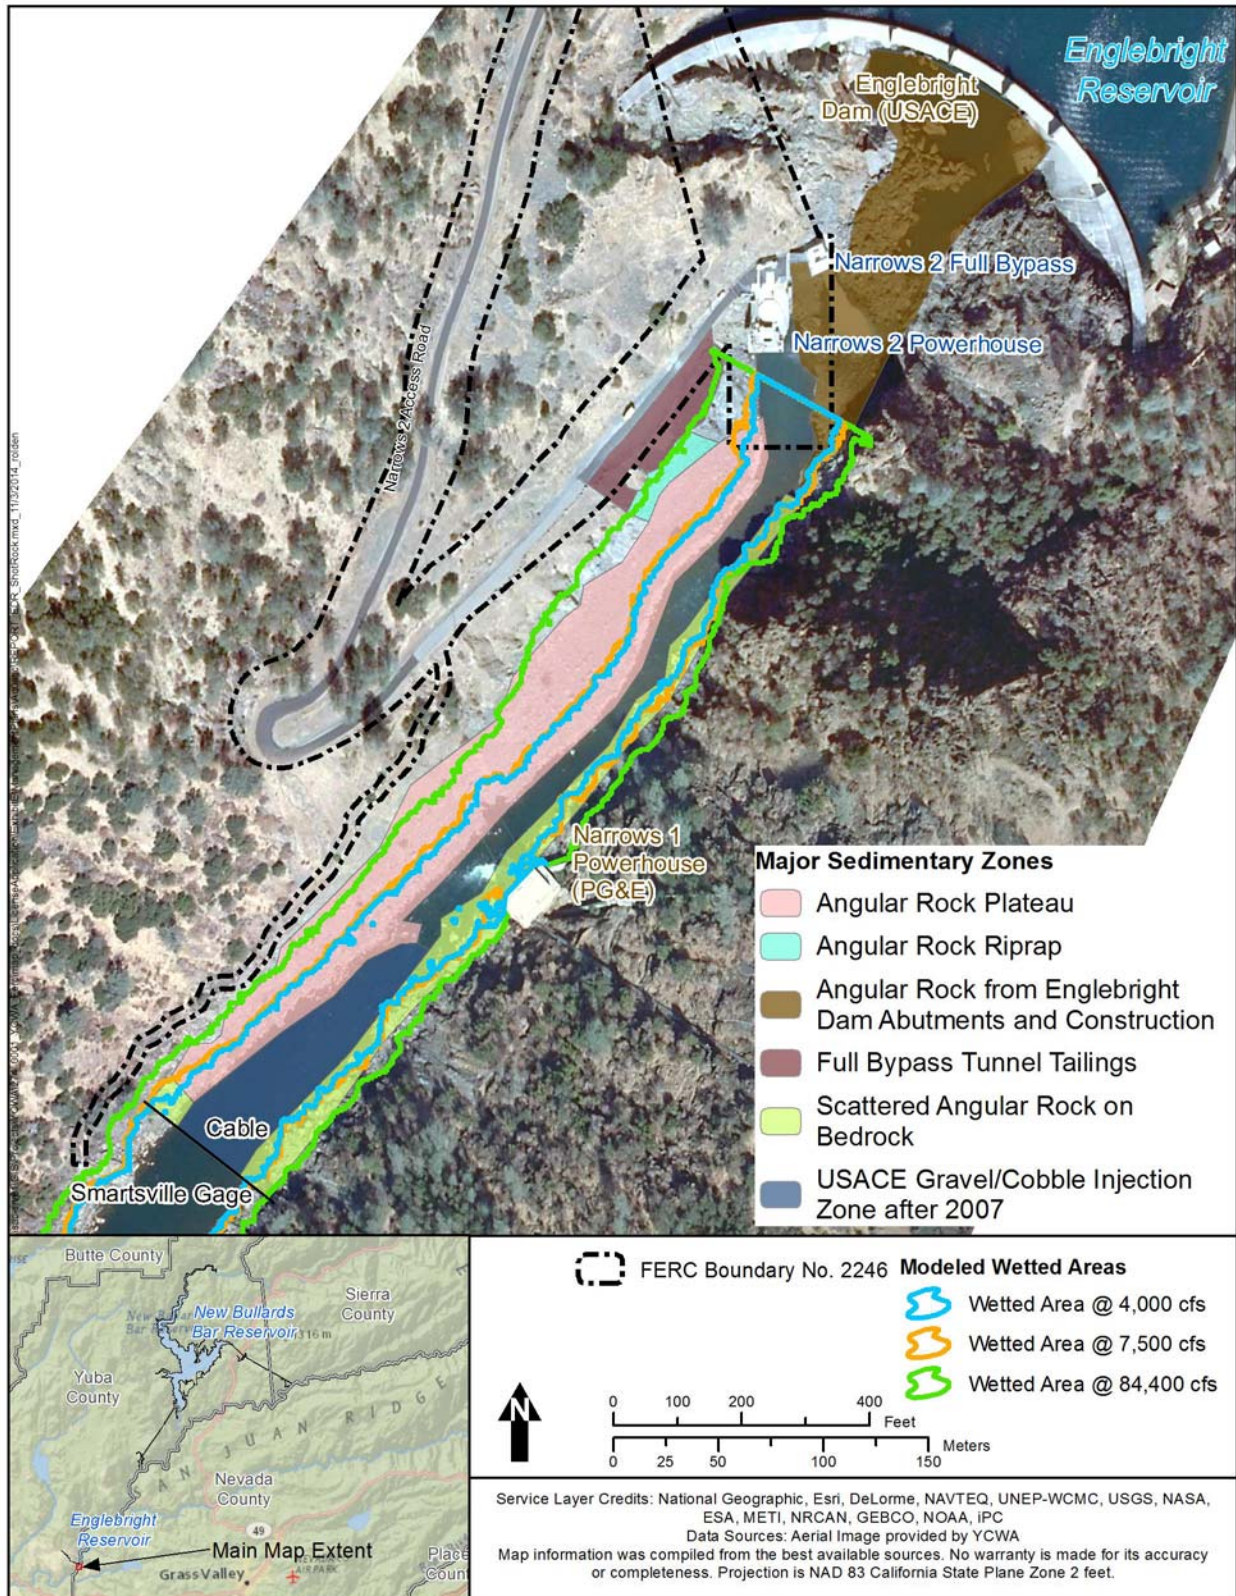
Figure 2.3-1. YCWA’s good faith effort to characterize the major sedimentary zones in the Reach.

²⁹ YCWA did not attempt to characterize the inundated areas in Figure 2.3-1 between Narrows 2 and Narrows 1 powerhouses, though YCWA's best estimate based on recent relicensing underwater investigations, the areas shown submerged at the approximately 820-850 cfs flow when the photo was taken is mostly exposed bedrock with scattered boulder and cobble angular rock, some in denser pockets.

Table 2.3-1. Description of major sedimentary zones shown in Figure 2.3-1.

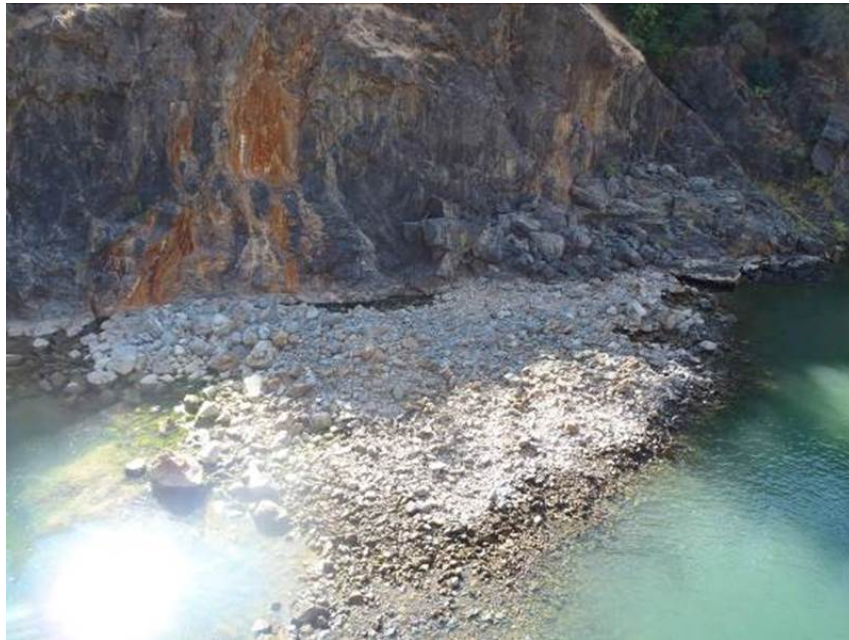
Figure 3.1-1. Picture of dry gravel bar on which the work would occur. The photo was taken during a Narrows 2 outage when no flow was being released from the Narrows 2 Facilities.³²

³² The photo was taken from the Narrows 2 Powerhouse deck looking south across the Yuba River. The dry existing isolation pool depression shown in Figure 3.1-2 is the small discolored area at the center of the figure. As reference, the larger rocks at the upstream end of the bar (i.e., left end of the photo) ranges in size from about 4 to 10 ft in diameter. The majority of the rocks in the center and downstream end of the bar range in size from about 0.5 to 4 ft in diameter.

During the work, no material will be removed from the streambed, and no fill will be added to the streambed. No structures (e.g., rip-rap or culverts) will be placed, built, or completed in or near the river. Water will not be directed or drafted for the purpose of the work (i.e., YCWA intends to perform the work opportunistically when the bar and existing isolation pool depression are dry). Therefore, the work does not include fish rescue. Figures 3.1-1 and 3.1-2, which were taken on September 1, 2014, show the dry bar and dry existing isolation pool depression.

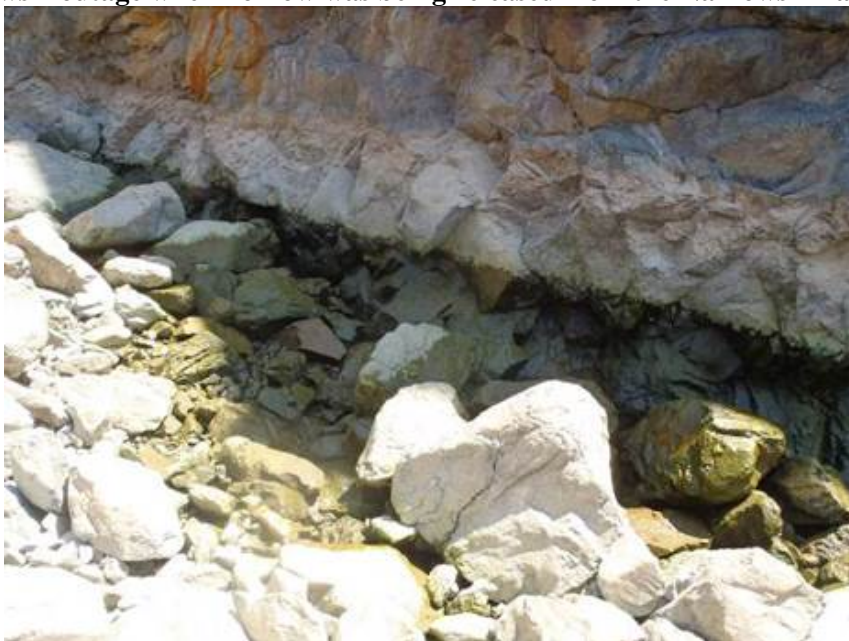
Figure 3.1-2. Picture of dry existing isolation pool depression on which the work would occur. The photo was taken during a Narrows 2 outage when no flow was being released from the Narrows 2 Facilities³³
