Interim Technical Memorandum 7-3

**Attachment 7-3A
Part 1**

**California Red-Legged Frog
Detailed Site Assessment Results**

**Yuba River Development Project
FERC Project No. 2246**

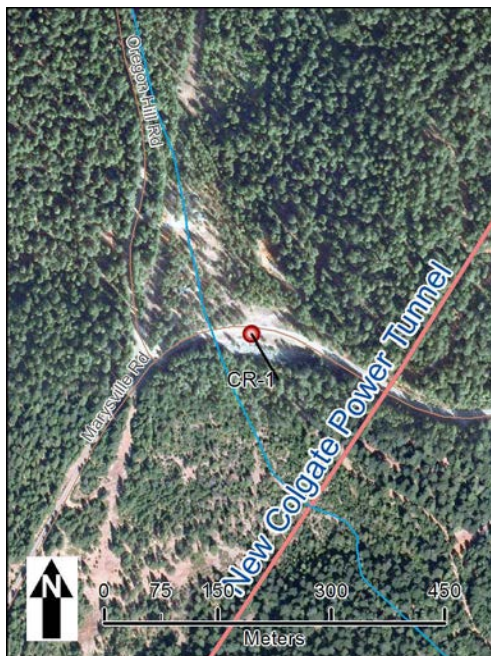
CR1 is a portion of Chute Ravine, a perennial tributary to the Yuba River that is located 2.2 km southwest of New Bullards Bar Reservoir, and within a portion of the FERC project boundary associated with Marysville Road on YCWA Land. Chute Ravine is 5.8 km from the nearest known CRLF occurrence, and is located outside of the USFWS critical habitat unit. This site is not depicted as a wetland on NWI maps of the area.

on the left bank and soil and cobble on the right bank. No emergent vegetation and overhanging vegetation are present at the site. The over-story canopy cover consists of tanoak, willows (*Salix* sp.), and alders. No fish or amphibians were observed. Surrounding upland consists of residential development to the north and second-growth, mixed coniferous/deciduous forest to the south.

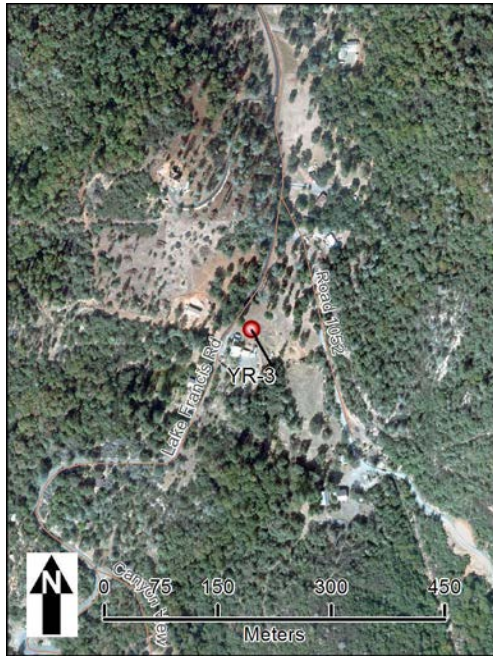
The site was assessed on March 2, 2012 from Lake Francis Road; a follow-up visit was conducted on May 29, 2012, which confirmed the absence of surface water on this date. YR3 appears to be an excavated pond receiving seasonal runoff and with no outlet. The site covers approximately 25 m²; maximum depth was visually estimated to be at least 0.3 m; substrate is soil. Grazed grasses were present around the pond margin. Surrounding upland was agricultural grassland.

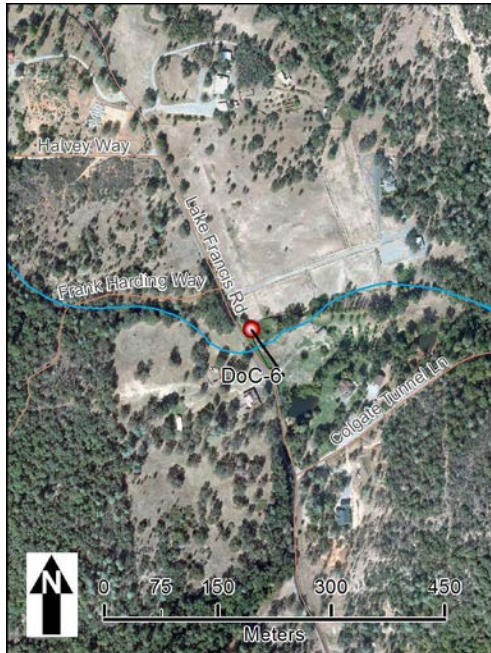
DoC6 is a small intermittent tributary to Dobbins Creek that occurs within 1.6 km the New Colgate Power Tunnel. DoC6 is located 6.6 km southwest of New Bullards Bar Reservoir and 679 m outside of the FERC Project Boundary on private property. DoC6 is 9.1 km from the nearest known CRLF occurrence, and is located outside of the USFWS critical habitat unit. This site is not depicted as a wetland on NWI maps of the area.

was low-gradient riffle and slow moving runs and glides. The substrate was silt and soil. The banks were low gradient and consisted of soil with some Himalayan blackberry. Emergent vegetation was negligible in the stream channel; vegetation on the streambank and above top-of-bank consisted of soft rush and grasses. No fish or amphibians were observed. Surrounding upland is open oak woodland and pasture.

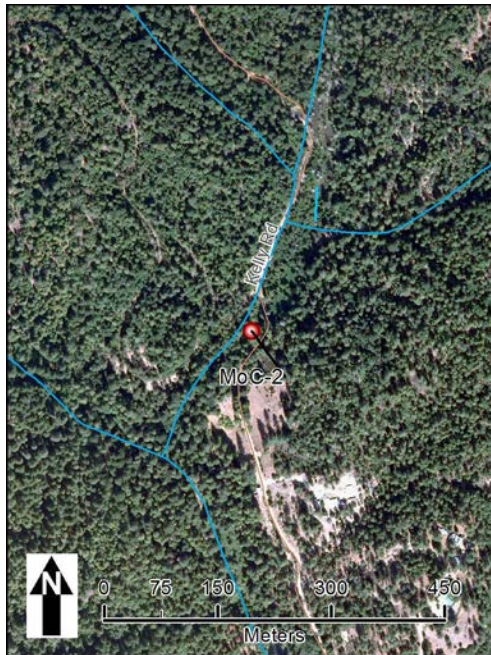
The site was assessed on March 5, 2012 accompanied by Forest Service and SWRCB agency staff listed under site WaC1 above. A follow-up visit was conducted on June 20, 2012, which confirmed stream flow on this date. MoC2 at bank full is approximately 6.5 m wide, and the bank full depth was estimated to be 1.5 m. MoC2 is located downstream of MoC1, originating from a culvert under Kelly Road. The stream segment is impounded by an approximately 3-meter-tall concrete dam located 60 m downstream of Kelly Road. The stream gradient averaged 1 percent. The site is one large pool measuring 5 m x 60 m, with a maximum depth of 1.5 m. Non-pool habitat was absent. The substrate was silt and sand. The banks were low gradient and consisted of soil. The channel was sparsely vegetated with water-purslane (*Ludwigia palustris*), mainly in shallower pockets of water; willows, Himalayan blackberry, giant chain fern, and

sword fern overhanging. An aggregation of numerous Sierra newts in amplexus was observed in a small pool approximately 1 m deep located near an undercut bank, and other individual Sierra newts were observed throughout the site. No fish were observed in the impoundment. Surrounding upland is second-growth, mixed coniferous/deciduous forest.

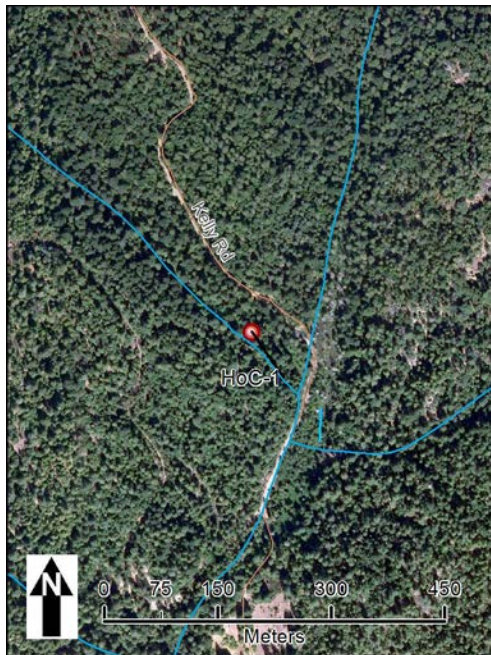
The site was assessed on March 5, 2012 accompanied by Forest Service and SWRCB agency staff listed under site WaC1 above. A follow-up visit was conducted on June 20, 2012, which confirmed stream flow on this date. HoC1 at bank full is approximately 1 m wide, and the bank full depth was estimated to be 0.2 m. The stream discharges into MoC3 via multiple small channels near the stream “mouth” at Kelly Road. The stream gradient averaged 1 percent. Pools within the stream measured approximately 2.5 m x 4 m, with a maximum depth of 0.3 m. Non-pool habitat was low-gradient riffle. The substrate was predominantly cobble and sand in the upstream portion of the assessed creek channel, and mud and sand towards the mouth of the creek. The banks were low gradient and consisted of soil. Some LARGE WOODY MATERIAL occurs within the wetted perimeter. The upstream portion of the assessed stream lacked emergent or aquatic vegetation; scattered senesced horsetail (*Equisetum* sp.) was observed in the mouth of the creek; dense horsetail was growing in the mouth of the creek during the follow-up visit. Willows, Himalayan blackberry, western dogwood (*Cornus nuttallii*), sword fern, and tanoak were overhanging. The over-story canopy cover consists of pine and tanoak. No fish or amphibians were observed. Surrounding upland is second-growth, mixed coniferous/deciduous forest.

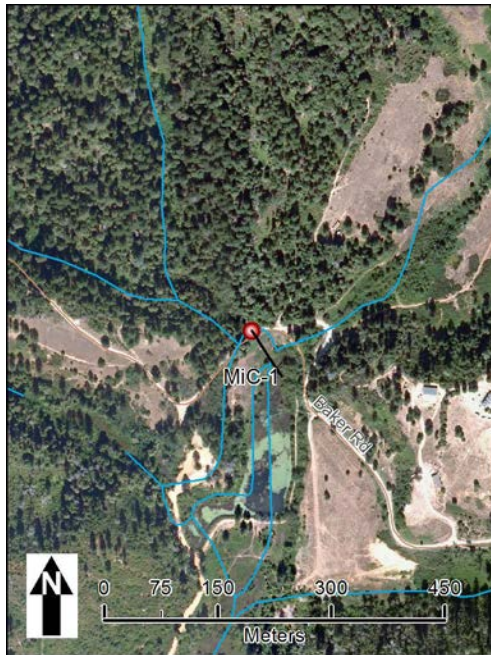
The site was assessed on March 5, 2012 from Baker Road, accompanied by Forest Service and SWRCB agency staff listed in the WaC1 description above. MiC1 is a pond that is impounded by Baker Road and discharges through a culvert under the road. The site covers approximately 200 m². The maximum observed water depth was estimated to be 0.2 m. The substrate was mud/soil and leaf litter/detritus. Emergent vegetation was mainly limited to the margins of the impoundment, and consisted of scouring rush (*Equisetum hyemale*) and scattered cattail. Numerous live willow runners also occurred. Himalayan blackberry and willow were overhanging the pond perimeter. The over-story canopy cover consisted of willow, madrone, and pine. No fish or amphibians were observed. Surrounding upland is second-growth, mixed coniferous/deciduous forest.

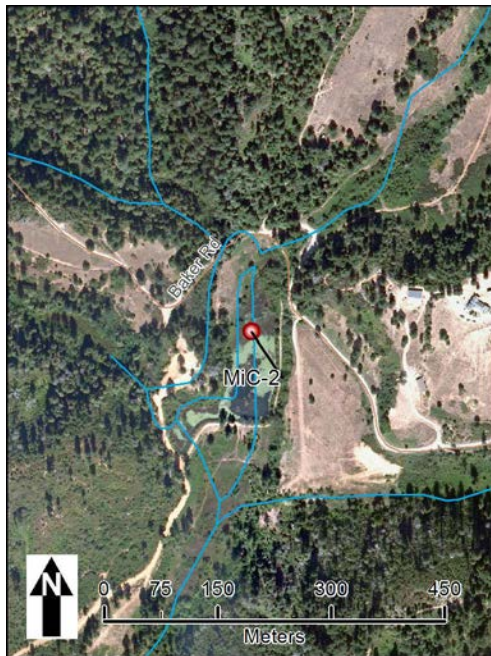
MiC2 is a large impounded wetland that occurs within 1.6 km of New Bullards Bar Reservoir. MiC2 is located on the mainstem of Mill Creek, approximately 878 m north of New Bullards Bar Reservoir and 795 m outside of the FERC Project Boundary on private land. MiC2 is 5.3 km from the nearest known CRLF occurrence and outside of the USFWS critical habitat unit. National Wetlands Inventory (NWI) data for the area (USFWS 2011) depict MiC1 as a palustrine, open water, artificially flooded, intermittently exposed (POWKZ) wetland feature associated with Mill Creek.

south portion of the feature is mostly open water and was visually estimated to have a maximum depth of at least a meter; the north portion of the feature is not as deeply inundated and is likely less than 0.5m at maximum depth. Dense cattail surrounds the margin of the open water feature and becomes denser to the north. Dense rushes, grasses, and willows were growing throughout the north portion of the wetland. The over-story canopy cover consisted of willow, madrone, and pine. The substrate was mud/soil and leaf litter/detritus. No fish or amphibians were observed. Surrounding upland is second-growth, mixed coniferous/deciduous forest.

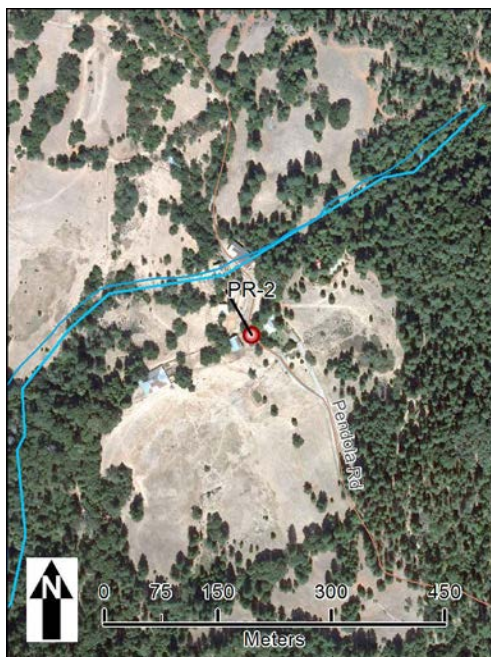
PR2 is a perennial stock pond that occurs within 1.6 km of New Bullards Bar Reservoir. PR2 is located west of Pendola Road, approximately 1 km north of New Bullards Bar Reservoir and 897 m outside of the FERC Project Boundary on private land. PR2 is 9 km from the nearest known CRLF occurrence and outside of the USFWS critical habitat unit. This site is not depicted as a wetland on NWI maps of the area.

observed in the pond. Surrounding upland is mainly grassland with patches of oak trees.

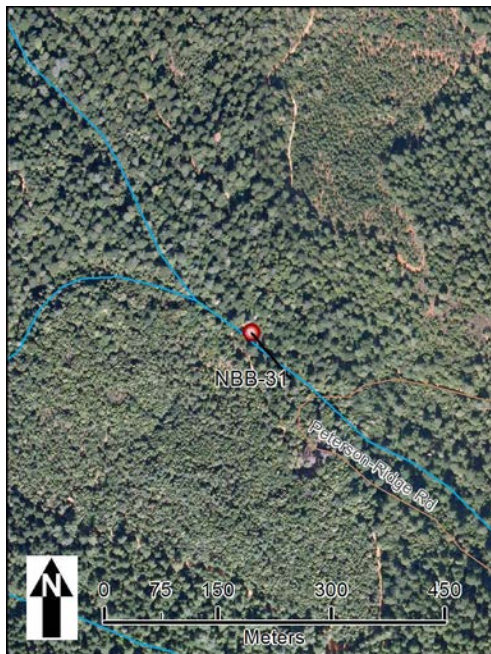
NBB31 is a portion of an unnamed perennial tributary to New Bullards Bar Reservoir. NBB31 is located 1.1 km west of New Bullards Bar Reservoir and 1.1 km outside of the FERC Project Boundary on the Plumas National Forest. NBB31 is 4.5 km from the nearest known CRLF occurrence, and is located outside of the USFWS critical habitat unit. This site is not depicted as a wetland on NWI maps of the area.

maple (*Acer macrophyllum*). No fish or amphibians were observed; however, no known barriers occur between NBB31 and New Bullards Bar Reservoir. Surrounding upland is second-growth, mixed coniferous/deciduous forest.

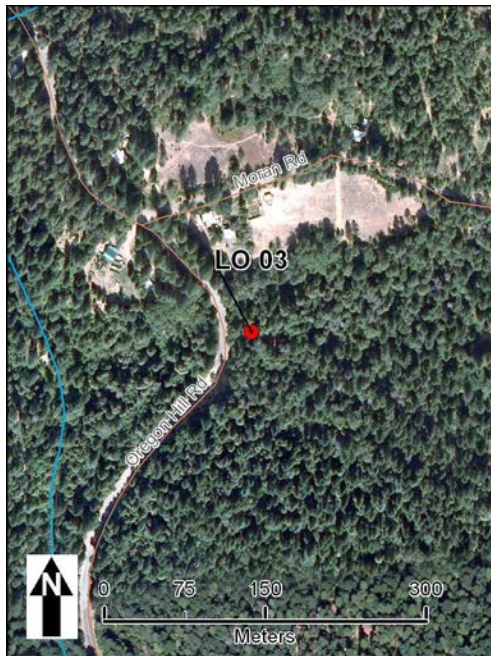
LO3 is a 10-m-long section of an unnamed perennial left bank tributary of Little Oregon Creek, located at a crossing of Oregon Hill Road, 1.3 km west of New Bullards Bar Reservoir, and 1.2 km outside of the FERC Project Boundary on private land. LO3 is 695 m from the nearest known CRLF occurrence and within the USFWS critical habitat unit. The site is not depicted as a wetland on NWI maps of the area.

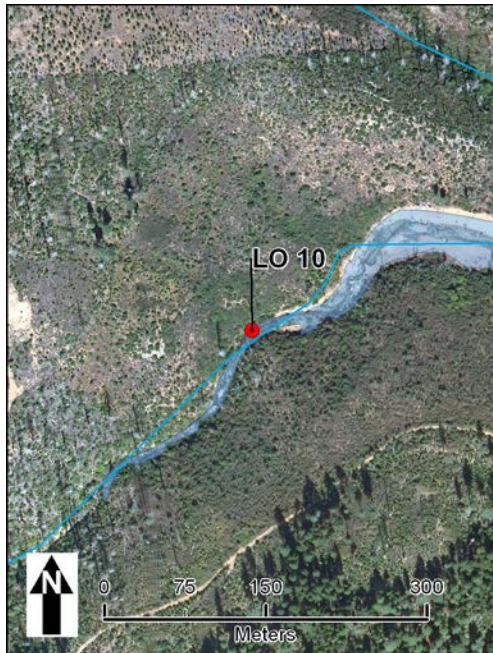
The site was assessed on November 16, 2011. Little Oregon Creek flows into New Bullards Bar Reservoir; LO10 is downstream of LO1, LO14, LO20, and LO18. The bank full width was estimated to be 7 m, and the bank full depth was 1.8 m. The stream gradient was approximately 3 percent. One large pool was present, measuring approximately 5 m x 7 m, with a maximum depth of 1.1 m. Non-pool habitat was riffle. The substrate was bedrock, boulder, and cobble. The banks were steep bedrock. Scattered Indian rhubarb (*Darmera peltata*) and small-fruited bulrush (*Scirpus microcarpus*) were emergent; scattered alder was overhanging. No fish or amphibians were observed; however, fish are known to be present in Little Oregon Creek. Surrounding upland is early successional, shrub-stage vegetation regenerating from a 1999 fire.

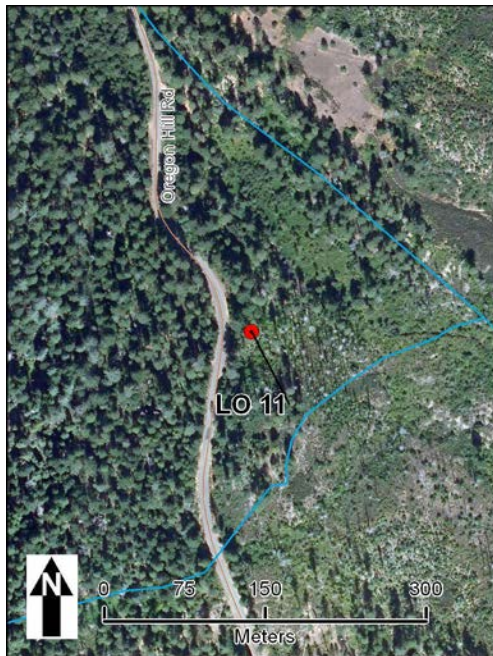
LO11 is a palustrine emergent wetland, located in conifer forest, approximately 20 m east of Oregon Hill Road, 673 m west of New Bullards Bar Reservoir, and 513 m outside of the FERC Project Boundary on the Plumas National Forest. LO11 is 247 m from the nearest known CRLF occurrence and within the USFWS critical habitat unit. This site is not depicted as a wetland on NWI maps of the area.

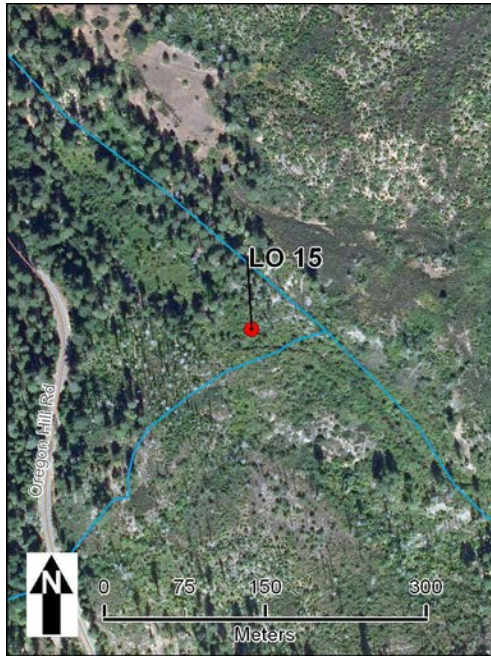
LO15 is a palustrine emergent wetland located on the edge of conifer forest and scrub shrub approximately 529 m west of New Bullards Bar Reservoir and 429 m outside of the FERC Project Boundary on the Plumas National Forest. LO15 is 291 m from the nearest known CRLF occurrence and within the USFWS critical habitat unit. This site is not depicted as a wetland on NWI maps of the area.

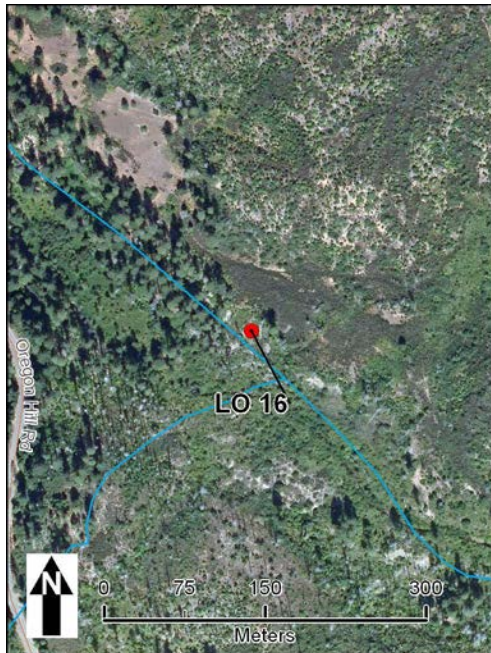
The site was assessed on November 14, 2011. LO16 is an irregularly-shaped shallow depression formed from mine tailings north of Little Oregon Creek; there is no defined channel connection between the two features. The site covers approximately 725 m². The maximum observed water depth was 0.1 m; bank full depth was estimated to be 0.25 m. Some large woody material occurred within the wetted perimeter. Substrate consisted of detritus, leaf litter, and mud/sand. Emergent vegetation was very dense and included small-fruited bulrush, soft rush, slough sedge (*Carex obnupta*), spike-rush (*Eleocharis* sp.), and common cattail. Willow is overhanging. No amphibians were observed; fish access is not possible. Surrounding upland is mixed conifer/deciduous forest early successional, shrub-stage vegetation regenerating from a 1999 fire.

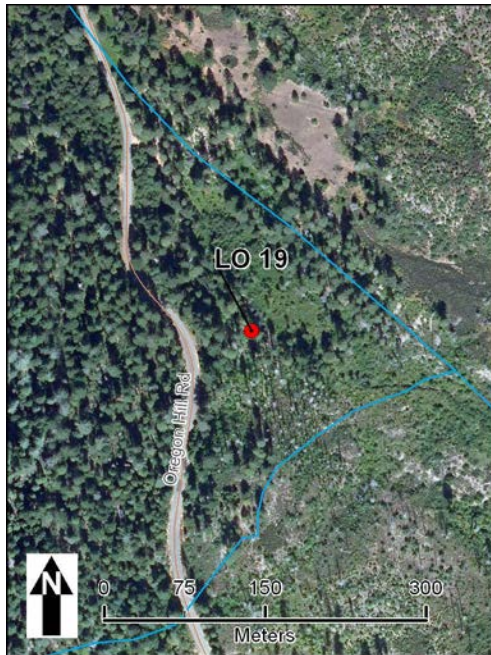
The site was assessed on November 14, 2011. LO19 is a trench-like depression above the right bank of Little Oregon Creek; the feature likely receives overbank flooding from Little Oregon Creek during high flow events. The site covers approximately 66 m². The maximum observed water depth was 0.1 m; bank full depth was estimated to be 0.2 m. Some large woody material occurs within the wetted perimeter. Substrate consists of detritus and silt/sand. Vegetation in the east portion of the wetland was limited to overhanging Himalayan blackberry; the west portion of the wetland was vegetated with dense American brooklime. The substrate was sand, gravel, and cobble; the banks were steep and incised. No amphibians or fish were observed; however, fish are known to be present in Little Oregon Creek. Surrounding upland is mixed conifer/deciduous forest, portions of which had been burned during a 1999 fire.

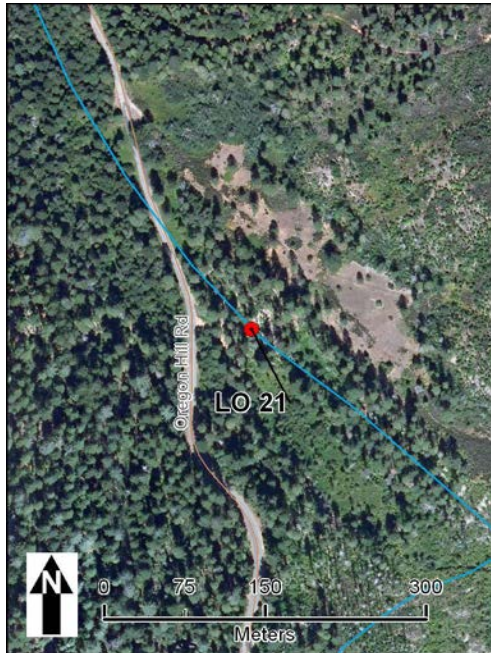
LO21 is a palustrine emergent wetland, located 83 m east of Oregon Hill Road, approximately 759 m west of New Bullards Bar Reservoir, and 640 m outside of the FERC Boundary on the Plumas National Forest. LO21 is in same network of mine tailing depressions as reported CRLF occurrence. This site is not depicted as a wetland on NWI maps of the area.

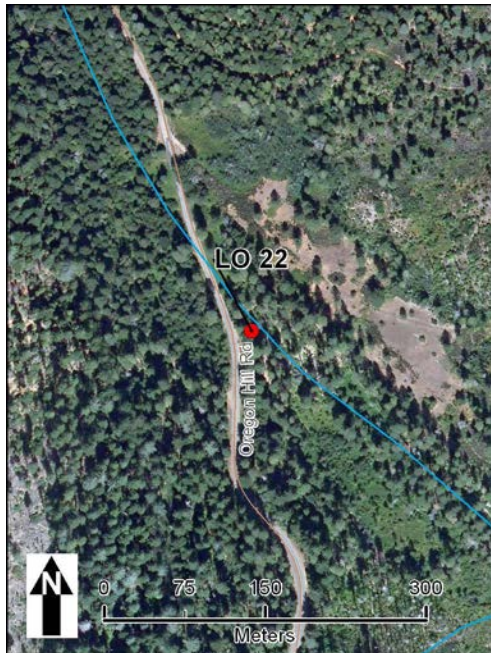
The site was assessed on November 14, 2011. LO22 is situated in an area of mine tailings and includes two depressions which hold water seasonally. The site covers approximately 8 m². The site held no standing water when examined. Based on the vegetation patterns, much of the site may be dry by early spring. The substrate was debris and soil. Giant chain fern and alder saplings are dominant within the depressions. An adult Sierra newt was observed in the adjacent uplands. The site is not accessible to fish. Surrounding upland is mixed conifer/deciduous forest.

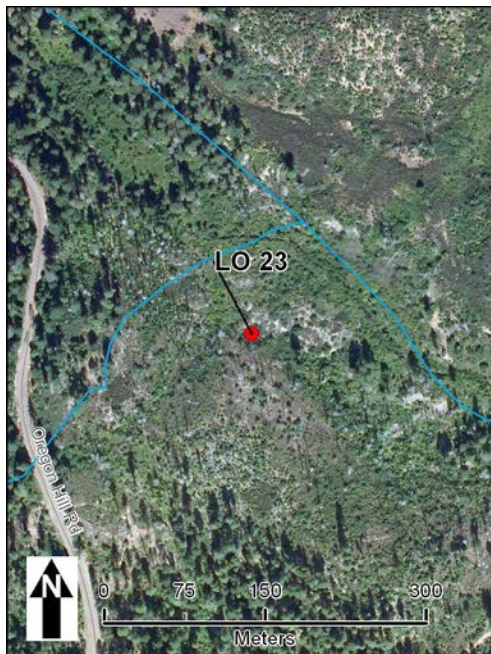
LO23 is a palustrine emergent wetland, located between Oregon Hill Road and Little Oregon Creek, 500 m west of New Bullards Bar Reservoir, and 406 m outside of the FERC Project Boundary on the Plumas National Forest. LO23 is 1.1 km from the nearest known CRLF occurrence and within the USFWS critical habitat unit. This site is not depicted as a wetland on NWI maps of the area.

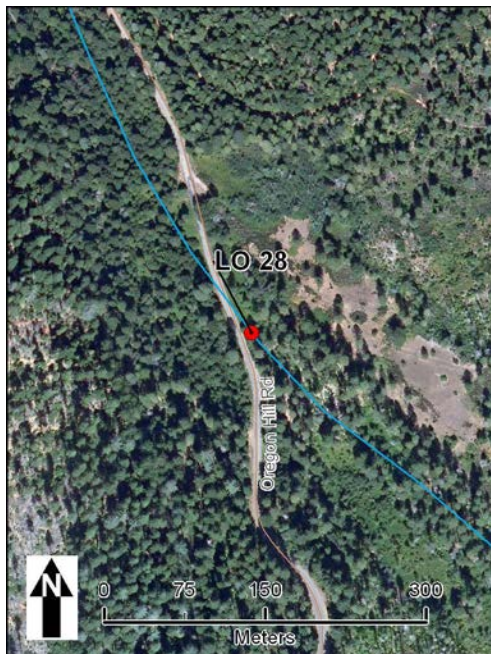
1.2.49 LO28

LO28 is a palustrine emergent wetland located in conifer forest, approximately 5 m east of Oregon Hill Road, 840 m west of New Bullards Bar Reservoir, and 719 m outside of the FERC Project Boundary on the Plumas National Forest. LO28 is one of the reported locations of CRLF in the assessment area and within the USFWS critical habitat unit. This site is not depicted as a wetland on NWI maps of the area.

The Forest Service provided information on the site location; the site was located accompanied by M. Tierney, USFS biologist and photographed on December 19, 2011. The site was formally assessed on March 5, 2012 accompanied by Forest Service and SWRCB agency staff listed in the WaC1 description above. The site is one of two reported locations of CRLF in the assessment area, with the first observations in 2000. LO28 is situated in an extensive

area of mine tailings and associated with an apparent kidney-shaped excavation. The site is approximately 35 m². The maximum observed water depth was 0.25 m; bank full depth was

estimated to be 0.3 m. The pond was dominated by small-fruited bulrush, American brooklime, soft rush and pondweed, with some scouring rush and willows near the pond edge. Large woody material occurred within the wetland perimeter. No amphibians were observed. The site is not accessible to fish. LO28 is bound on the west side by the Oregon Hill Road embankment and on other sides by mine tailing berms. Surrounding upland is mixed conifer/deciduous forest, portions of which had been burned during a 1999 fire.

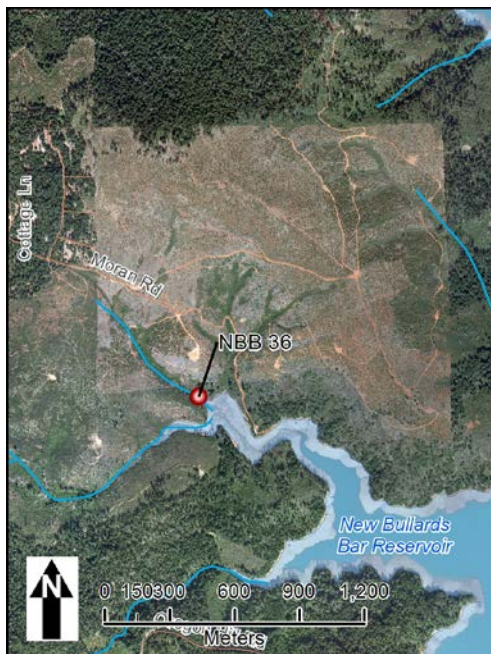
1.2.52 NBB36

NBB36 is a 10-m-long section of an unnamed perennial stream, located approximately 17 m north of New Bullards Bar Reservoir at Moran Cove, within the FERC Project Boundary on the Plumas National Forest. NBB36 is 1.1 km from the nearest known CRLF occurrence and within the USFWS critical habitat unit. This site is not depicted as a wetland on NWI maps of the area.

The site was examined on October 19, and formally assessed on November 16, 2011. NBB36 is in a separate tributary west of NBB35A and NBB35B that flows into New Bullards Bar Reservoir at Moran Cove. The bank full width was approximately 1.5 m and the bank full depth was 0.2 - 0.3 m. The stream gradient was approximately 5 percent. No pools occur. Non-pool habitat was riffle. The substrate was silt, sand, and gravel. The banks were steep and densely vegetated with Himalayan blackberry. Field horsetail (*Equisetum hyemale*), soft rush, and mannagrass (*Glyceria* sp.) were dominant at edgewater of the stream; Himalayan blackberry, alder, and willows were overhanging. No fish or amphibians were observed. Surrounding upland is early successional, shrub-stage vegetation.

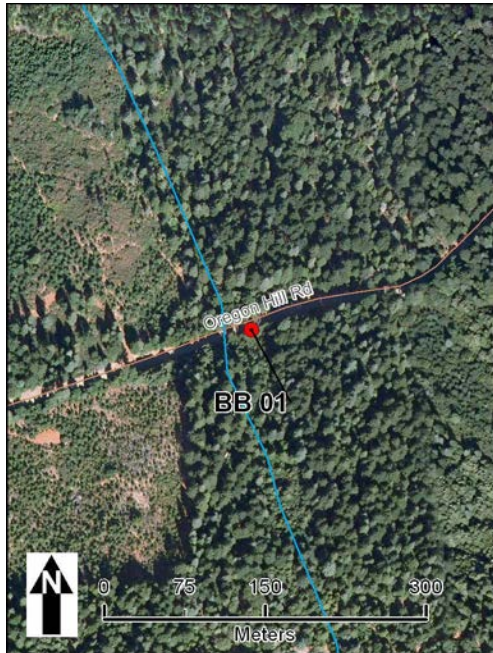
1.2.53 BB1

BB1 is a 4-m-long section of an ephemeral tributary to Burnt Bridge Creek, located approximately 1.1 km west of New Bullards Bar Reservoir, and 570 m outside of the FERC Project Boundary on the Plumas National Forest. BB1 is 1.9 km from the nearest known CRLF occurrence and within the USFWS critical habitat unit. This site is not depicted as a wetland on NWI maps of the area.

The site was examined on October 18 and formally assessed on November 15, 2011. BB1 is a colluvial, headwater tributary to Burnt Bridge Creek and did not hold water during either site visit. BB1 is in the same drainage, but upstream of BB2. Based on abundant leaf litter in the poorly defined channel, BB1 is an ephemeral stream conveying runoff after precipitation events. The bank full width was estimated to be 2 m, and the bank full depth was 0.15 m. The stream

gradient was approximately 5 percent. Based on gradient, aquatic habitat consisted of riffle; no pools occur. The substrate was cobble and gravel, and large woody material was abundant in the streambed. The shallow, barely formed stream banks were sparsely vegetated with California honeysuckle (*Lonicera hispidula*). There was no emergent or overhanging vegetation. No fish or amphibians were observed. Surrounding upland habitat is coniferous forest.

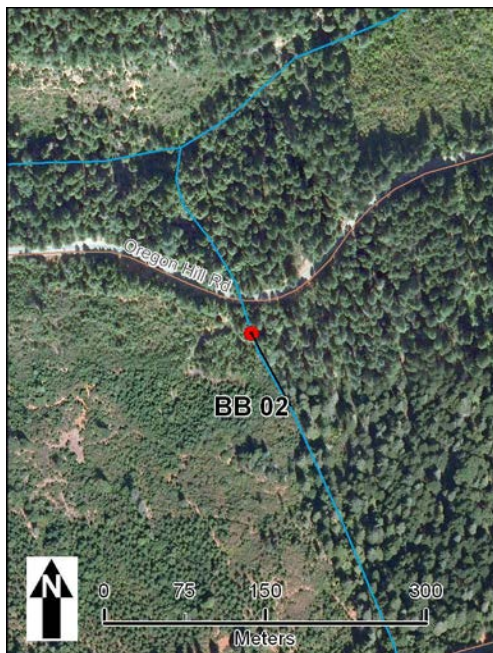
1.2.54 BB2

BB2 is a 40-m-long section of a perennial tributary to Burnt Bridge Creek, located approximately 970 m west of New Bullards Bar Reservoir, and 252 m outside of the FERC Project Boundary on private property. BB2 is 1.5 km from the nearest known CRLF occurrence and within the USFWS critical habitat unit. This site is not depicted as a wetland on NWI maps of the area.

The site was examined on October 18 and formally assessed on November 15, 2011. BB2 is in the same drainage as BB1; however, BB2 receives water via a hillside seep down-slope of BB1, and BB1 is ephemeral. The bank full width was estimated to be 1.5 m, and the bank full depth was 0.6 m. The stream gradient was approximately 7 percent; the gradient was about 10 percent upslope of the assessment location. One pool was present, measuring 1 m x 1 m, with a maximum depth of 0.6 m. Non-pool habitat was riffle.

The substrate was cobble and gravel, and large woody material was abundant in the streambed. The steep and incised banks were primarily gravel and boulder and sparsely vegetated at the road crossing with overhanging giant chain fern, madrone, Himalayan blackberry, tanoak, and western dogwood. Further upstream, overhanging vegetation was very dense and consisted primarily of Himalayan blackberry. Emergent vegetation was absent. No fish or amphibians were observed. Surrounding upland habitat is mixed coniferous/deciduous forest; early successional, shrub-stage vegetation regenerating from logging activities borders the stream on the south west side.

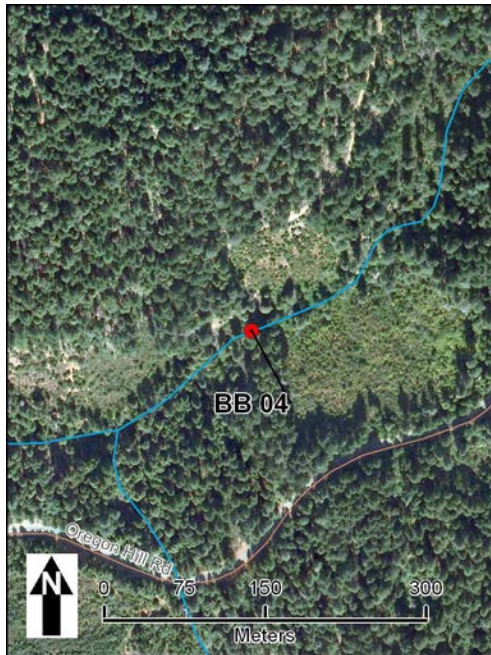
1.2.56 BB4

BB4 is a 12-m-long section of a perennial stream, Burnt Bridge Creek, located approximately 760 m west of New Bullards Bar Reservoir, within the FERC Project Boundary on the Plumas National Forest. BB4 is 1.3 km from the nearest known CRLF occurrence and is within the USFWS critical habitat unit. NWI maps of the area (USFWS 2011) depict a palustrine, forested, semi-permanent/seasonal/saturated (PFOY) linear wetland feature along the lower portion of Burnt Bridge Creek, including this site.

The site was examined on October 18 and formally assessed on November 16, 2011. Burnt Bridge Creek flows into New Bullards Bar Reservoir; BB4 is downstream of BB3. The bank full width was estimated to be 6 m, and the bank full depth was 0.6 m. The stream gradient ranged from 1 to 2 percent. One large pool was present, measuring approximately 4 m x 8 m, with a maximum depth of 0.3 m. Non-pool habitat was riffle. The substrate was mud, silt and sand with some organic matter; large woody material was abundant in the channel. The banks were low gradient and consisted of soil. Emergent vegetation was absent; western dogwood, Himalayan blackberry, beaked hazelnut (*Corylus cornuta*) and California wild grape were overhanging. Himalayan blackberry and California wild grape were very dense and covered the stream channel downstream of the large pool. No fish or amphibians were observed. Surrounding upland is

mixed coniferous/deciduous forest and a small area of early successional, shrub-stage vegetation regenerating from logging activities just downstream of BB4, outside of a 30 m riparian buffer.

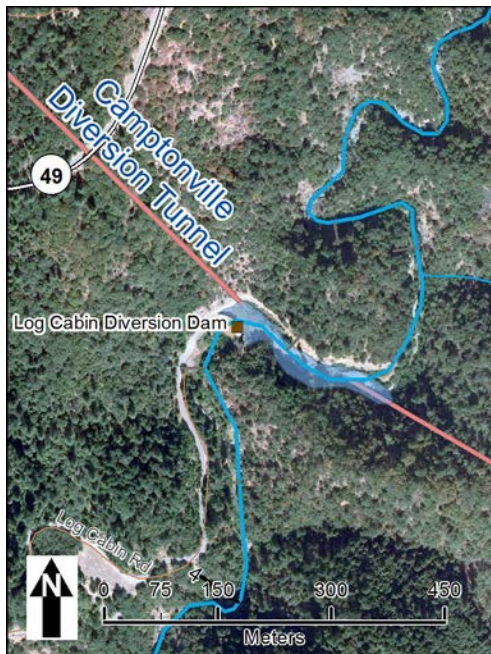
1.2.59 Log Cabin Diversion Dam Impoundment

Log Cabin Diversion Dam Impoundment is located on Oregon Creek, a perennial stream. The impoundment is located 1.8 km west-southwest of New Bullards Bar Reservoir, within the FERC Project Boundary on YCWA property and the Tahoe National Forest. Log Cabin Diversion Dam Impoundment is 10.1 km from the nearest known CRLF occurrence, and is located outside of the USFWS critical habitat unit. National Wetlands Inventory (NWI) data for the area (USFWS 2011) depict Log Cabin Diversion Dam Impoundment as a palustrine, open water, artificially flooded, intermittently exposed (POWKZ) wetland feature.

Oregon Creek, a tributary to the Middle Yuba River, originates at an elevation of approximately 5,600 feet and flows southwesterly for about 21.4 mi to where it converges with the Middle Yuba River. Log Cabin Diversion Dam is located at RM 4.1. Streams as large

wide, and has a maximum bank full depth of about 4 to 5 m. The substrate was cobble in the upstream portion of the impoundment, and silt/sand in the downstream portion of the impoundment. The right bank was steep boulder; the left bank was moderately steep to steep boulder and bedrock outcrop. Aquatic and emergent vegetation are limited in extent. Patches of submerged aquatic vegetation were growing in the sandy substrate; and only patches of sedges were found near the left bank. Willow was overhanging primarily on the right bank. Fish were observed in the impoundment. No amphibians were observed in the impoundment proper; however, foothill yellow-legged frogs (*Rana boylei*) have been detected upstream of the impoundment. At least one western pond turtle (WPT) (*Actinemys* [formerly *Emys* or *Clemmys*] *marmorata*) has been observed during 2012 basking surveys for the YRDP. Surrounding upland is second-growth, mixed coniferous/deciduous forest.

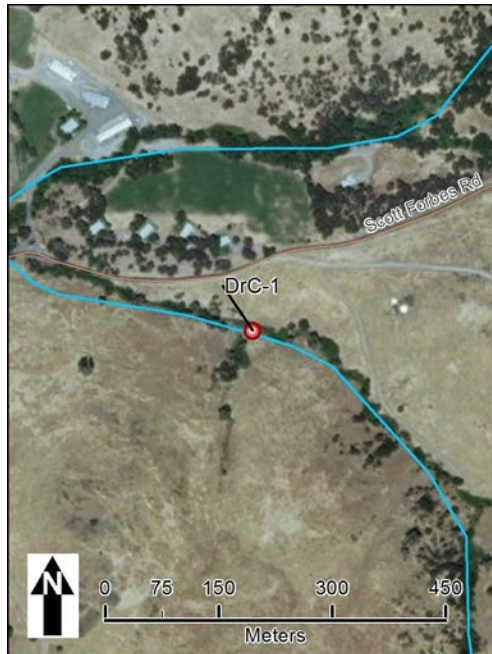
2.2.1 DrC1

DrC1 is a portion of a seasonal unnamed tributary to Dry Creek that is within 1.6 km of the Narrows 2 Access Road. It is a seasonal stream that is approximately one mi from Englebright Reservoir. DrC1 is 1.6 km outside of the FERC Project Boundary on State of California land. Dry Creek is 23.2 km from the nearest known CRLF occurrence, and is located outside of the USFWS critical habitat unit. This site is not depicted as a wetland on NWI maps of the area.

The site was assessed on March 3, 2012. DrC1 at bank full is approximately 2 m wide, and the bank full depth was estimated to be 0.5 m deep. The stream gradient averaged 1-2 percent. Pools within the stream measured approximately 1 m x 3.5 m, with a maximum depth of 0.25 m. Non-pool habitat was low-gradient riffle. The substrate was unknown, but likely sand/mud with cobble and gravel. The banks were moderately steep and consisted of soil. Dense emergent vegetation consisting of cattail and cress was growing throughout the channel; and California buckeye (*Aesculus californica*) was

overhanging along the bank. The over-story canopy cover along the banks consists of oak and pine. No fish or amphibians were observed. Surrounding upland consists of open grass meadows with some chaparral.

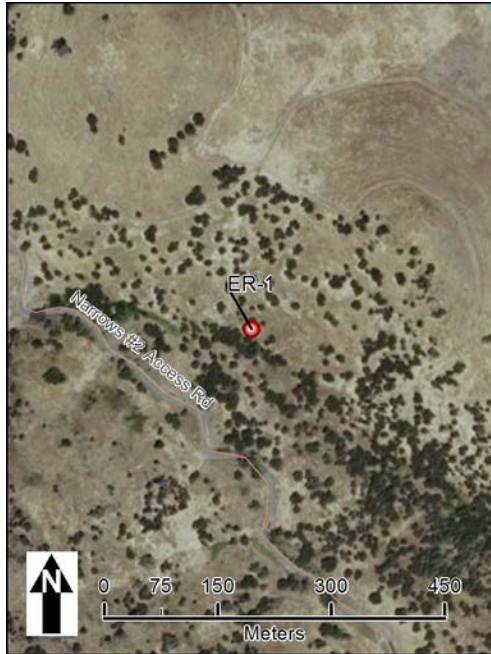
2.2.7 ER1

ER1 is a seasonal tributary to Englebright Reservoir located within 1.6 km of the Narrows #2 Access Road. ER1 is 100 m outside of the FERC Project Boundary on State of California land. ER1 is 22.0 km from the nearest known CRLF occurrence, and is located outside of the USFWS critical habitat unit. This site is not depicted as a wetland on NWI maps of the area.

The site was assessed on March 3, 2012. ER1 at bank full is approximately 4 m wide, and the bank full depth was estimated to be 0.15m. The stream gradient averaged between 1 and 2 percent. Pools within the stream measured approximately 4 m x 10 m, with a maximum depth of 0.1 m. Non-pool habitat was low-gradient riffle. The substrate was mud and sand. Dense cattail and soft rush were growing throughout the swale; overhanging vegetation was not present. The banks were low gradient soil and grass with some

cobble and boulders. No fish or amphibians were observed.
