INTERIM
TECHNICAL MEMORANDUM 7-11

**Fish Behavior and Hydraulics
Near Narrows 2 Powerhouse**

Yuba River Development Project
FERC Project No. 2246

November 2012

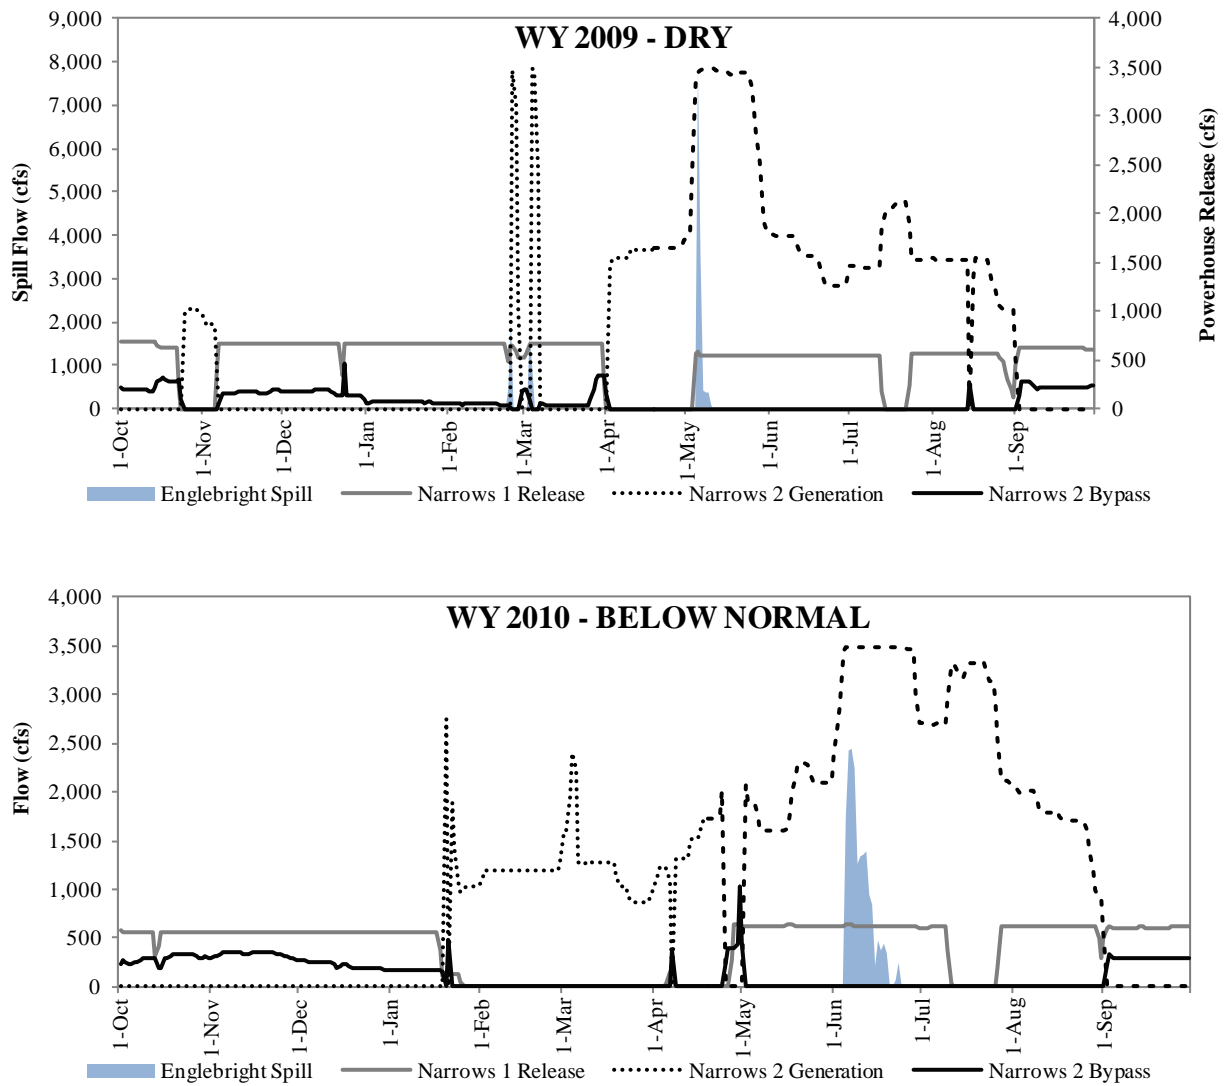
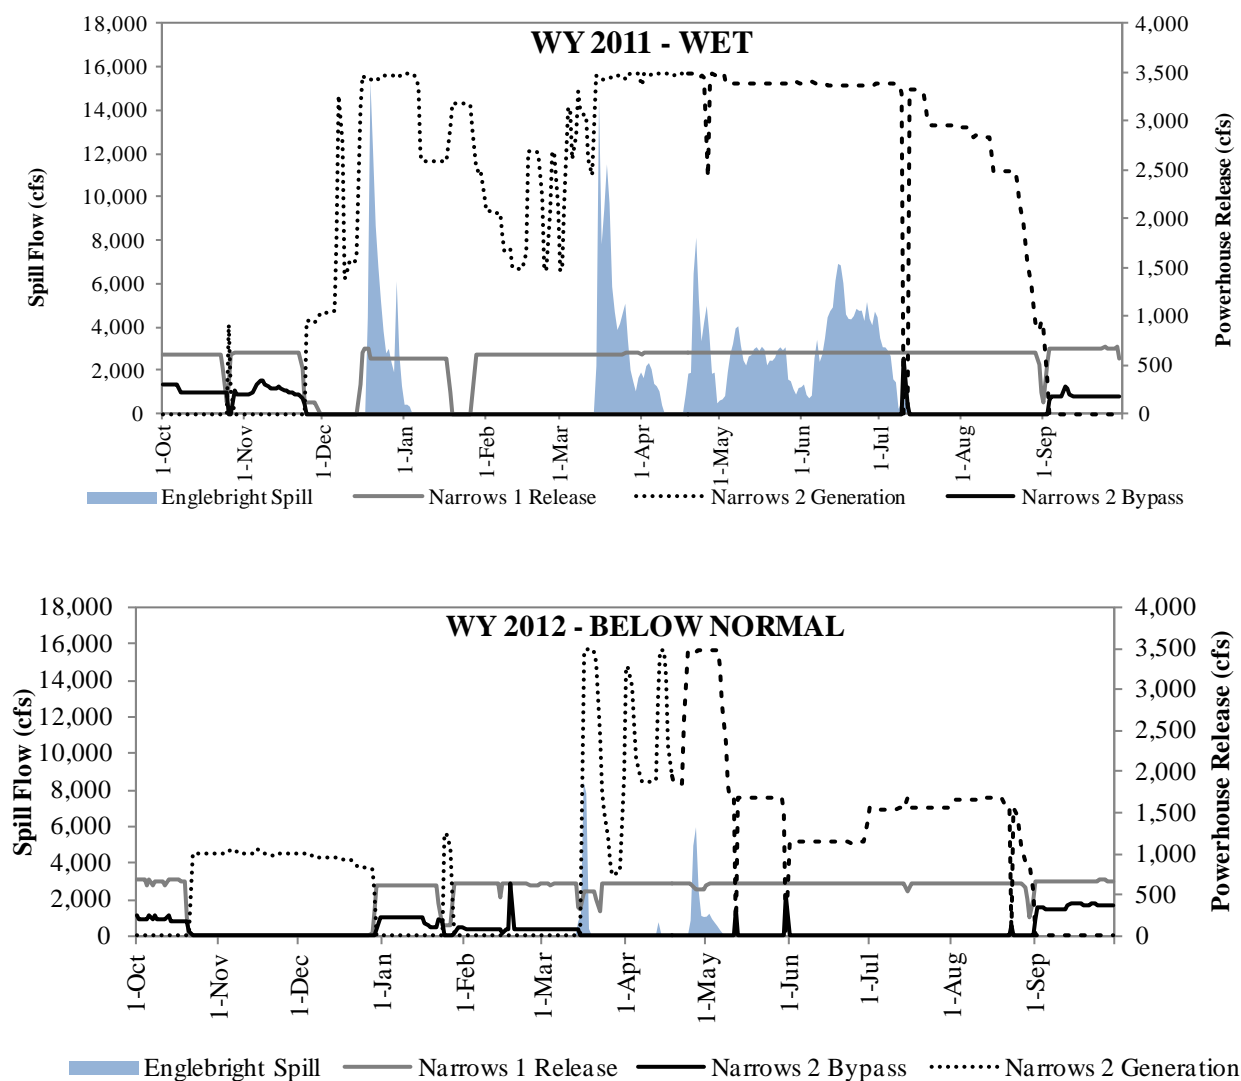
Figure 3.1-3. Daily mean release or spill from Narrows 1 and 2 powerhouses and Englebright Dam by in WYs 2009, 2010, 2011 and 2012.

In relation to capacity, operations of Englebright Dam, Narrows 1, and Narrows 2 powerhouses from WY 2009, following installation of the full bypass, to the current WY 2012 depended on water quantity (Figure 3.1-3). In wet years, like WY 2011, Narrows 1 Powerhouse operated at a predictable and steady rate. The 2009 dry water year also showed relatively steady operations from Narrows 1 Powerhouse, but in WY 2010 (below normal) operations were more variable. Narrows 2 Powerhouse releases fluctuated with the upstream hydrograph, passing upstream flows, and ramping up during potential spill events. Spill events were frequent in wet years (WY 2011).

Daily operational releases during WYs that are not designated as wet generally stayed within the operational capacity of the Narrows 2 Powerhouse (Figure 3.1-3). The cumulative flow downstream of Englebright and Daguerre Point dams is measured at the Marysville Gage (CDEC 2012). Water infiltration from the Yuba Goldfields may contribute additional water into the lower channel, but is considered not quantifiable within the scope of this report. When spill is

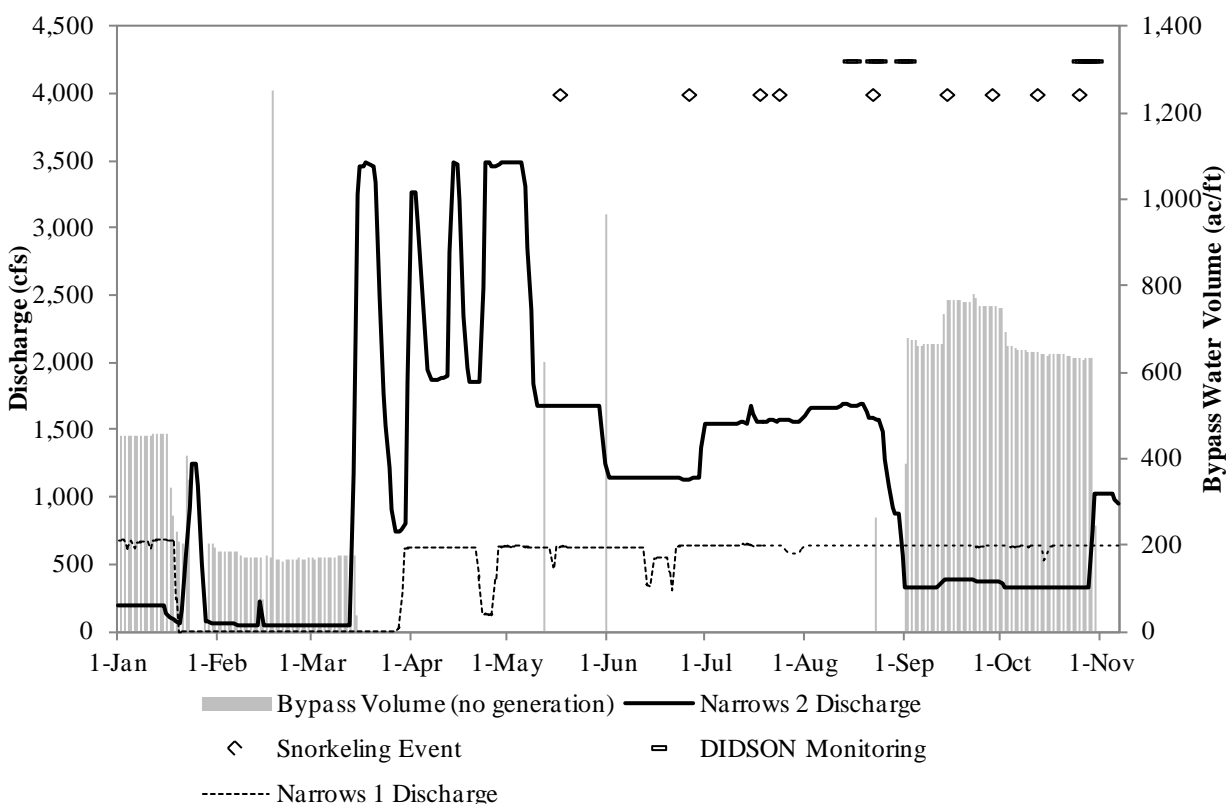
Figure 3.3-1. Summary of monitoring events based on the flow discharge at Narrows 2 Powerhouse from daily generation discharge or bypass flow volume from January through November 2012. (Bypass volume is the total volume of water passed through the full or partial bypasses, but not through the powerhouse.)

The timing of the direct observation snorkeling and DIDSON camera monitoring events relative to the Narrows 2 Powerhouse discharge is summarized in Figure 3.3-1.

Figure 3.3-1 shows the total amount of water released from the Narrows 2 Powerhouse (i.e. bypass or generated). Where bypass water overlaps (grey vertical bars in Figure 3.3-1), limited or no generation was occurring. Bypass flows were represented by both the full and partial bypasses.⁶ Water was passed through the bypasses and not generated primarily from January through early March and September through November, while powerhouse generation occurred from mid-March through September. The Narrows 1 Powerhouse was operational during the entire monitoring period.

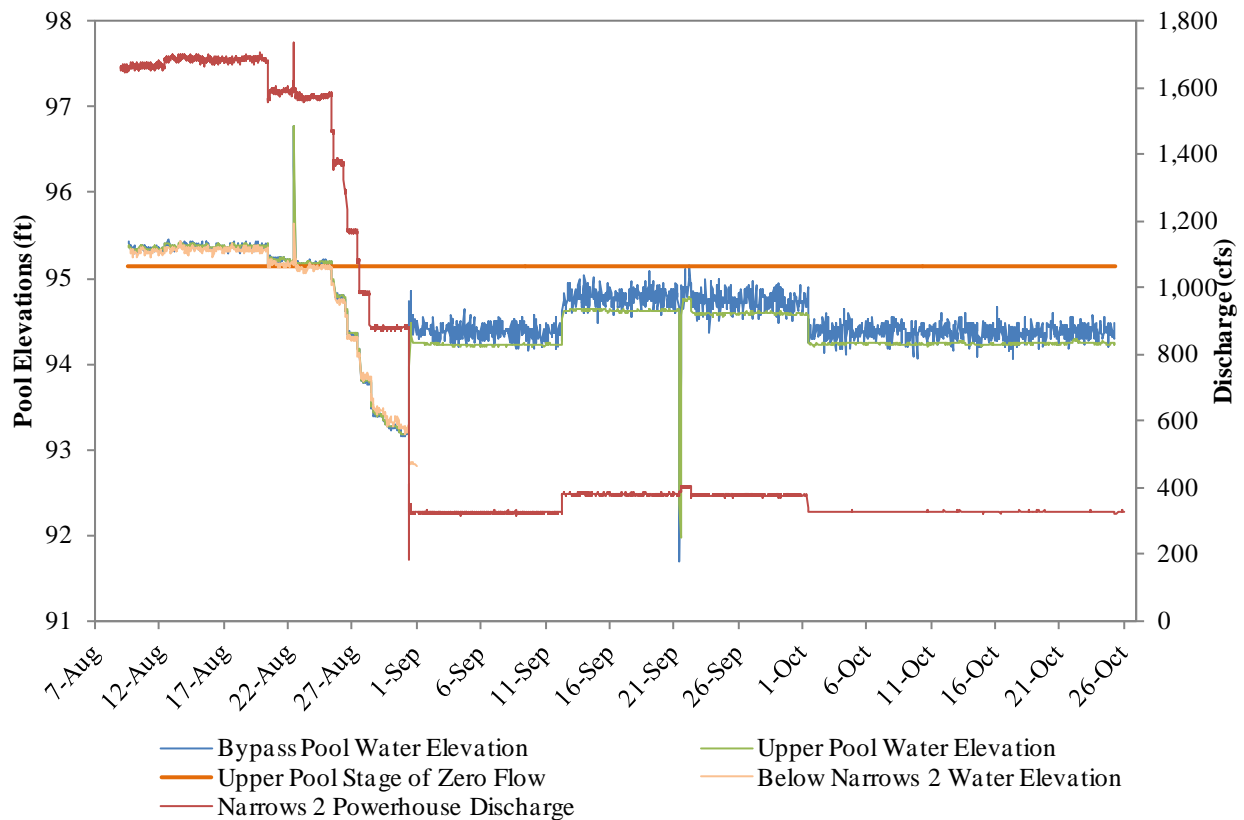
Figure 3.4-2. Discharge from the Narrows 2 Powerhouse and resultant water surface elevation at the Dam Pool, Bypass Pool and below the Narrows 2 Powerhouse.

The Dam Pool and Bypass Pool elevations remained nearly identical throughout the entire recording period (Figure 3.4-2). Both pools were directly influenced by the discharges from the powerhouse and releases from the full bypass. Both pools were connected by surface water at discharges above 1,570 cfs. At 1,660 cfs, the surface water channel connecting the two pools measures approximately 0.5 ft wide. Although biologists surveyed a stage at zero flow (SZF) for the Dam Pool at that channel, YCWA found that the two pools are connected through interstitial flow below the rocks and boulders which allows the Dam Pool to drain below the SZF. During a 2-day period where Narrows 2 was generating approximately 880 cfs, both pools continued to drain by almost 1 foot (Figure 3.4-2).

Following August 31, the full bypass was operated (Figure 3.4-2). A release of 326 cfs from the full bypass increased the water surface elevation for the Dam and Bypass pools higher than a discharge of 880 cfs from the powerhouse. On September 21, there was a notable variation in the elevation data. This was due to a brief operational change that required flow to be routed through the partial bypass. The reroute only lasted for a few hours while a minor repair was completed, but resulted in a change to the trend in water surface elevation.

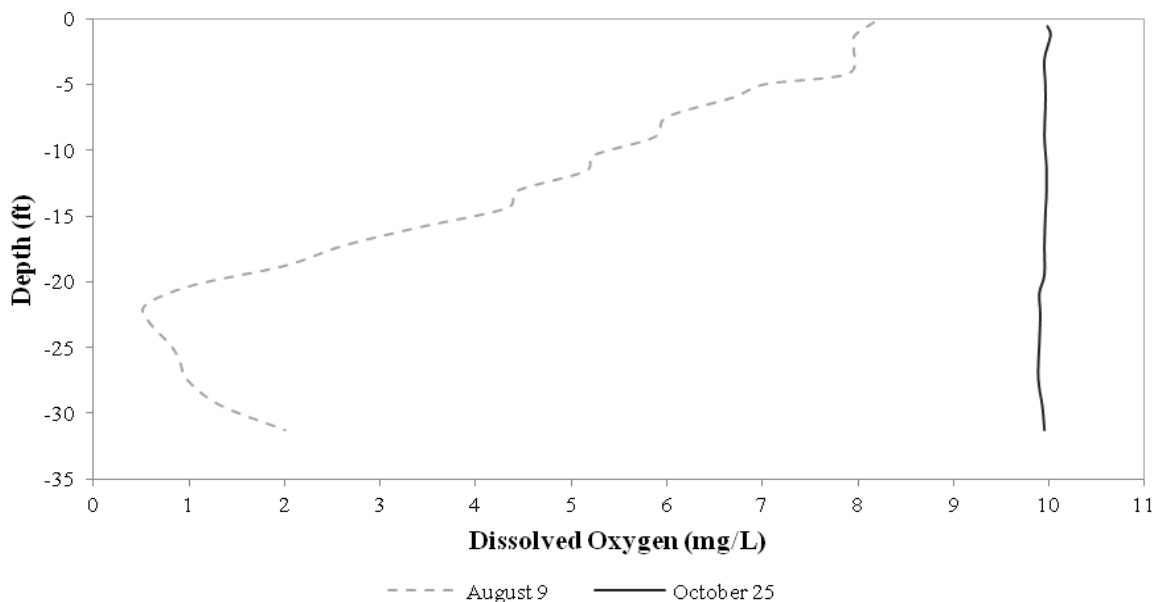
Figure 3.4-5. Profiles of DO in the Dam Pool on August 9 and October 25, 2012.

Instantaneous DO measurements captured on August 9 appeared stratified, with maximum measurements of 8.2 mg/L found near-surface. The minimum DO was located at 26.1 ft below water surface elevation (0.9 mg/L), rising slightly to 2.0 mg/L at near-bottom of the pool (31.3 ft deep). On October 25, 2012 DO levels increased as water temperatures lowered. Maximum DO was observed near-surface (10.0 mg/L) and minimum levels were found near the bottom (9.9 mg/L).

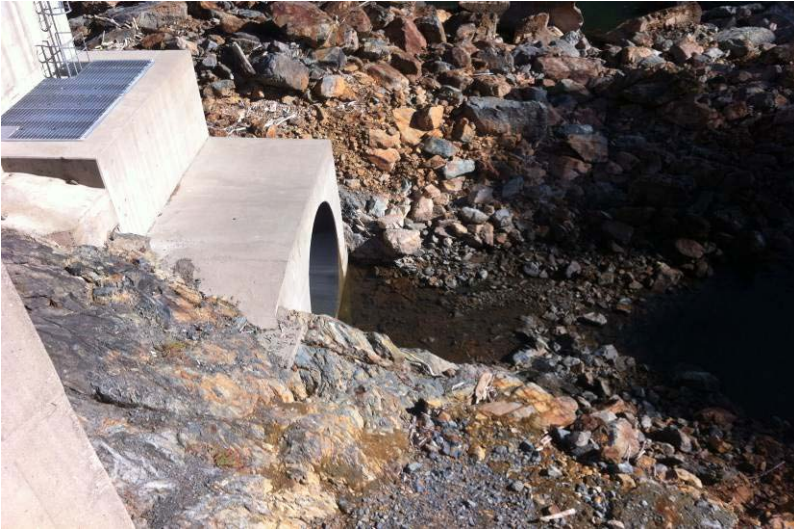
Figure 5. Full bypass valve looking upstream from Narrows 2 Powerhouse.

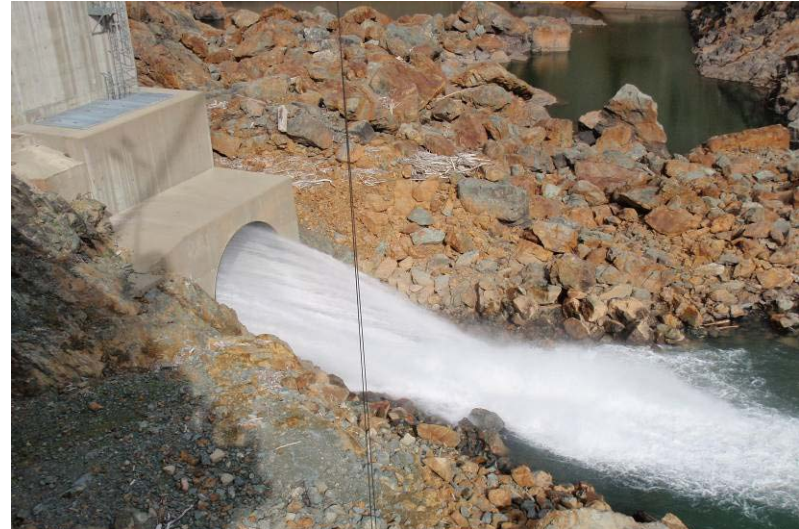
Figure 6. Operation of full bypass valve looking upstream from Narrows 2 Powerhouse.

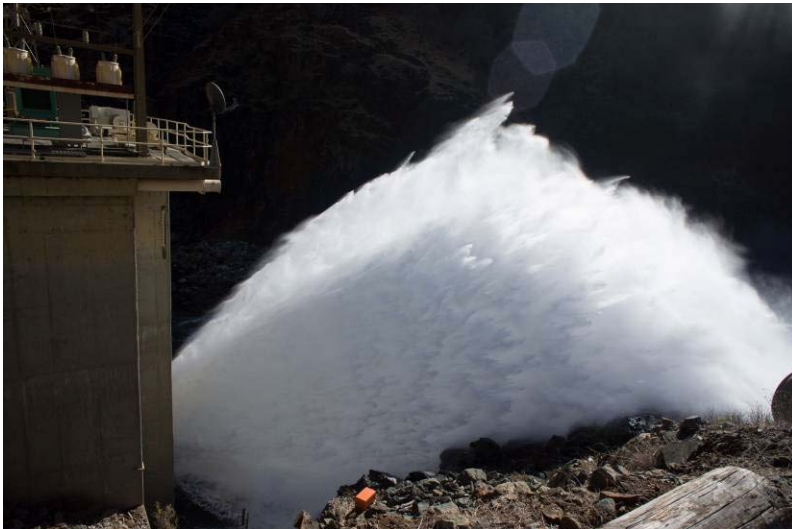
Figure 9. Narrows 2 Powerhouse during operation of partial bypass valve.

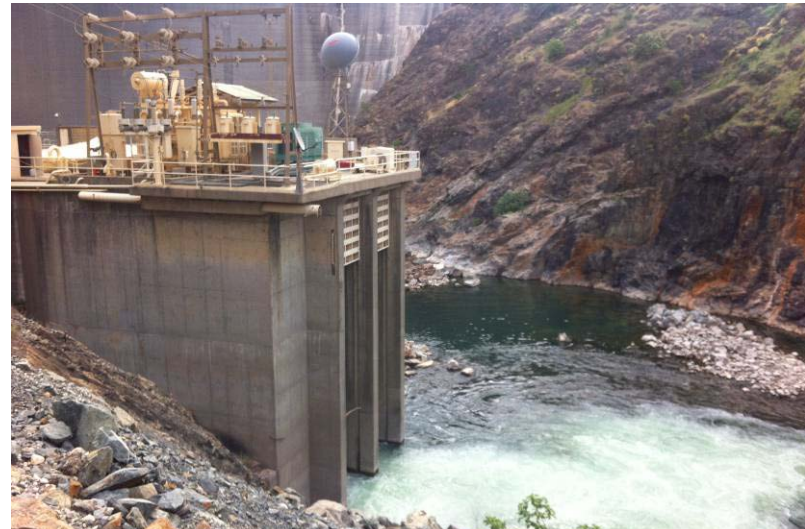
Figure 10. Narrows 2 Powerhouse during normal powerhouse generation (1,674 cfs).

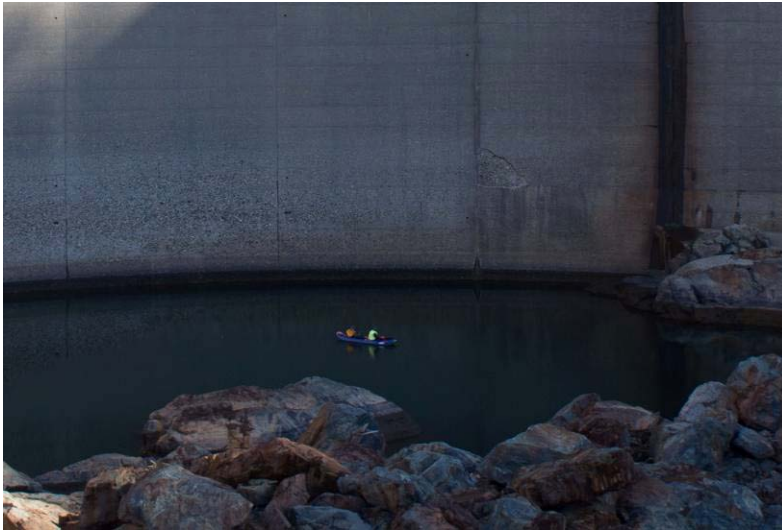
Figure 17. Temperature and dissolved oxygen profiles at the Englebright Dam Pool.

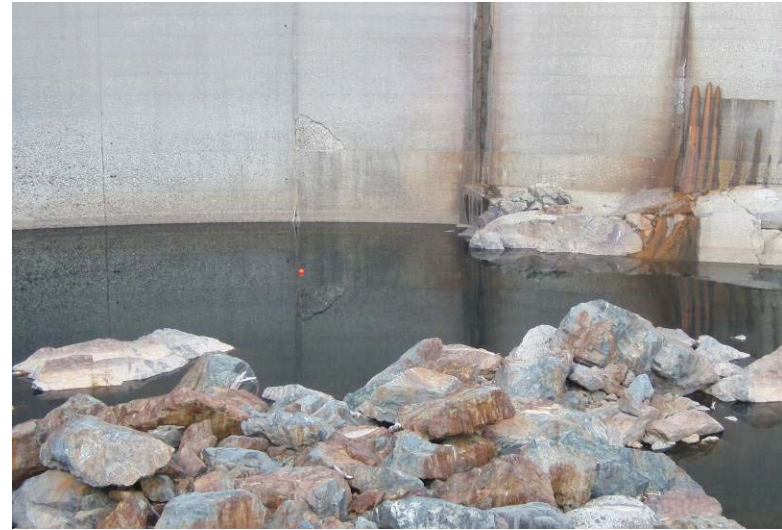
Figure 18. Temperature loggers attached to buoy (near-surface and pool bottom) at Englebright Dam Pool.

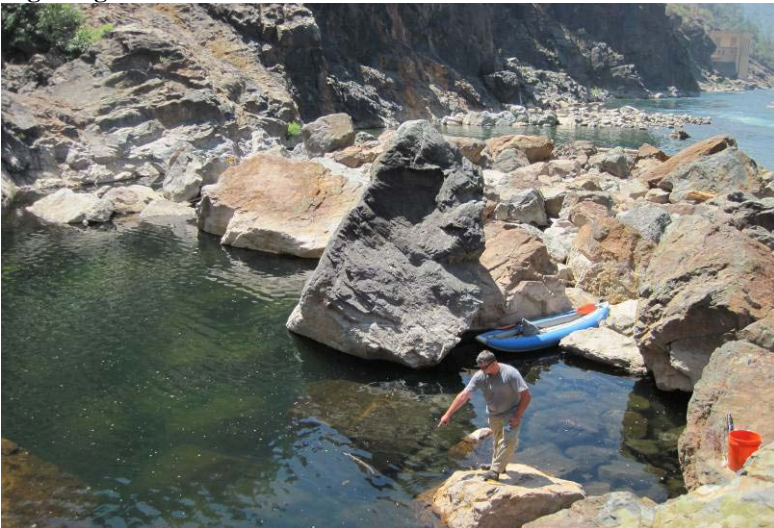
Figure 19. Water level logger location in the Dam Pool.

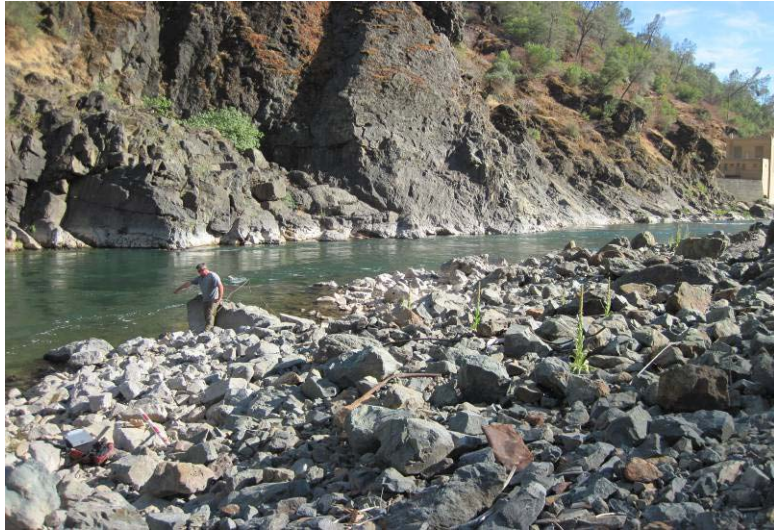
Figure 21. Water level logger location at tailout of Narrows 2 Pool.

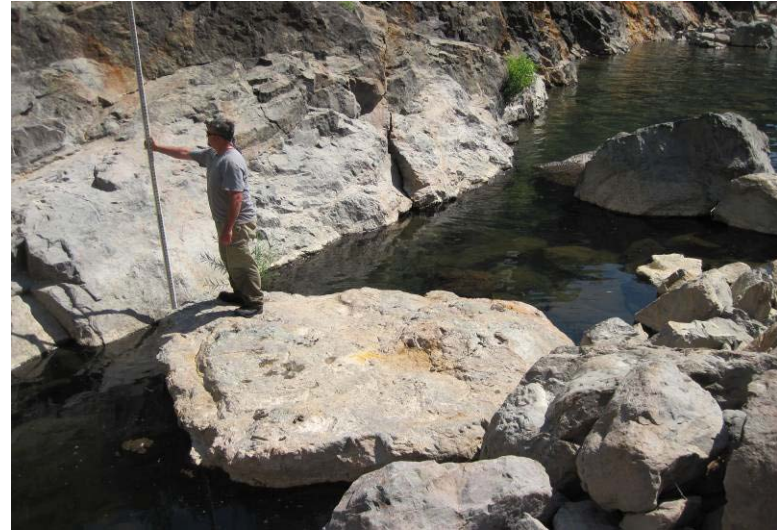
Figure 22. Blockage between dam pool and Bypass Pool (1,660 cfs).

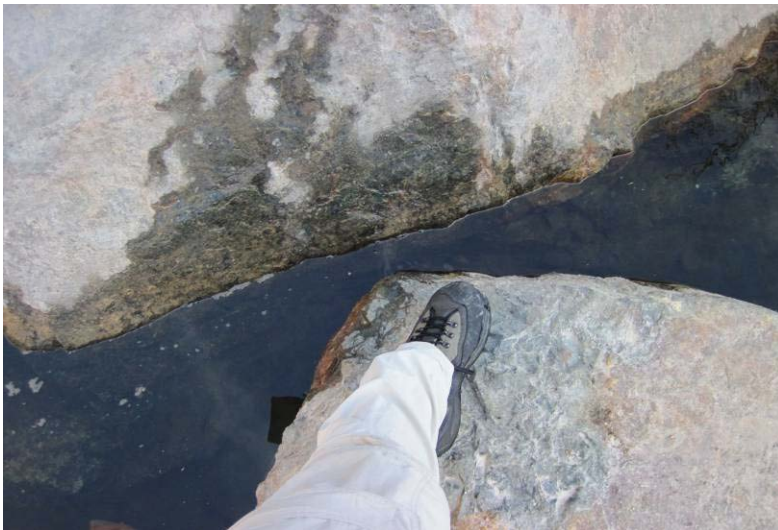
Figure 23. Accessibility at 1,660 cfs.

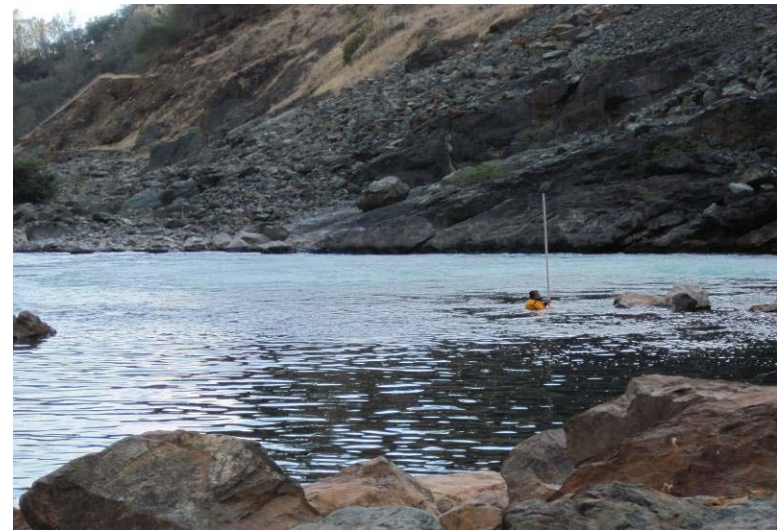
Figure 24. Survey of hydraulic control between Bypass Pool and Narrows 2 Pool.
