TECHNICAL MEMORANDUM 7-13

Fish Stranding Associated with Shutdowns of Narrows 2 Powerhouse Partial Bypass

**Yuba River Development Project
FERC Project No. 2246**

February 2014

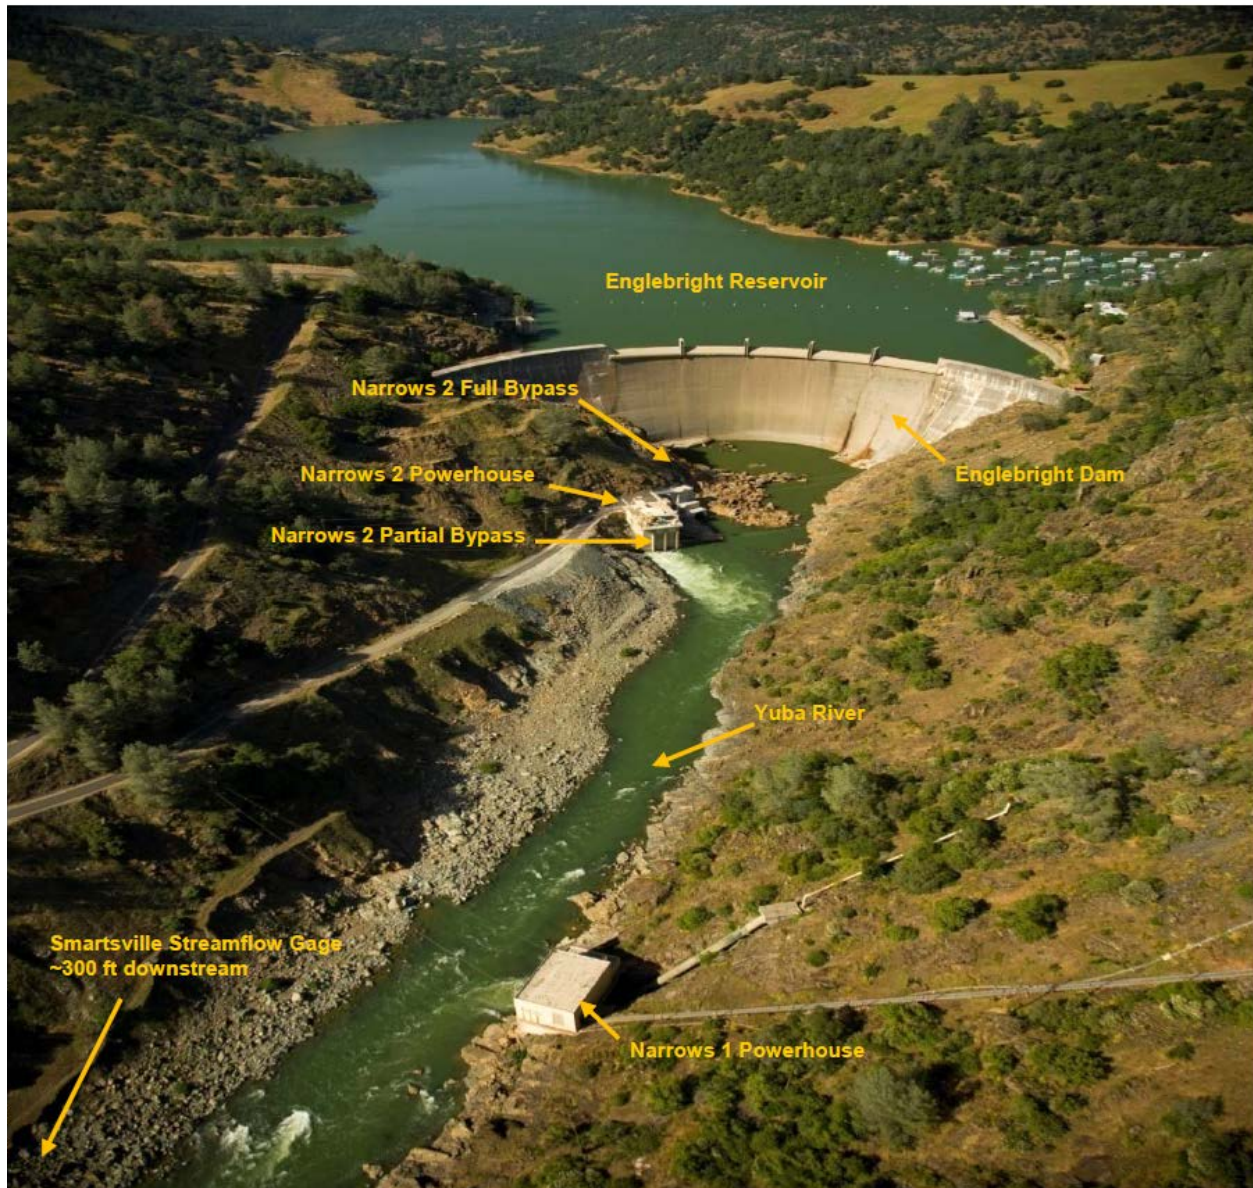
Figure 2.1-1. Locations of Narrows 2 Powerhouse, Narrows 2 Partial Bypass, Narrows 2 Full Bypass and Narrows 1 Powerhouse on the Yuba River in relation to Englebright Dam, and measurement of flows through the facilities.

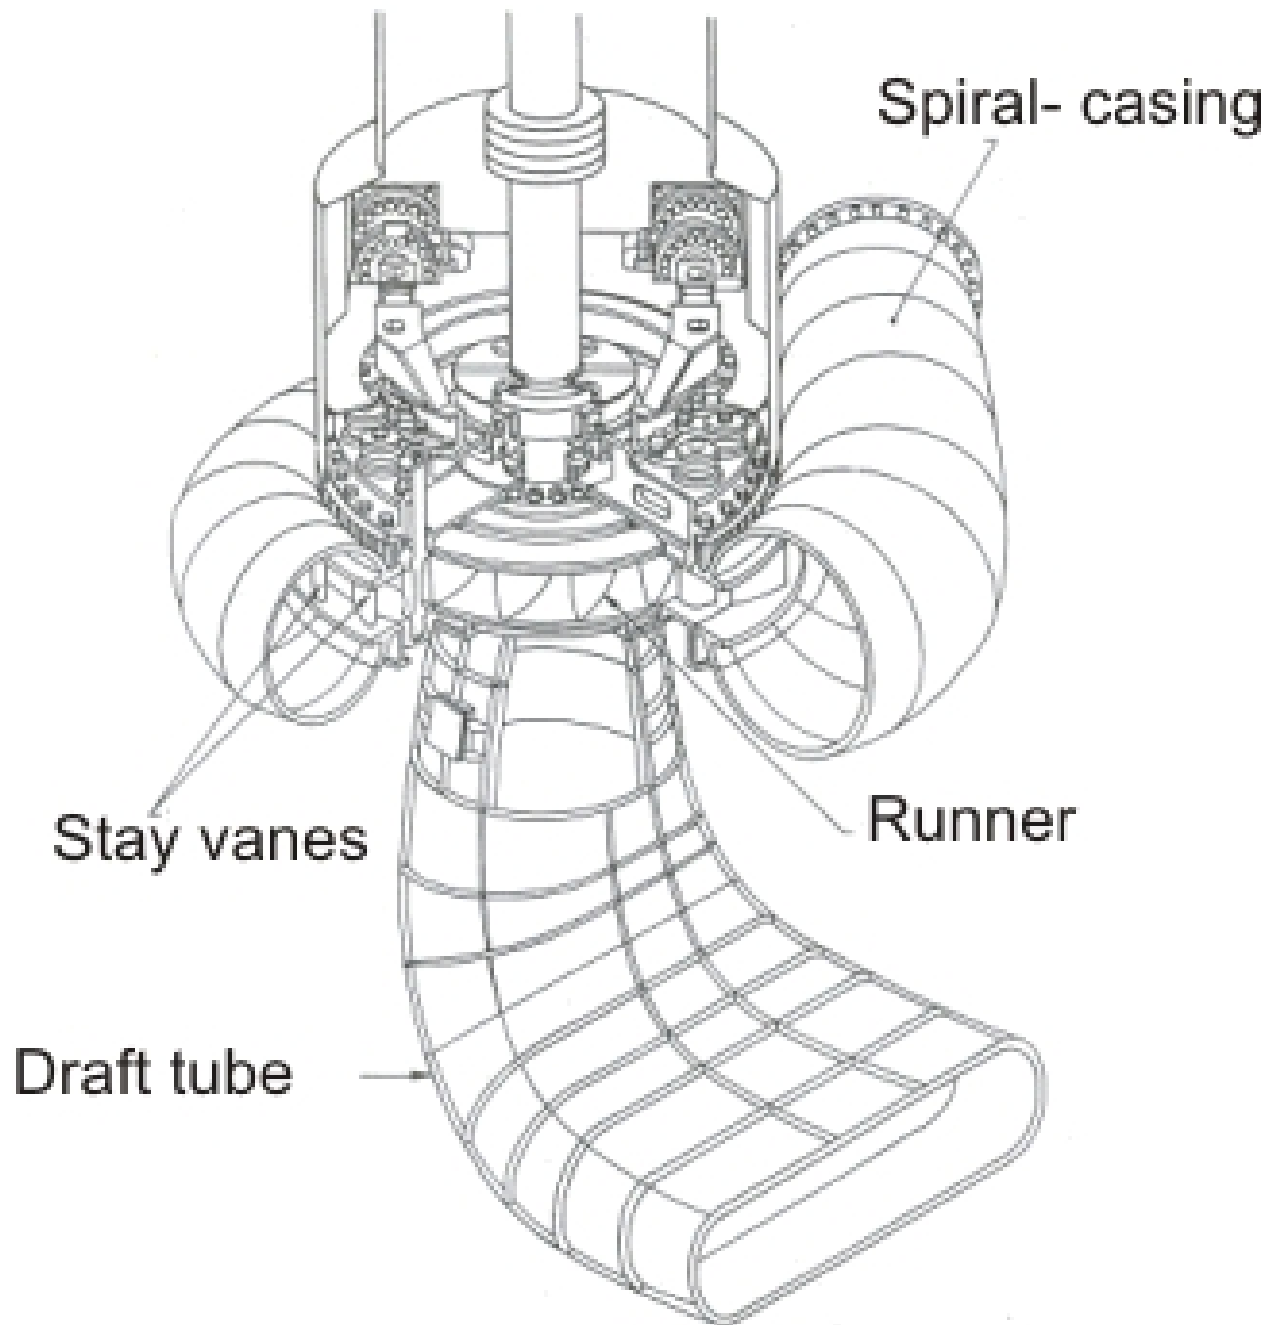
Figure 2.1-2. Schematic of a typical Francis turbine showing the spiral-casing, runner, and draft tube. The penstock connects to the spiral-casing.

The Narrows 2 Powerhouse is an indoor powerhouse consisting of one vertical axis Francis turbine (Figure 2.1-2) with a capacity of 55 megawatts at a head of 236 ft and flow capacity of 3,400 cubic ft per second (cfs). The powerhouse receives water from Englebright Reservoir via the Narrows 2 Powerhouse penstock, which has a maximum flow capacity of 3,400 cfs. The powerhouse includes two facilities for bypassing flow around the turbine; the first is the Narrows 2 Full Flow Bypass (Full Bypass), and the second is the Partial Bypass.

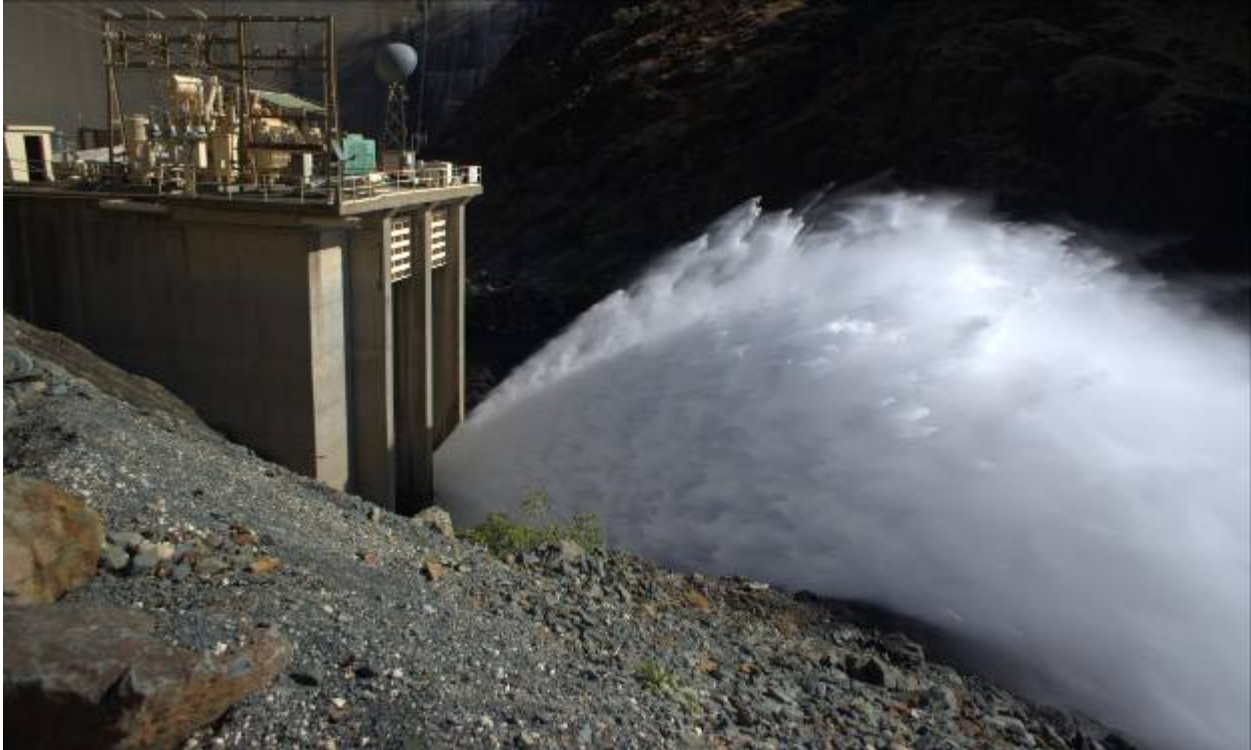
Figure 2.1-3. Operation of the Partial Bypass at Narrows 2 Powerhouse.

and the other branch conveys water to the Full Bypass. The Partial Bypass¹⁰ is a pipe off the Narrows 2 Powerhouse turbine spiral casing, which can discharge¹¹ up to 650 cfs at full head into the Yuba River through a 36-inch (in) valve located on the downstream face of the powerhouse above the draft tube outlet (Figure 2.1-3). The Full Bypass¹² is a 72-in fixed-cone valve and penstock branch off the Narrows 2 Penstock, which can discharge up to 3,000 cfs of water at full head into the Yuba River immediately upstream of the Narrows 2 Powerhouse. The Narrows 1 Powerhouse is capable of discharging up to 730 cfs. Water that passes through the draft tube enters the river subsurface.

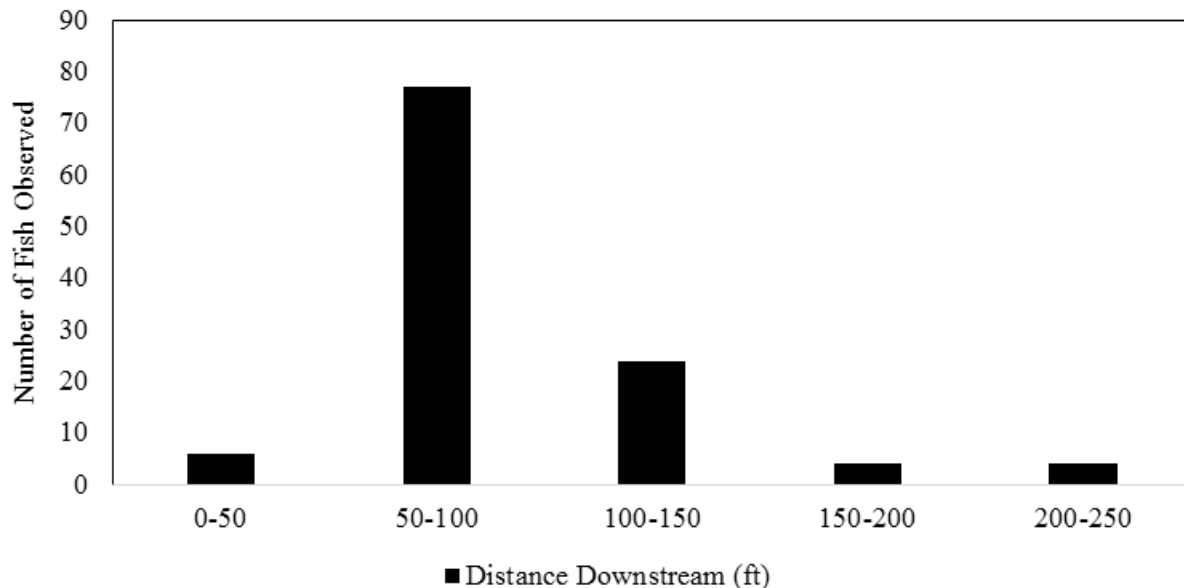
Figure 4.2-1. Number of fish observed by distance downstream from the Narrows 2 Powerhouse deck on September 8, 2013.

A total of 96 fish was observed swimming in the pool directly downstream of the Narrows 2 Powerhouse (Figure 4.2-1). Schooling was the primary behavior exhibited by this group. Other behaviors observed included splashing (11 fish) and jumping (4 fish). Observations of fish occurred as close as 15 ft and as far as 170 ft from the Narrows 2 Powerhouse deck; however, the majority of observations were of fish circling between 50 and 150 ft downstream of the powerhouse.

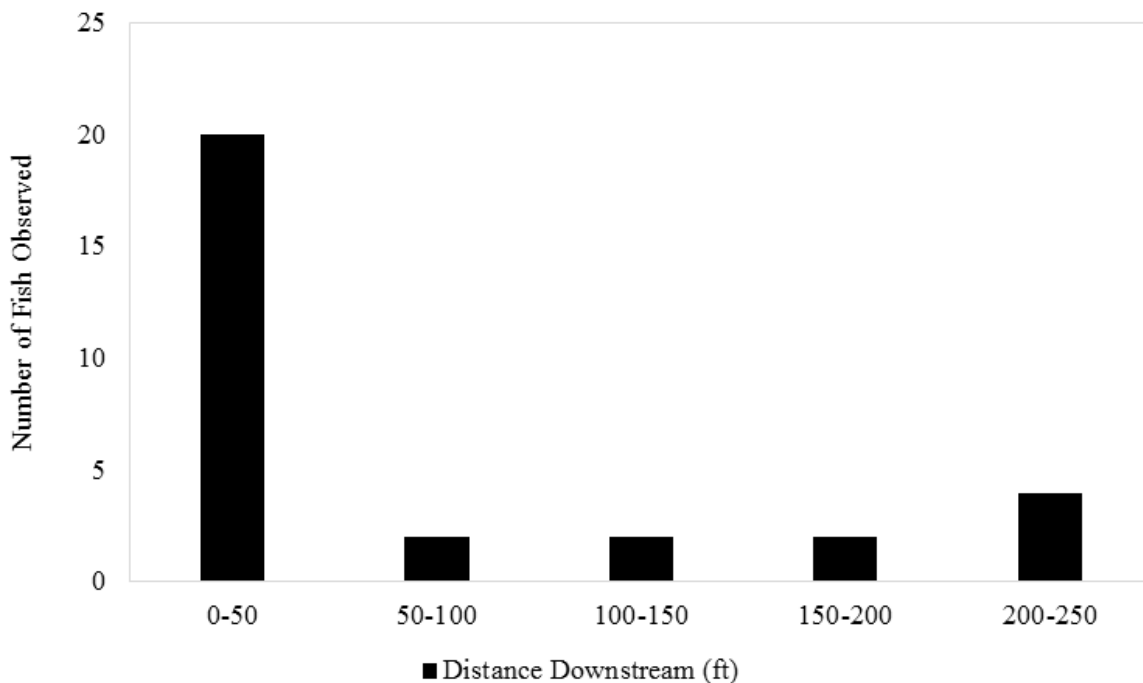
Figure 4.2-2. Number of fish observed by distance downstream from the Narrows 2 Powerhouse deck on October 7, 2013.

A total of 13 fish was observed swimming upstream into the thalweg between the Full Bypass outlet pool and the main channel; one was observed swimming downstream out of the same pool and two were observed swimming in the current. Two other fish were observed swimming in the main channel approximately 250 ft downstream of the Narrows 2 Powerhouse. Other behaviors observed included splashing (11 fish). The location of fish observations was generally within 50 ft of the Narrows 2 Powerhouse, as fish swam into or out of the pool below the Full Bypass (Figure 4.2-2).

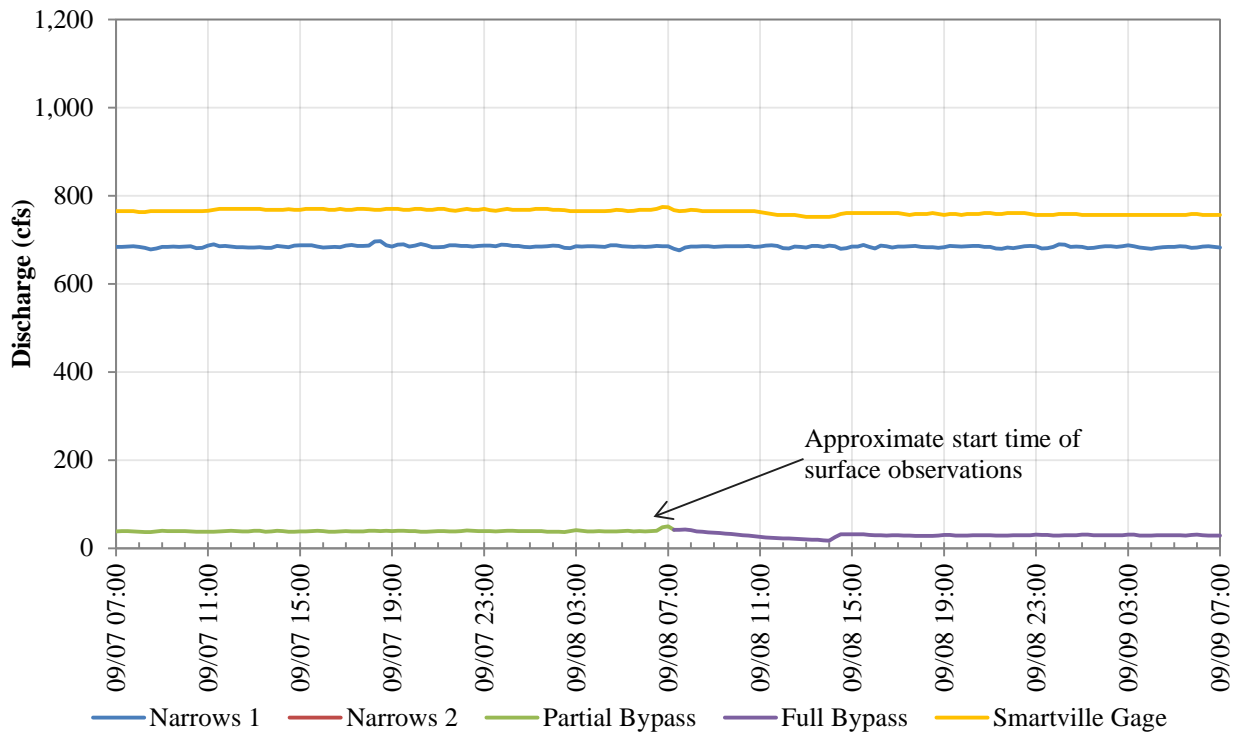
Figure 4.3-1. Fifteen-minute discharge data at the Partial Bypass, Full Bypass, Narrows 1 Powerhouse, and Smartsville Gage from 7:00 AM September 6, 2013 to 7:00 AM September 8, 2013. The Narrows 2 Powerhouse did not operate during this period, and spills over Englebright Dam did not occur.²⁰

²⁰ In this figure, Narrows 1 Powerhouse and Smartsville gage data are from PG&E, and the Partial and Full bypass data are based on flow data in the penstock AVM and YCWA operators' log books.

Prior to the operational change, the Partial Bypass operated at approximately 40 cfs during the 4 hour period before the operational change to the Full Bypass (Figure 4.3-1). Full Bypass flow decreased to about 31 cfs over the 4 hours following the shutdown. From 24 hours before to 24 hours after the operational change, the Narrows 1 Powerhouse remained at a near-constant discharge of 685 cfs. The Smartsville Gage remained stable around 760 cfs during this time.

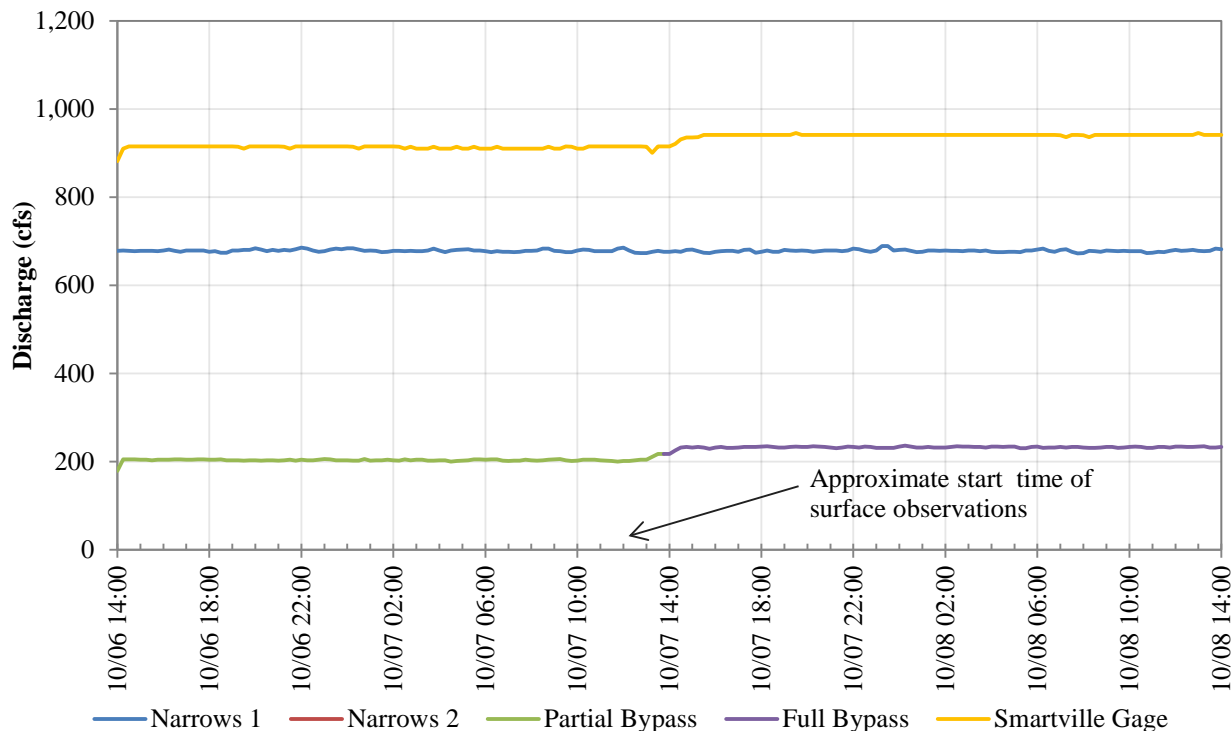
Figure 4.3-2. Fifteen-minute discharge data at the Partial Bypass, Full Bypass, Narrows 1 Powerhouse, and Smartsville Gage from 2:00 p.m. October 6, 2013 to 2:00 p.m. October 8, 2013.²¹ The Narrows 2 Powerhouse did not operate during this period, and spills over Englebright Dam did not occur.

The Partial Bypass operated at approximately 205 cfs during the 4 hours preceding the operational change over to the Full Bypass (Figure 4.3-2), which continued to operate at 231 cfs for the following 4 hours. From 24 hours before to 24 hours after the operational change, the Narrows 1 Powerhouse remained at a near-constant discharge of 675 cfs. The Smartsville Gage increased about 30 cfs after the operational change to about 940 cfs.

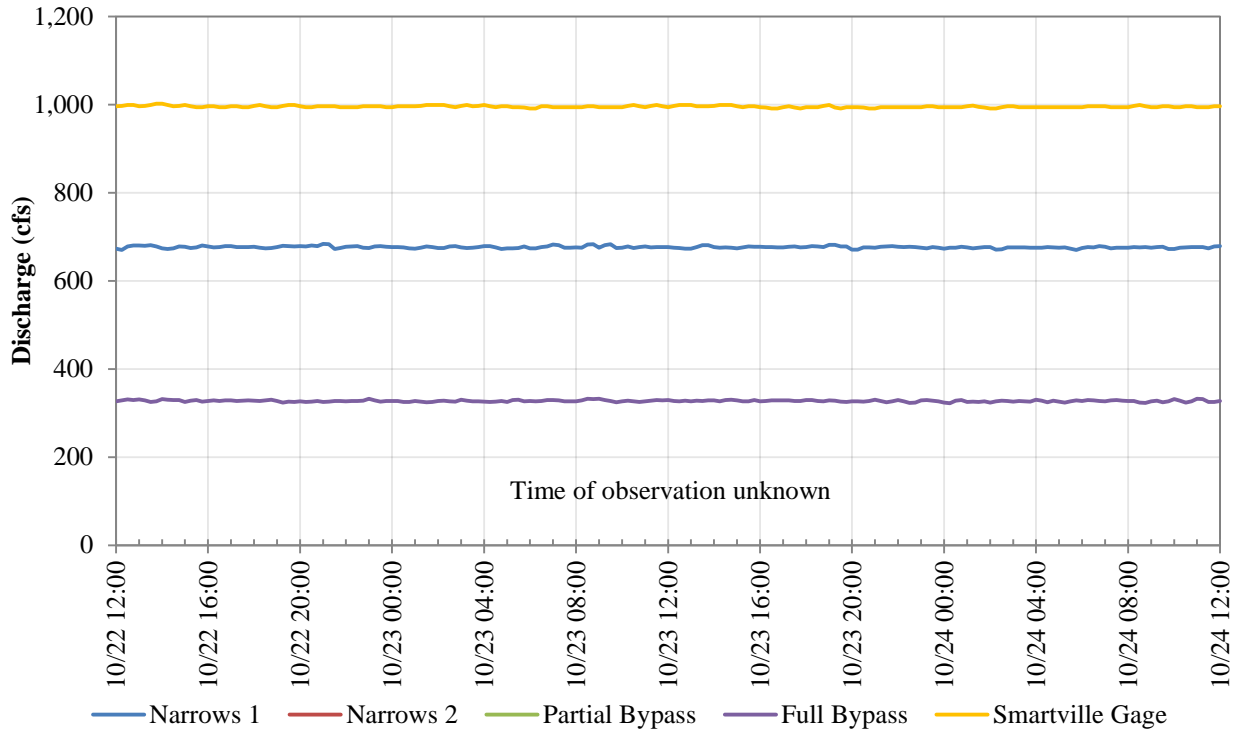
Figure 4.5-2. Fifteen-minute flows data at the Full Bypass, Narrows 1 Powerhouse, and Smartsville Gage from 12:00 p.m. on October 22, 2012 to 12:00 p.m. on October 24, 2012.²³ The Narrows 2 Powerhouse and the Partial Bypass did not operate during this period, and spills over Englebright Dam did not occur.

²³ In this figure, Narrows 1 Powerhouse and Smartsville gage data are from PG&E, and the Full Bypass data are based on flow data in the penstock AVM and YCWA operator’s log books.

Operational changes did not occur within 24 hours of the observation (Figure 4.5-2). The Full Bypass was operating before and after the observation at approximately 375 cfs and was the only point of discharge at Narrows 2 Powerhouse, while the Narrows 1 Powerhouse operated near 625 cfs. Discharge at the Smartsville gage was approximately 1,000 cfs during this period.

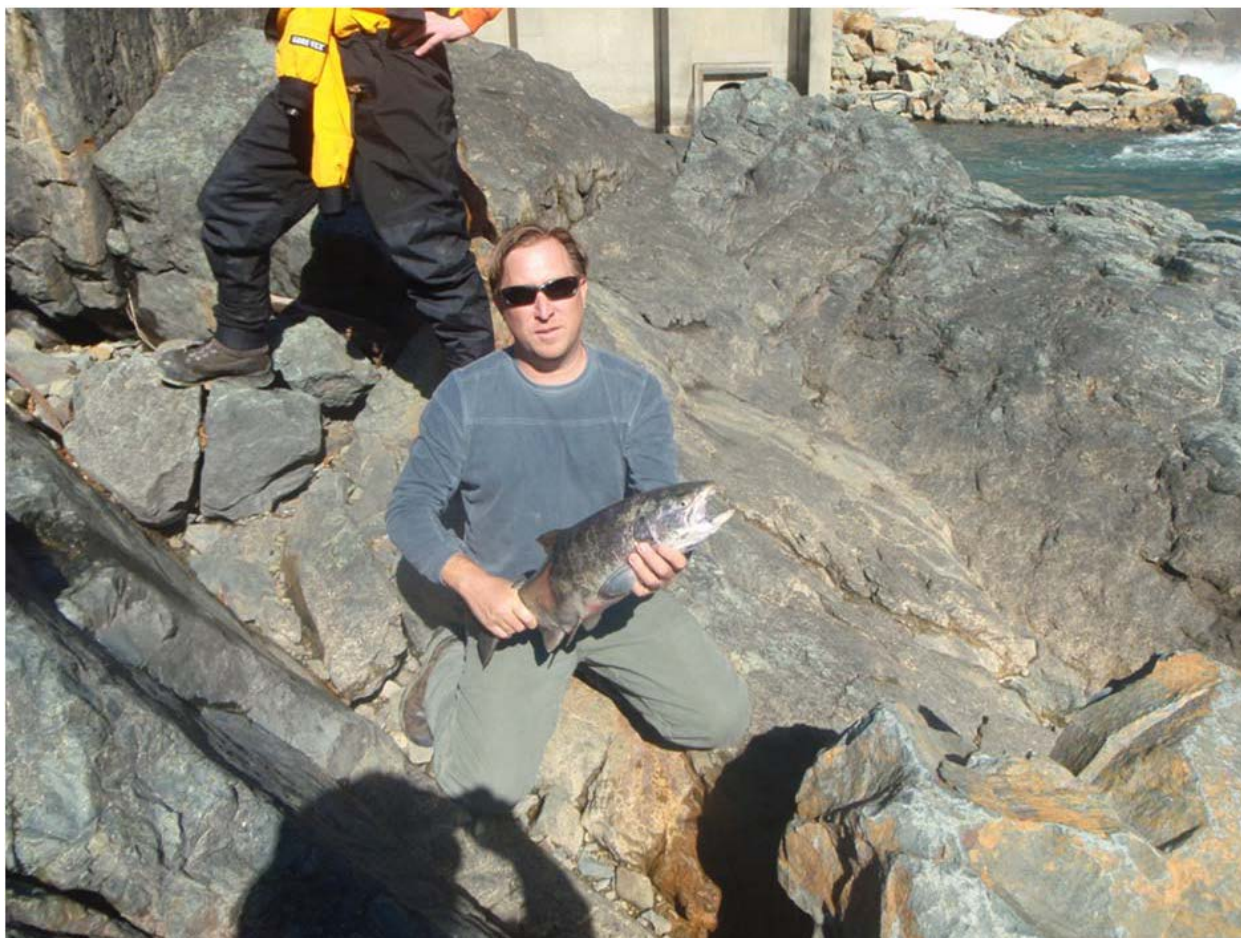
During a Relicensing Participant field event on October 25, 2012, Cal Fish and Wildlife personnel found an adult Chinook salmon carcass head down in a crevice on the right bank about 70 ft downstream of the Narrows 2 Powerhouse (Figure 4.5-3). When found, the fish was about 3 to 5 ft above the river water surface and 15 ft from the water’s edge. The fish, identified as a female that was still gravid, measured 88.9 cm FL and weighed 7.39 kilograms (kg) and had a girth of 43.1 cm (S. Hoobler, pers. comm., 2014). The carcass was relatively fresh and had a silver/blue color. The adipose fin was not clipped. (Figure 4.5-3.) The carcass was removed from the site by Cal Fish and Wildlife staff.

Figure 4.5-3. Sean Hobbler of Cal Fish and Wildlife holding an adult Chinook salmon carcass found in the crevice he is kneeling in on October 25, 2012. Photo taken by John Wooster of NMFS.

The carcass was discovered around 12:30 p.m., about 30 minutes after an operational change from the Partial Bypass to the Full Bypass. Discharge from the Narrows 2 facilities remained similar before, during, and after the operational change (Figure 4.5-4). The Smartsville Gage reported approximately 1,000 cfs during a 24-hour period before and after the operational change, with about 325 cfs from the Narrows 2 facility, and 675 cfs from the Narrows 1 Powerhouse.

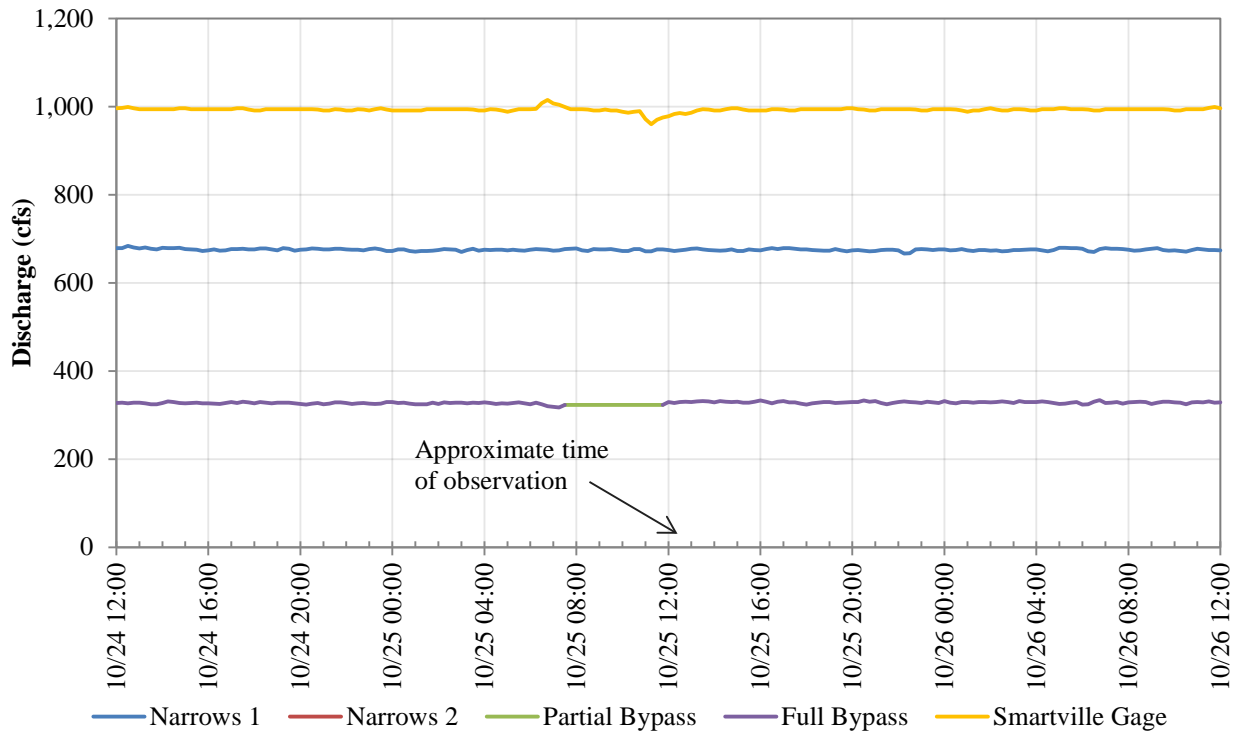
Figure 4.5-4. Fifteen-minute discharge data at the Partial Bypass, Full Bypass, Narrows 1 Powerhouse, and Smartville Gage from 12:00 p.m. on October 24, 2012, to 12:00 p.m. on October 26, 2012.²⁴ The Narrows 2 Powerhouse did not operate during this period, and spills over Englebright Dam did not occur. The time the fish carcass was observed is shown.

²⁴ In this figure, Narrows 1 Powerhouse and Smartville gage data are from PG&E, and the Full Bypass data are based on flow data in the penstock AVM and YCWA operators’ log books.

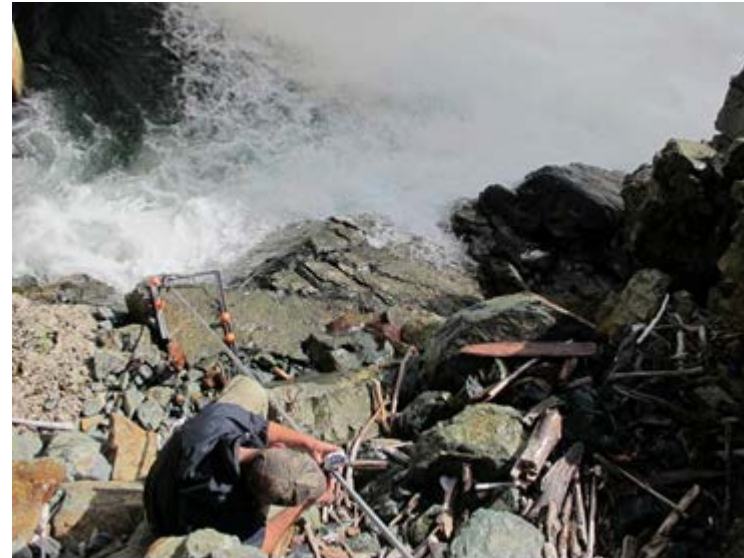
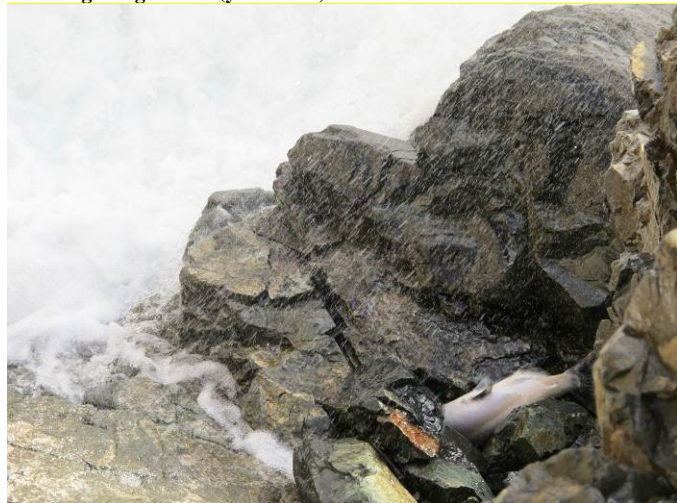
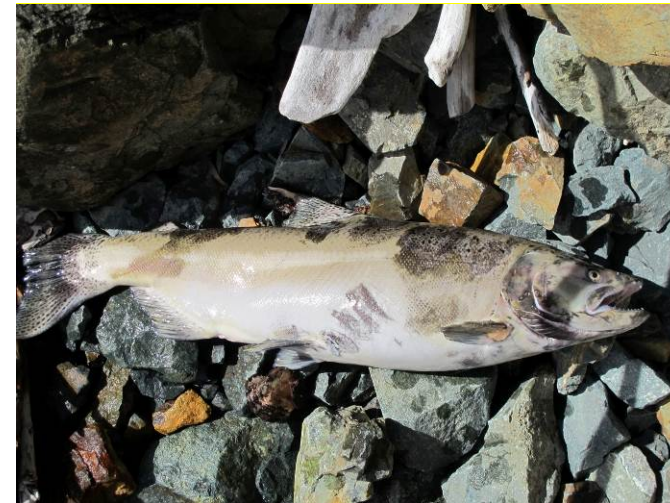
B) Specific location of the fish carcass before it was handled by staff.

C) Physical position of the fish carcass before it was handled by staff.

D) Photograph of the fish carcass positioned by staff for the photo.

Figure 4.5-5. Series of photos cataloging the location and position of the fish carcass found on October 7, 2013.

As staff prepared to perform the studies, they observed a fish carcass on the north bank of the Yuba River approximately 15 ft downstream from the face of the Narrows 2 Powerhouse (Figure 4.5-5 A through D).

Staff approached the carcass and found the carcass head first in a crevice under several angular rocks. Staff estimated that the carcass was approximately 2 ft from the water's edge and approximately 1.5 ft above the water surface. The dominant substrate at the location was bedrock and the subdominant substrate was angular cobble sized rock. Water temperature in the river in the vicinity of the carcass was 12°C. YCWA operations staff said the discharge from the Partial Bypass was 200 cfs when staff first observed the carcass.

Because the fish was dead, staff then handled the carcass and determined it was a gravid female Chinook salmon, 68 cm FL, and showed no obvious signs of recent spawning activity (e.g., no signs of tail abrasion). Staff described the carcass as fresh, and reported it showed no rigor mortis, no bloating, no obvious smell of decay, and a clear eye.

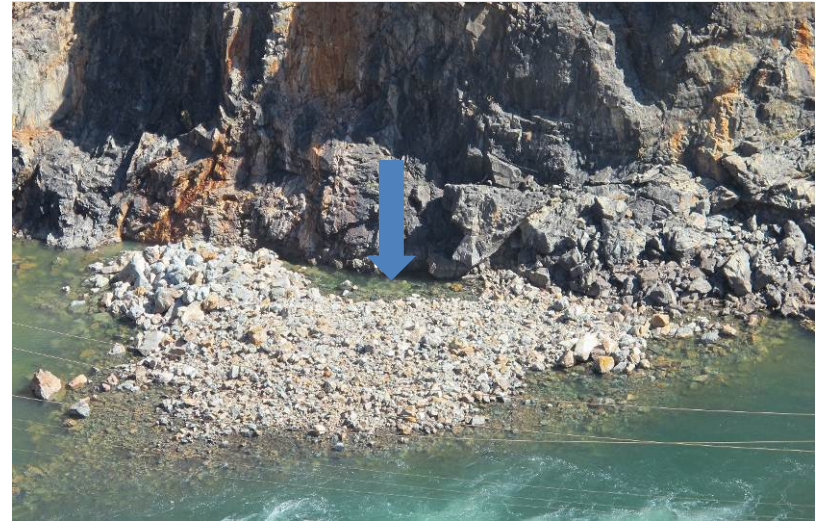
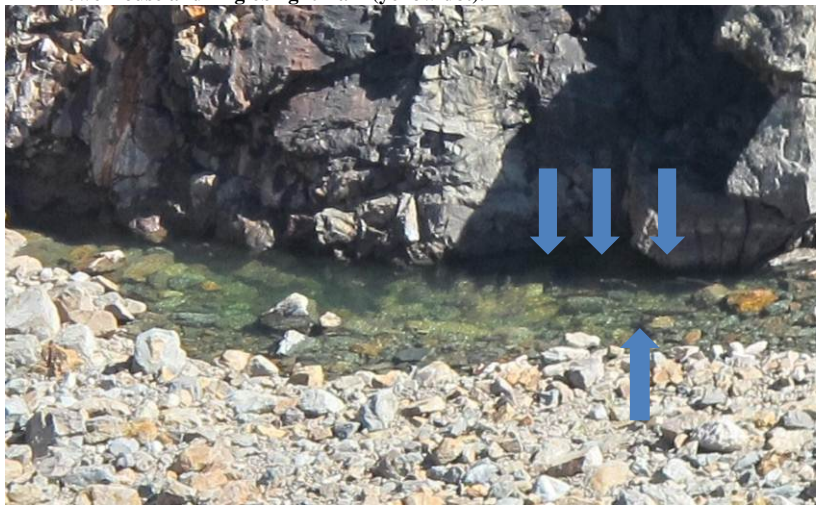
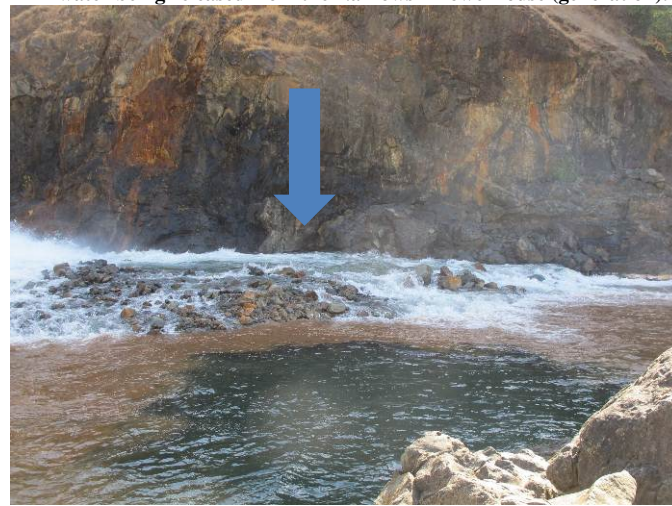
B) Specific location of observed fish, flow in the river was approximately 990 cfs with all water being released from the Narrows 2 Powerhouse (generation).

C) The blue arrows indicate four fish that can be seen in the pool.

D) Photograph of the pool when the flow in the river was approximately 990 cfs, with all water being released from the Narrows 2 Full Bypass. The area of the pool shown in photos b and C is indicated by the blue arrow.

Figure 4.5-6. Series of photos cataloging the pool in which the fish were observed on October 11, 2013. The photos were taken from the Narrows 2 Powerhouse deck looking south across the Yuba River.

As part of the change, flow through the Narrows 2 Full Bypass was increased from 400 cfs to 990 cfs. The increased flow inundated a gravel bar on the southern edge of the river between the Full Bypass pool and the main channel of the river. Then, over the next 5 minutes, flow was changed from the Full Bypass to the Narrows 2 Powerhouse, at which point flow from the Full Bypass ceased completely. Staff observed that the change-over had left a pool, approximately 30 ft by 10 ft wide, on the edge of the gravel bar (Figure 4.5-6 A through D).

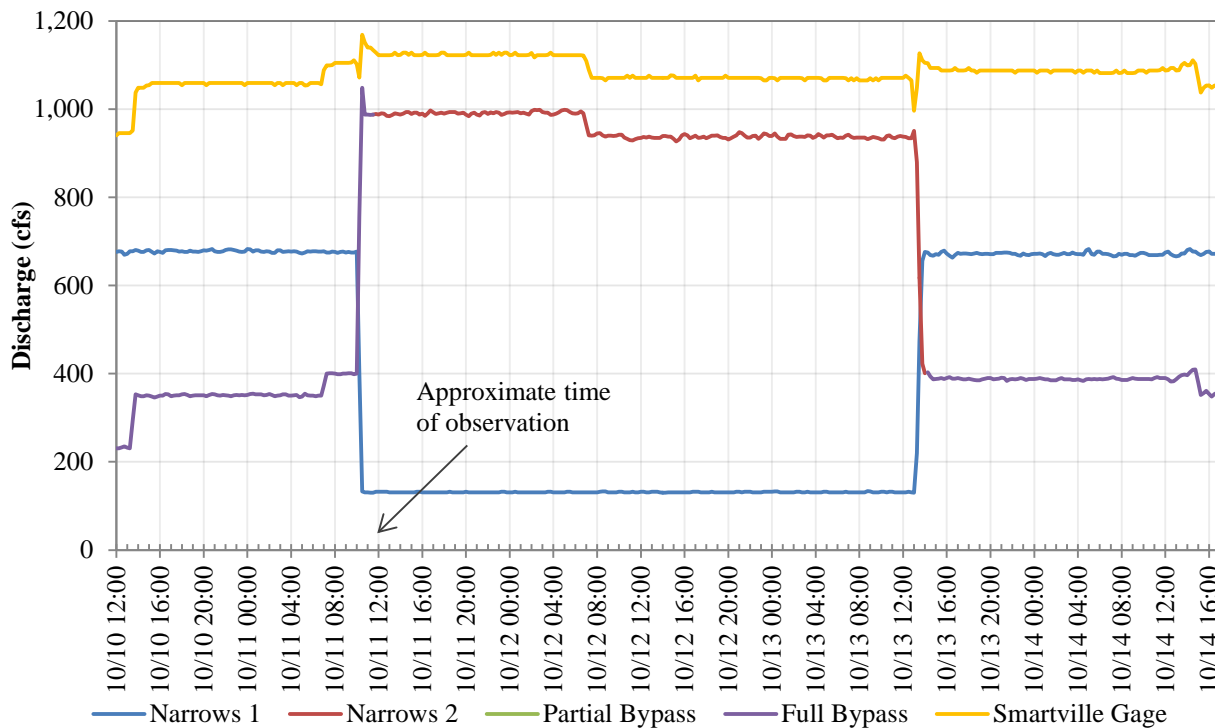
Figure 4.5-7. Fifteen-minute discharge data at the Narrows 2 Powerhouse, Full Bypass, Narrows 1 Powerhouse, and Smartville Gage from 12:00 p.m. October 10, 2013 to 12:00 p.m. October 14, 2013.²⁶ The Partial Bypass did not operate during this period, and Englebright Dam did not spill. The time the fish were observed in the pool is shown.

²⁶ In this figure, Narrows 1 Powerhouse and Smartville gage data are from PG&E, and the Full Bypass and Narrows 2 Powerhouse data are based on flow data in the penstock AVM, powerhouse generation records and YCWA operators’ log books.

On the morning of October 10, 2013, the Full Bypass was releasing approximately 230 cfs and PG&E’s Narrows 1 Powerhouse was releasing approximately 680 cfs (Figure 4.5-7). Starting shortly after 1:15 p.m., releases from the Full Bypass were increased to approximately 350 cfs by 1:45 p.m., PG&E’s Narrows 1 Powerhouse releases remained at approximately 680 cfs and no flow was passing through the Partial Bypass. At approximately 7:00 a.m. on October 11, 2013 flows through the Full Bypass were increased first to 400 cfs, and at 10:15 a.m. flows were further increased until they reached approximately 1,050 cfs at 10:30 a.m. Between 10:30 and 10:45 a.m., the Narrows 2 Powerhouse began generating at flows of approximately 990 cfs, releases from the Full Bypass were stopped, and releases from the Narrows 1 Powerhouse were reduced to 130 cfs. This operations mode was maintained until just after 1:00 p.m. on October 13, 2013, at which time flows through the Narrows 2 Powerhouse began to be reduced to approximately 400 cfs by 2:00 p.m. and releases from PG&E’s Narrows 1 Powerhouse were increased to approximately 670 cfs. By 2:15 p.m., releases through the Narrows 2 Powerhouse were stopped, and flow through the Full Bypass had been increased to approximately 400 cfs. These releases from the Full Bypass and PG&E’s Narrows 1 Powerhouse continued beyond 5:00 p.m. on October 14, 2013. As stated above, staff observed fish in the pool at approximately 12:05 p.m. on October 11, 2013.
