## 2.0 North Yuba River – New Bullards Bar Dam Reach

New Bullards Bar Dam Reach of the North Yuba River is 2.3 miles in length and extends from the confluence of the North Yuba River with the Middle Yuba River to New Bullards Bar Dam. Information used to evaluate conditions on this reach and investigate accessibility included a field reconnaissance on March 7 and 9, 2011. Additional information was collected in September and October 2009 as part of the Habitat Mapping Report (YCWA 2010).

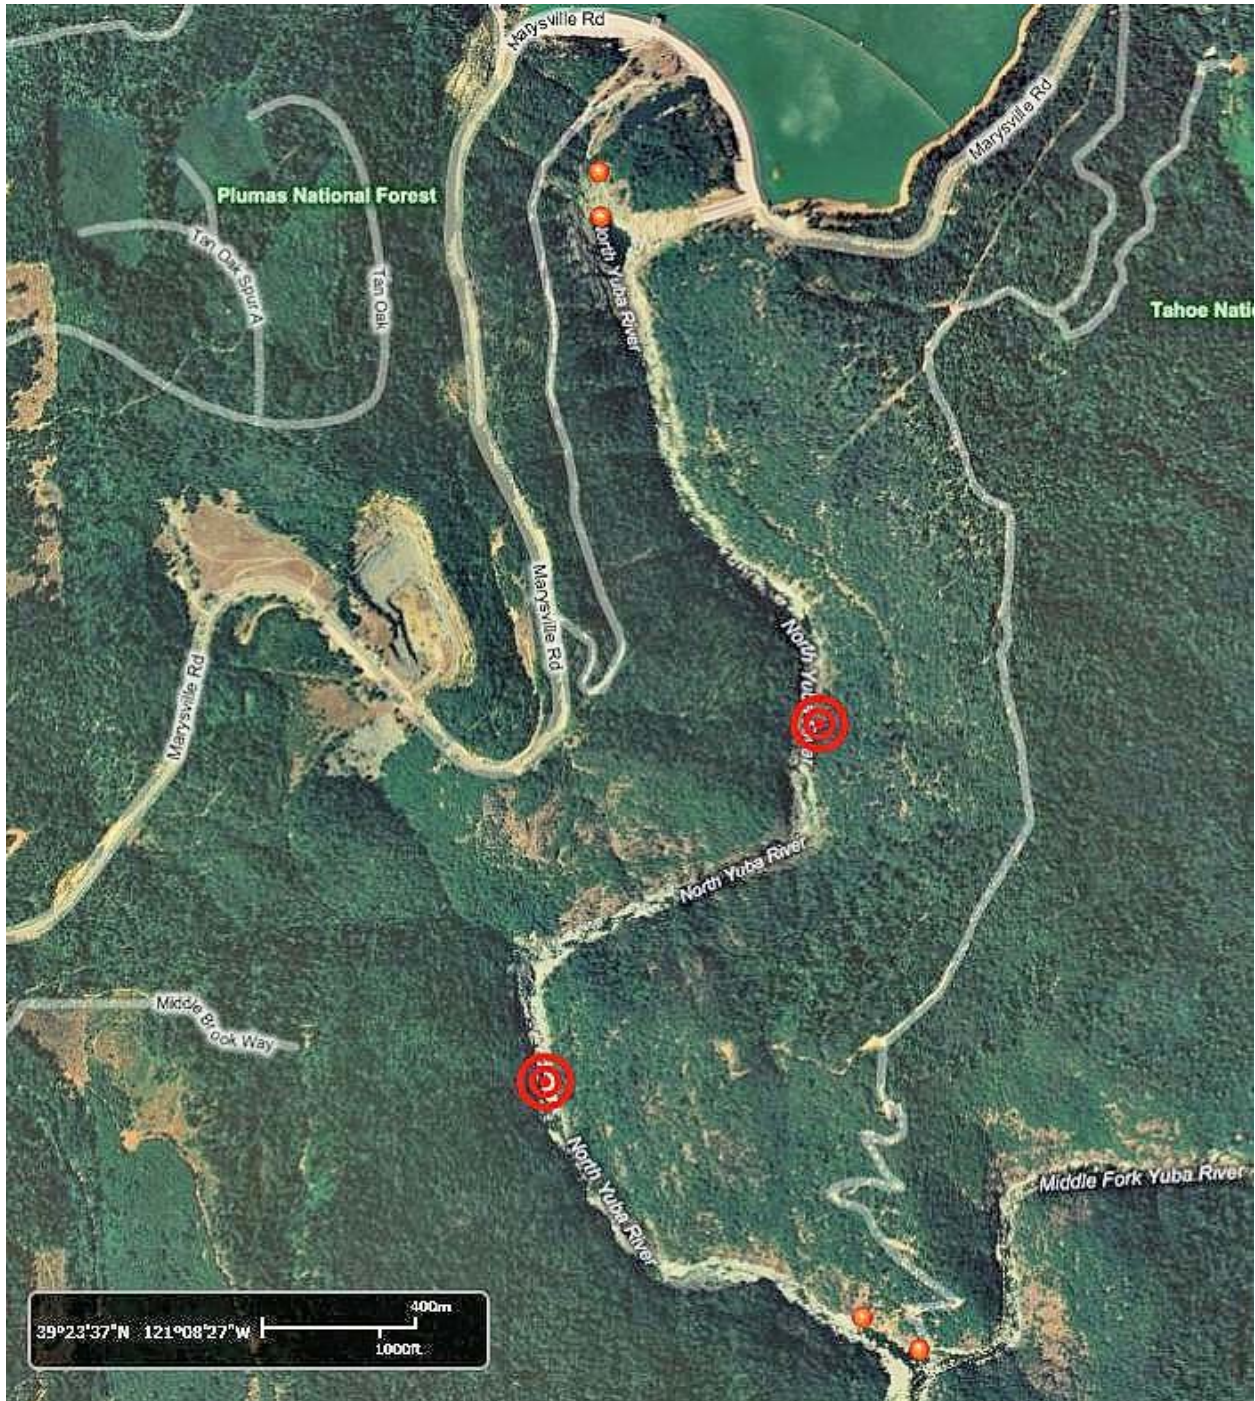
**Figure 2.0-3. North Yuba River – New Bullards Bar Dam Reach: overview aerial image. The approximate extent of the March 2011 reconnaissance areas are demarcated by red dots (two short sections). Concentric red circles indicate approximate extent of inaccessible middle section of reach (with boat and at low flows).**

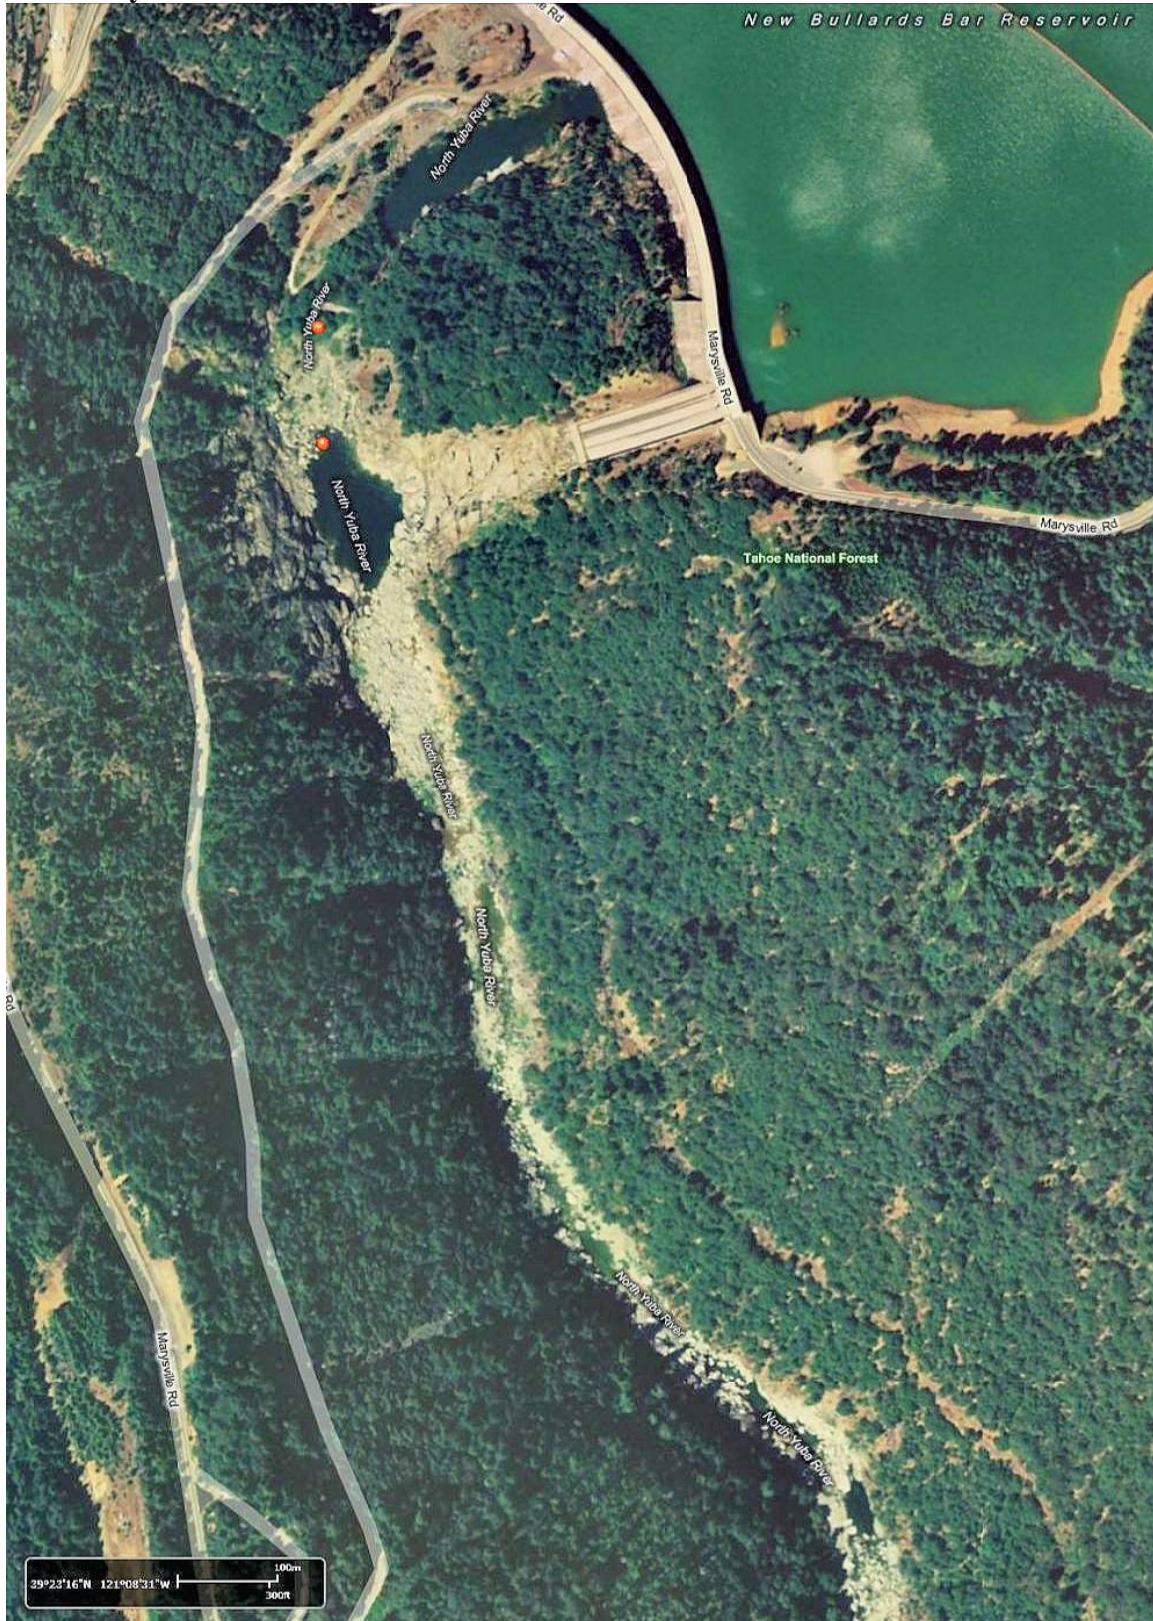
**Figure 2.0-4. North Yuba River – New Bullards Bar Dam Reach: aerial image of upstream section investigated in March 2011. The approximate extent of the March 2011 reconnaissance area is demarcated by red dots.**

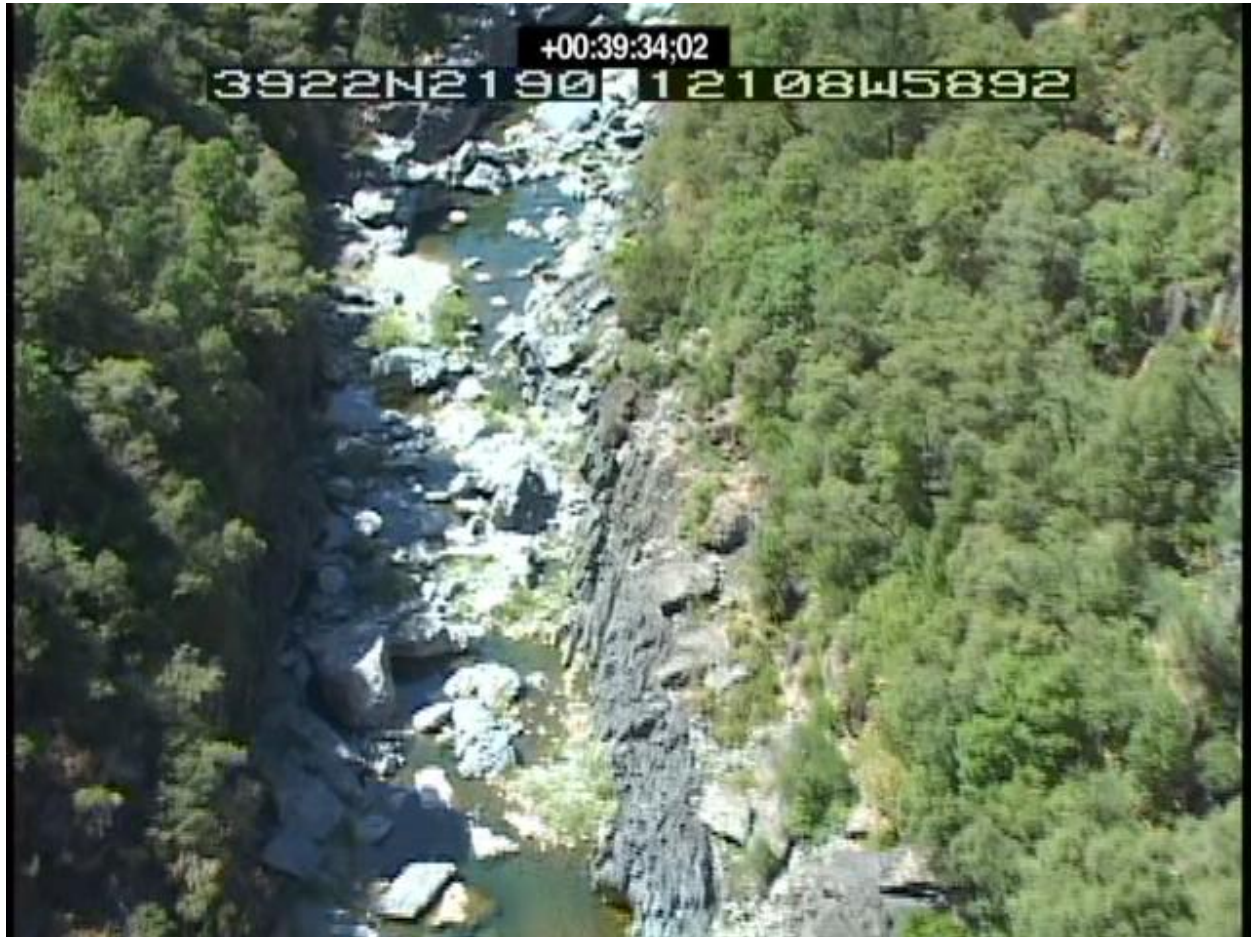
**Figure 2.0-8. North Yuba River NBBDR, Section 1 at RM 0.5, looking upstream. From this point going upstream is inaccessible by foot.**

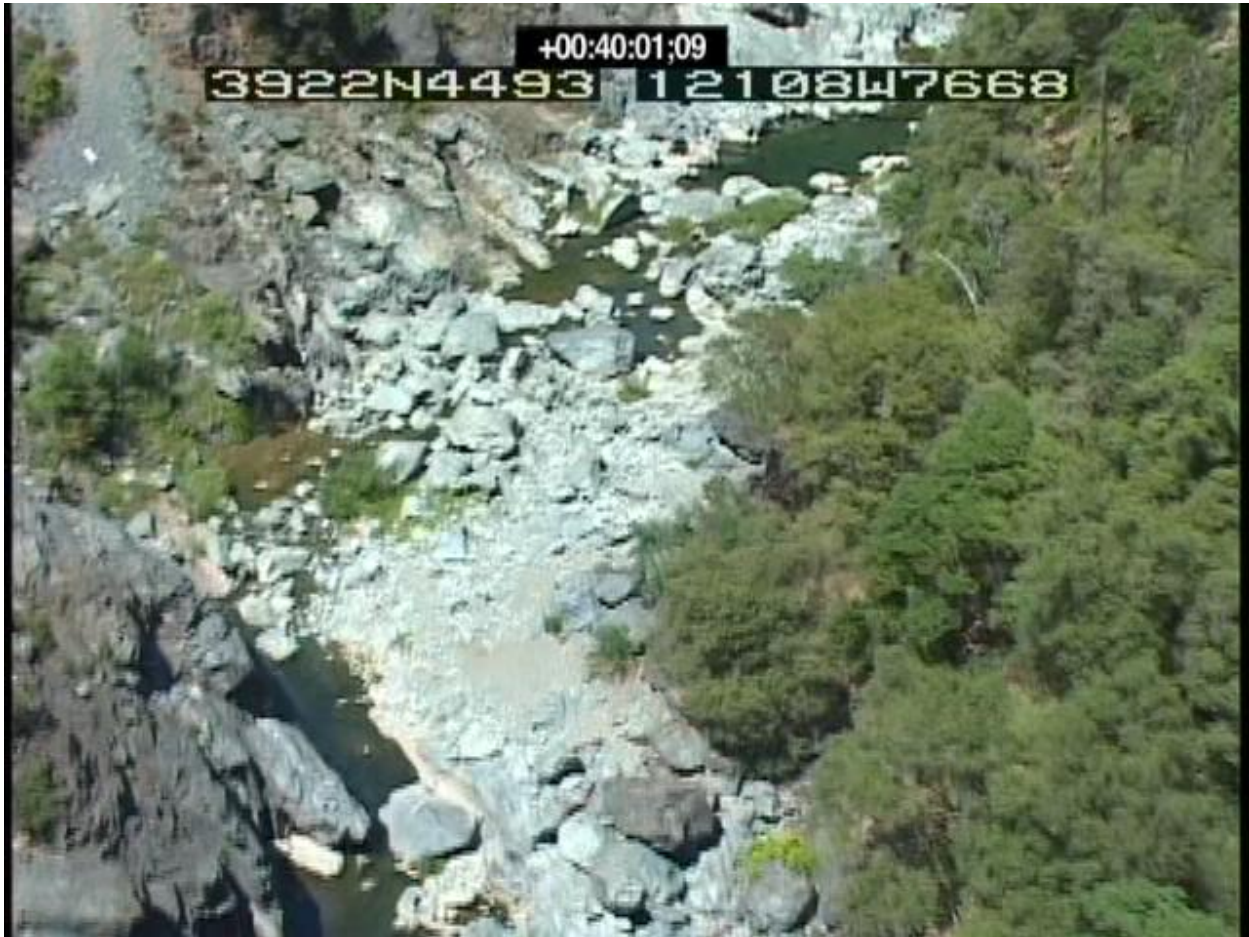
**Figure 2.0-9. North Yuba River NBBDR, Section 1 at RM 0.8, looking upstream. Tributary confluence is on left side.**

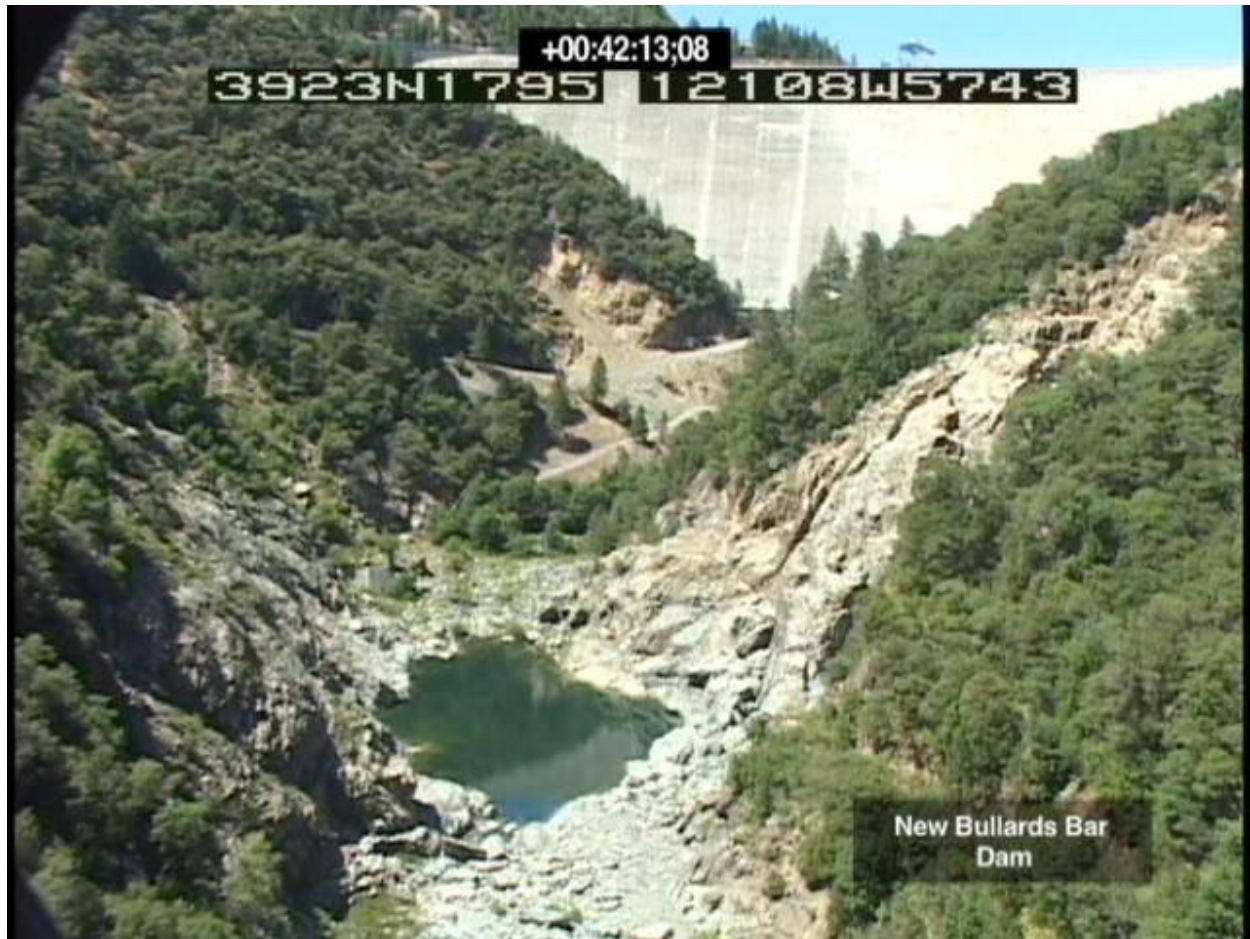
**Figure 2.0-17. North Yuba River NBBDR, Section 3 near RM 2.0, looking upstream at New Bullards Bar Dam. Spillway pool requires boat to cross.**

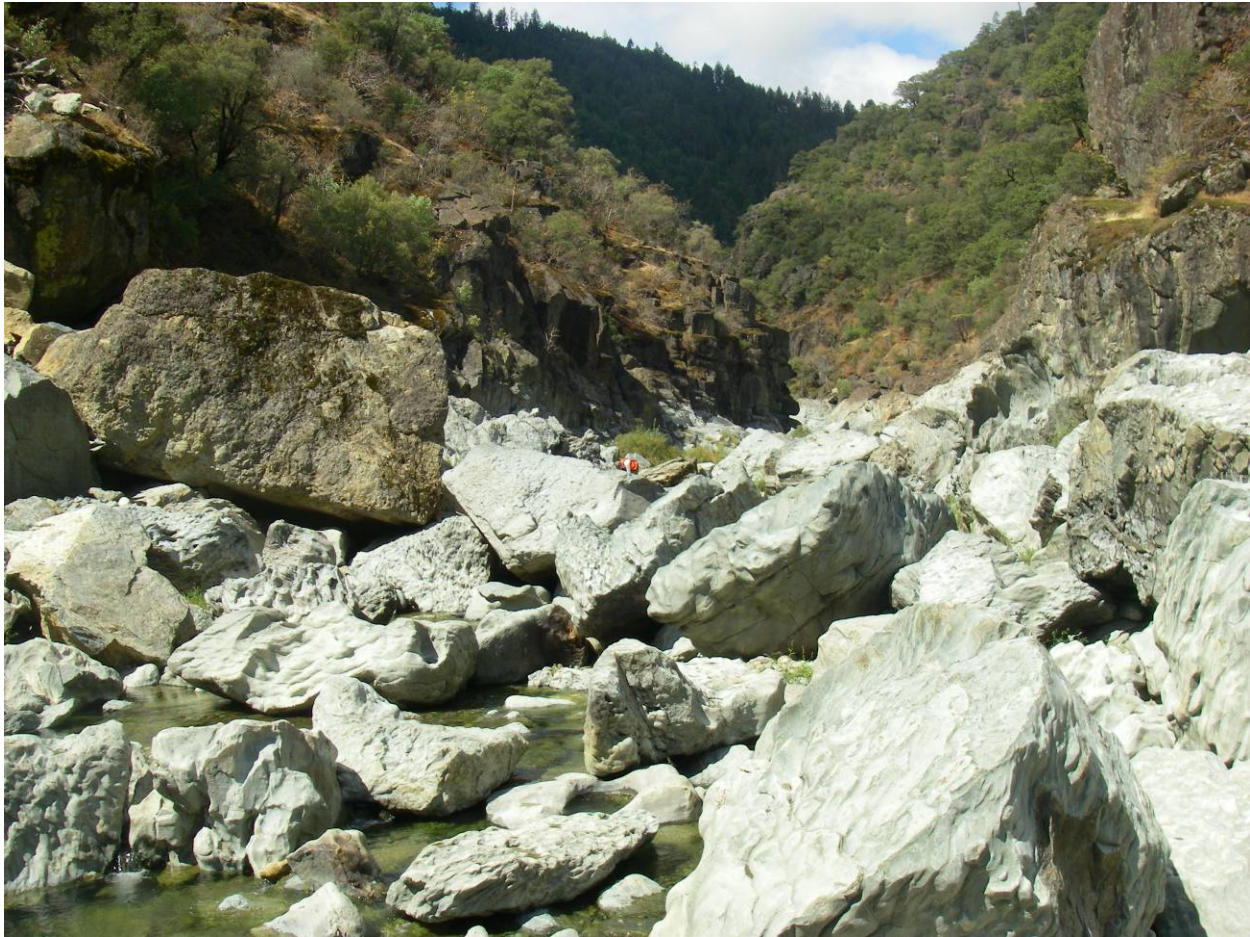
**Figure 2.0-20. North Yuba River NBBDR, Section 1 at RM 0.2, pocket water with bedrock-dominant substrate, looking downstream, September 14, 2009.**

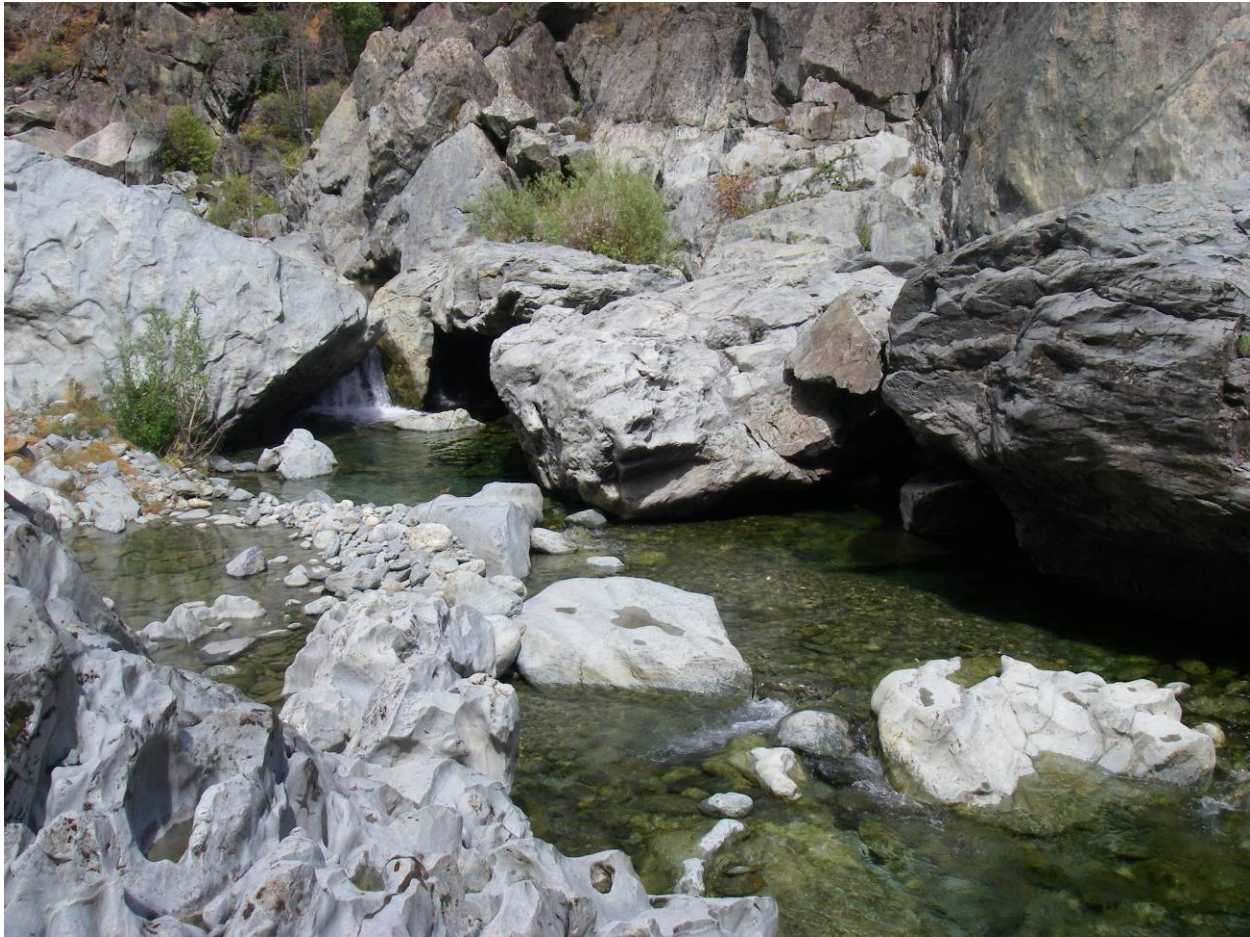
**Figure 2.0-21. North Yuba River NBBDR, Section 1 at RM 0.3, pocket water with bedrock/boulder-dominant substrate and some cobble, looking upstream, September 14, 2009.**

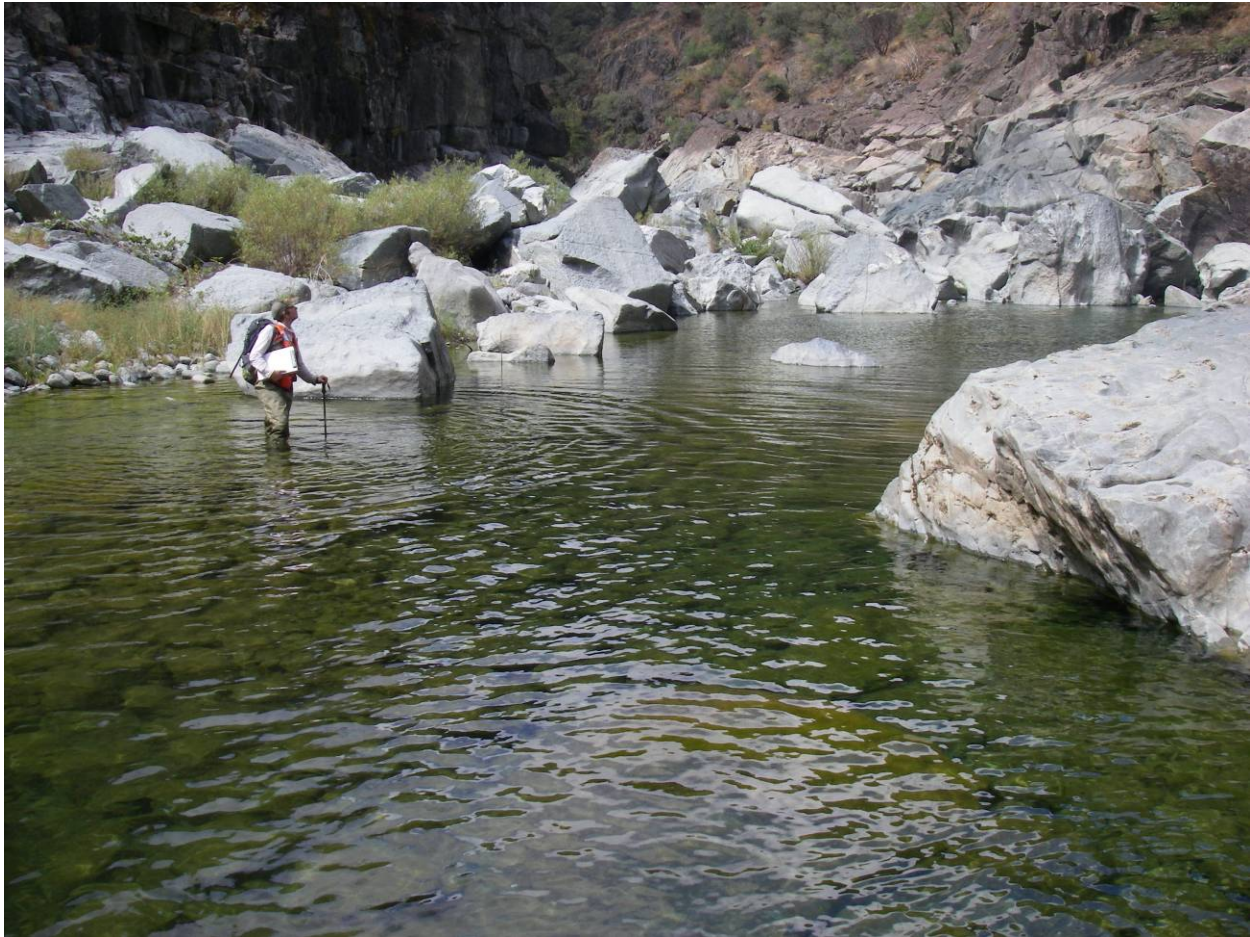
**Figure 2.0-22. North Yuba River NBBDR, Section 1 at RM 0.3, mid-channel pool with boulder-dominant substrate, looking upstream, September 14, 2009.**

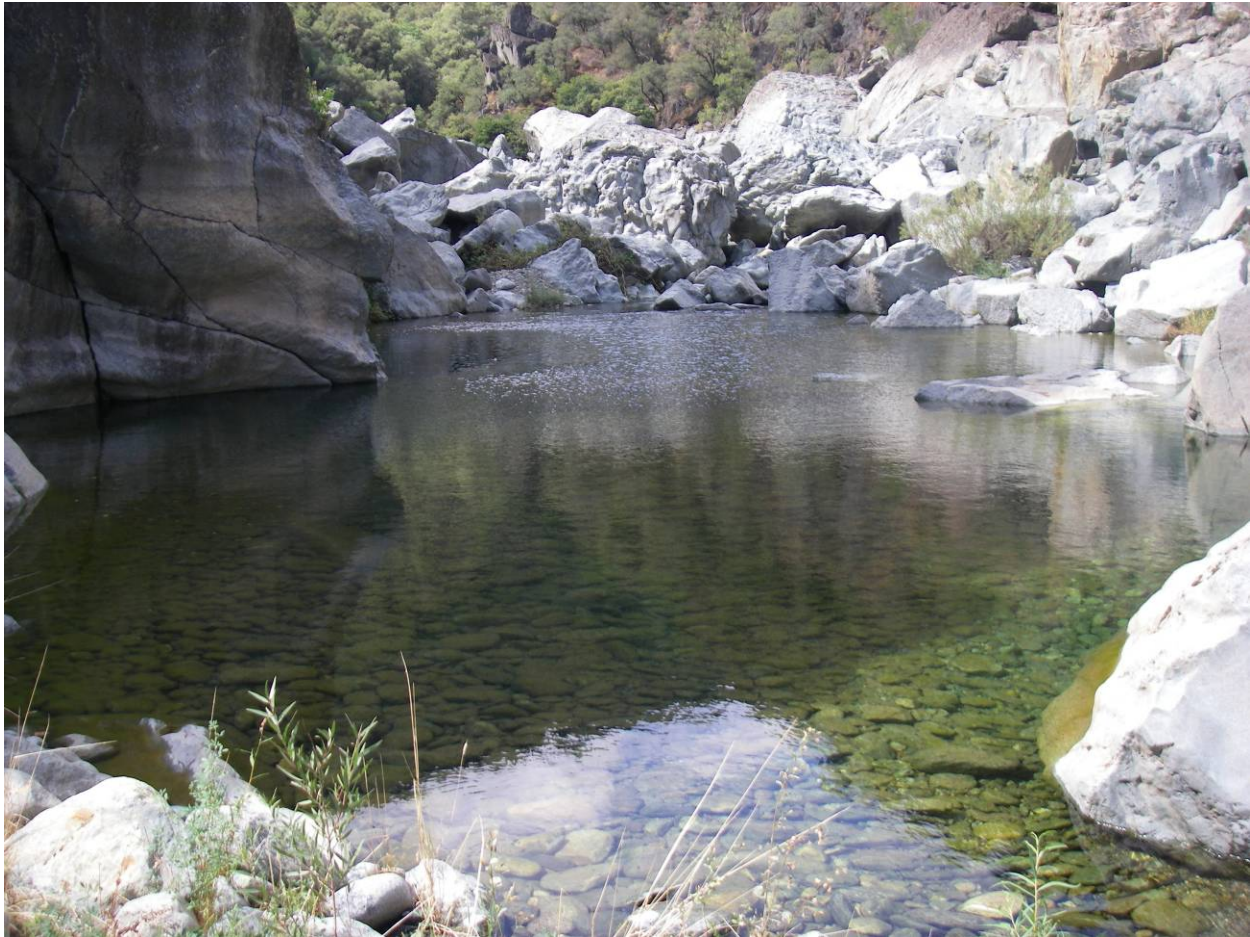
**Figure 2.0-23. North Yuba River NBBDR, Section 1 near RM 0.35, mid-channel pool with boulder/cobble substrates, looking upstream, September 14, 2009.**

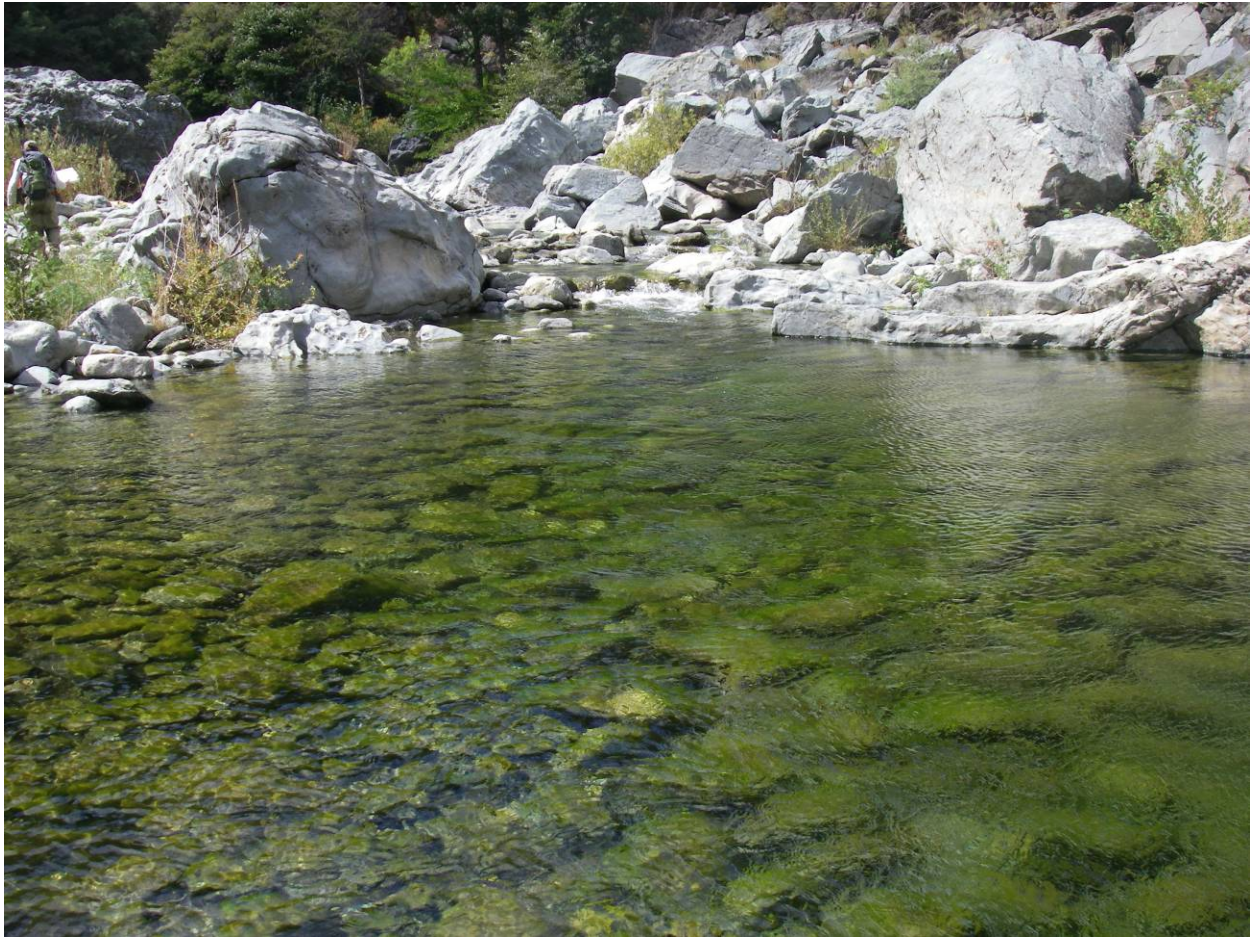
**Figure 2.0-24. North Yuba River NBBDR, Section 1 at RM 0.4, mid-channel pool with boulder-dominant substrate, looking upstream, September 14, 2009.**

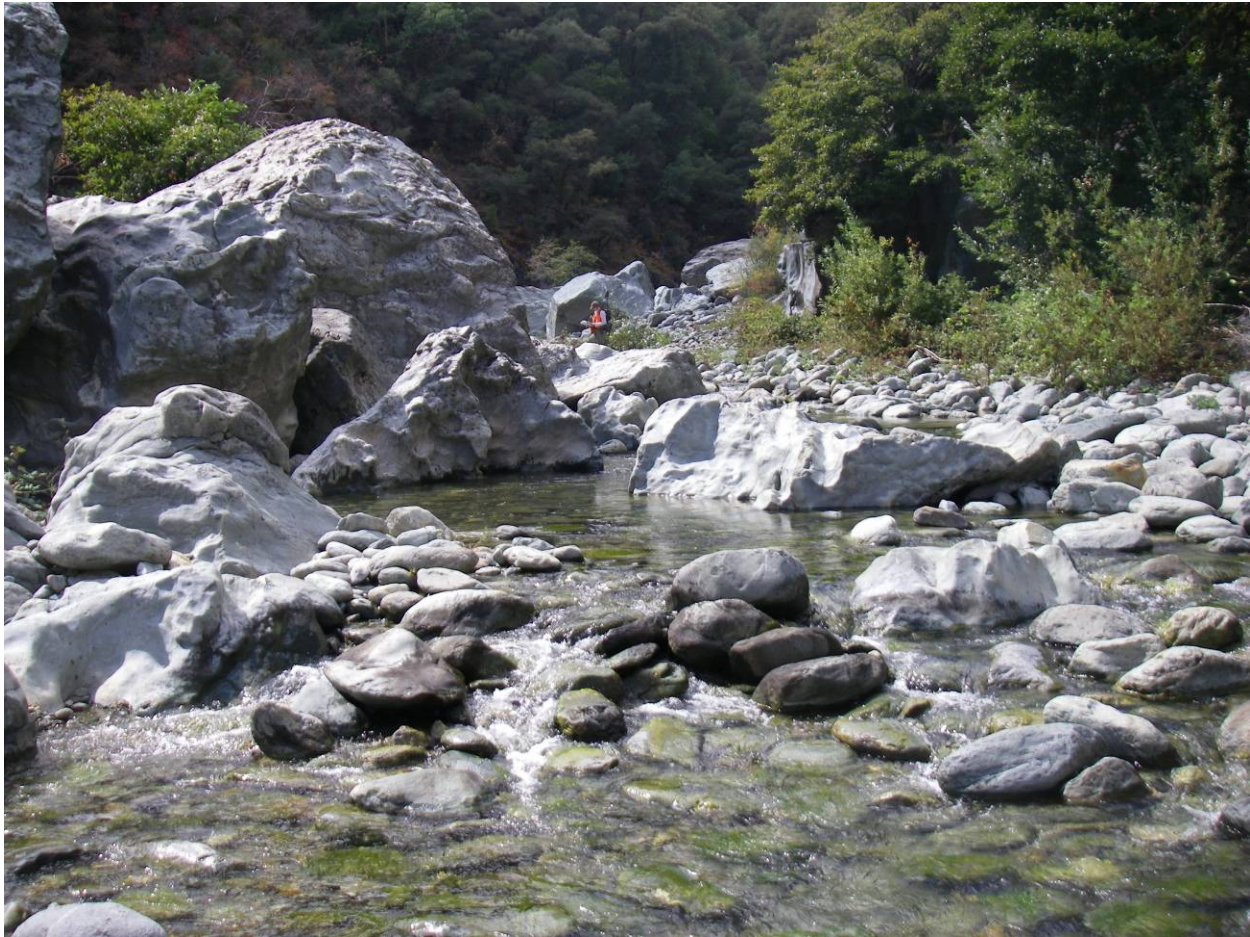
**Figure 2.0-25. North Yuba River NBBDR, Section 1 near RM 0.45, step-run/step-pool with boulder-dominant substrate, looking upstream, September 14, 2009.**

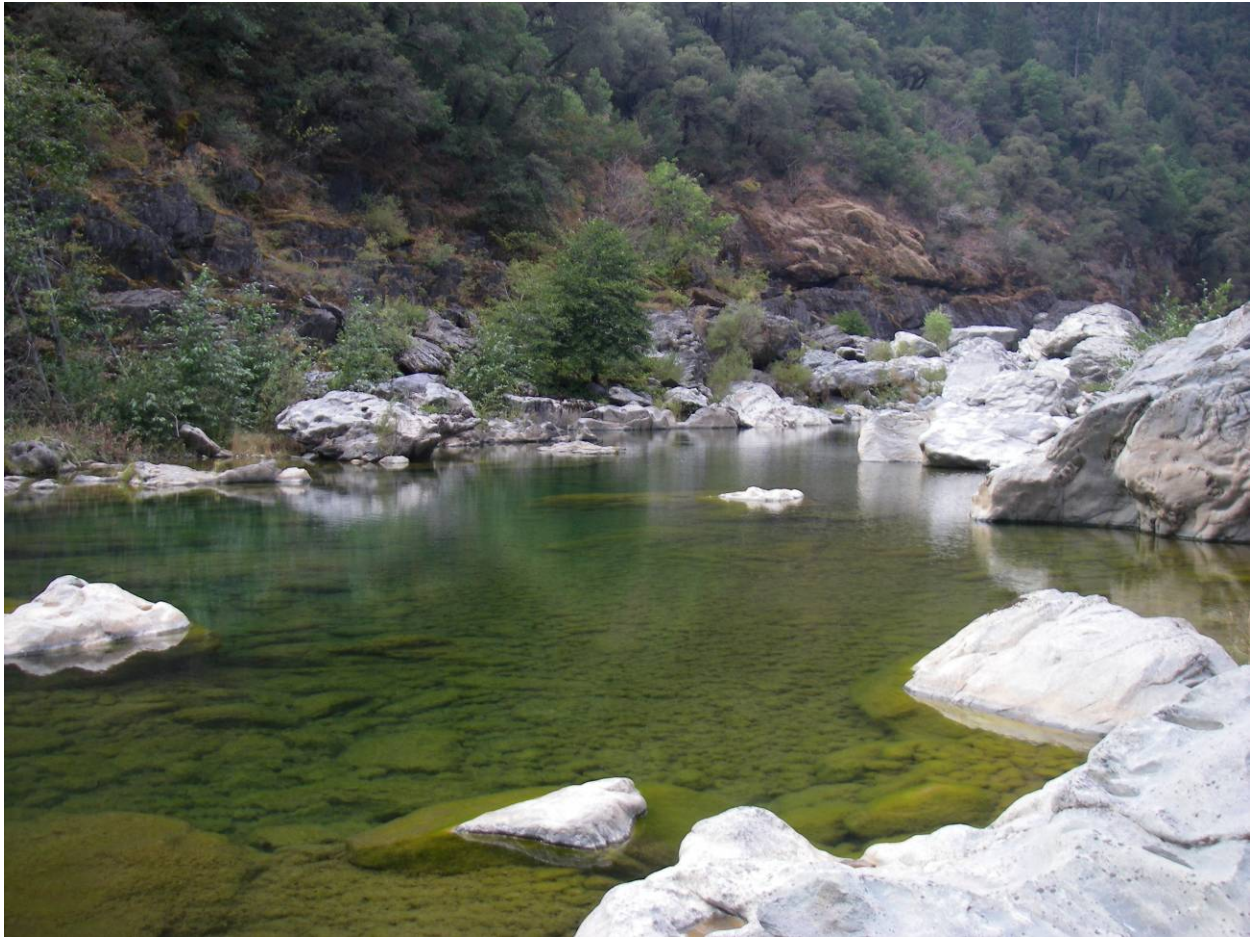
**Figure 2.0-26. North Yuba River NBBDR, Section 1 near RM 0.5, mid-channel pool with bedrock/boulder-dominant substrate and some cobble, looking upstream, September 14, 2009.**

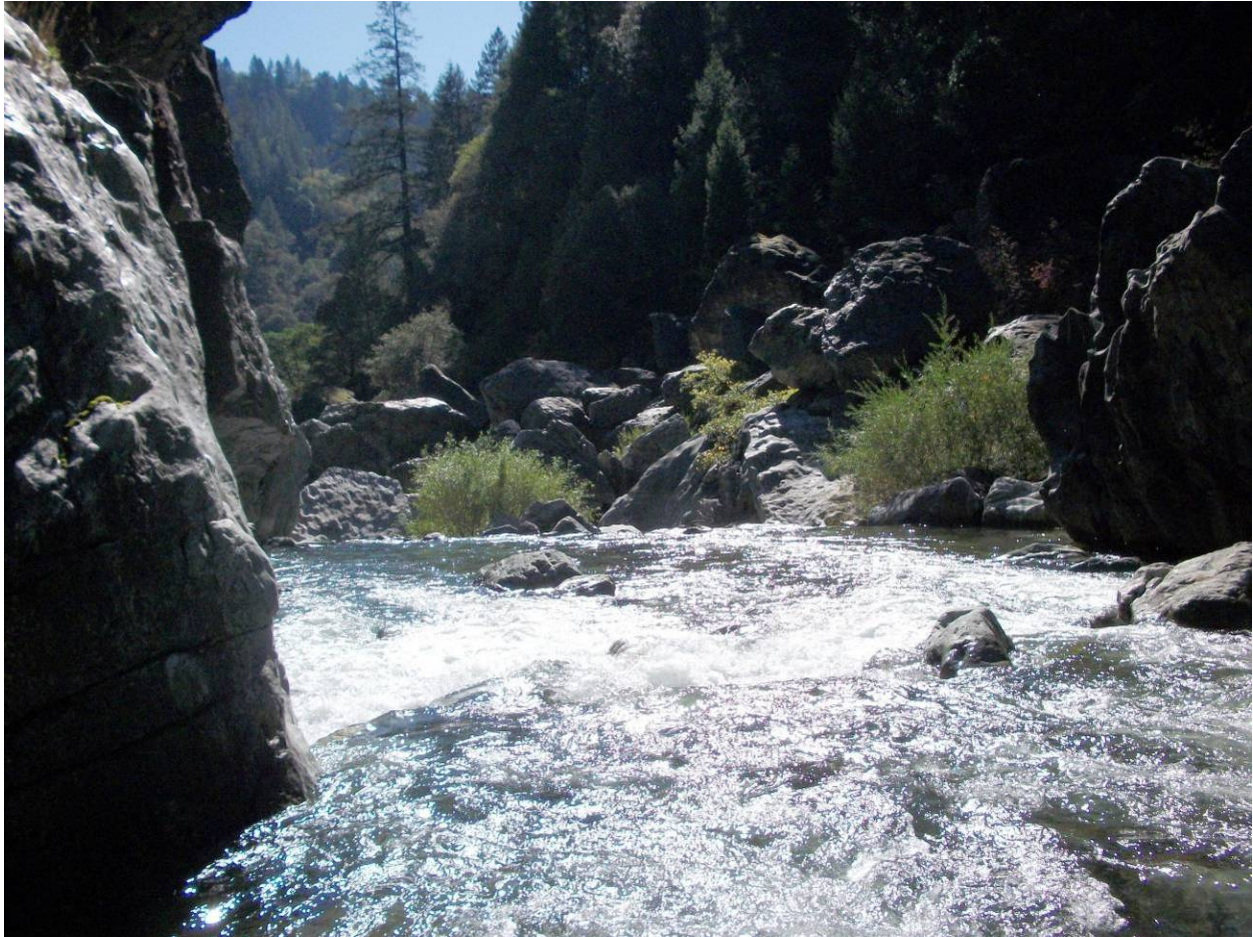
**Figure 2.0-27. North Yuba River NBBDR, Section 3 near RM 1.5, rapids with boulder and bedrock dominant substrate, looking downstream October 17, 2009. Below this section is inaccessible.**

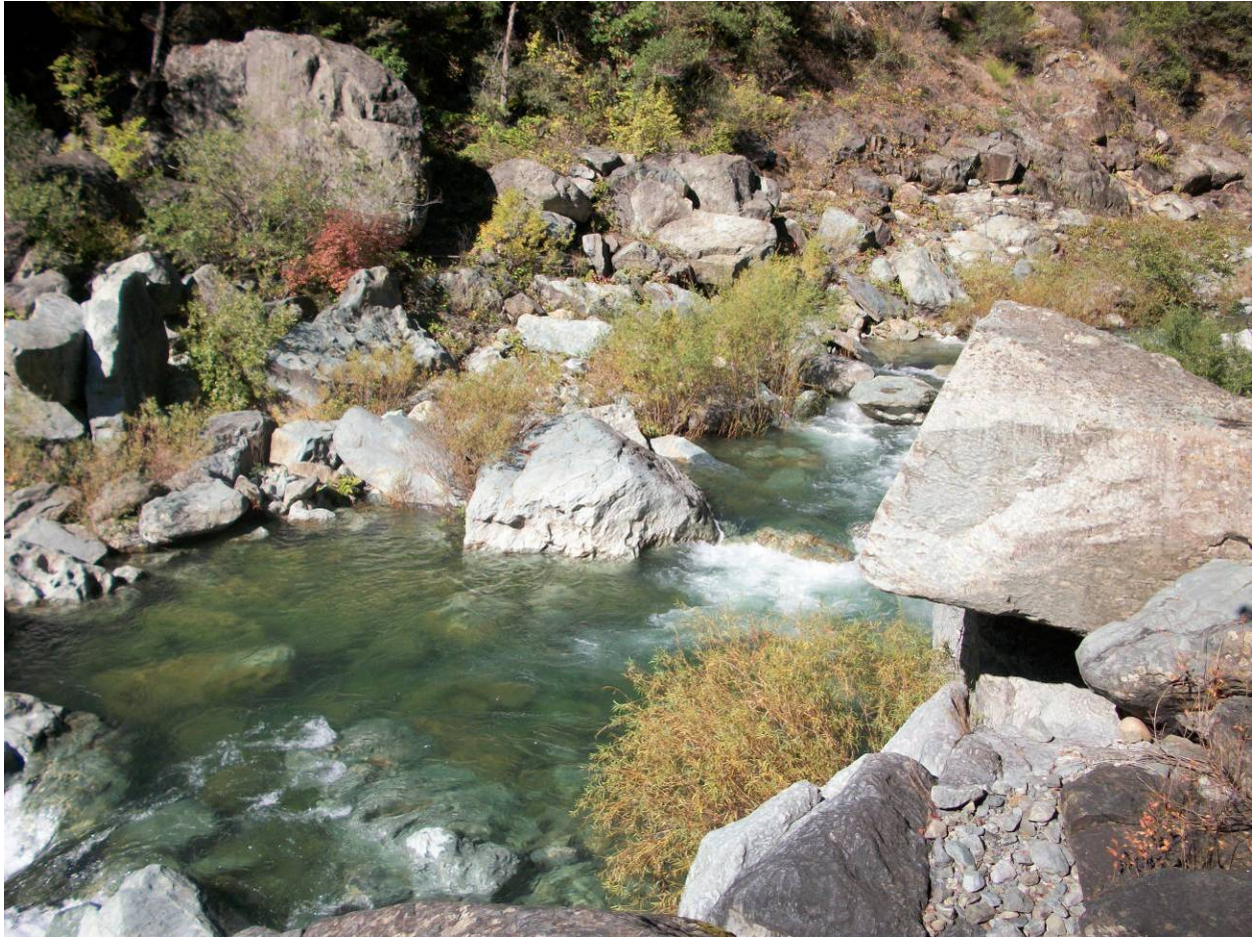
**Figure 2.0-28. North Yuba River NBBDR, Section 3 near RM 1.55, step-pool with boulder-dominant substrate, looking upstream October 17, 2009.**

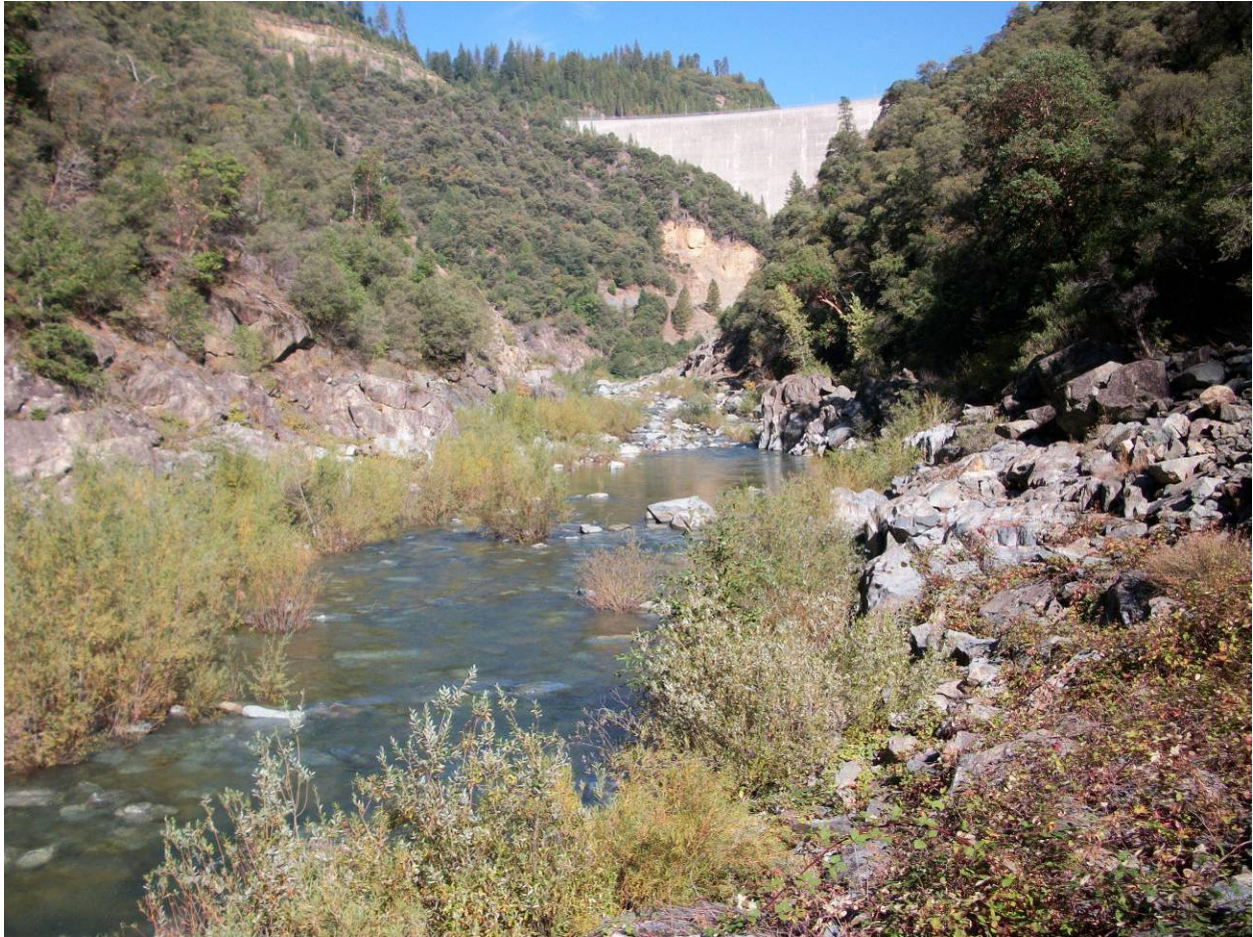
**Figure 2.0-29. North Yuba River NBBDR, Section 3 near RM 1.6, low-gradient riffle with boulder-dominant substrate and vegetated banks, looking upstream October 17, 2009.**

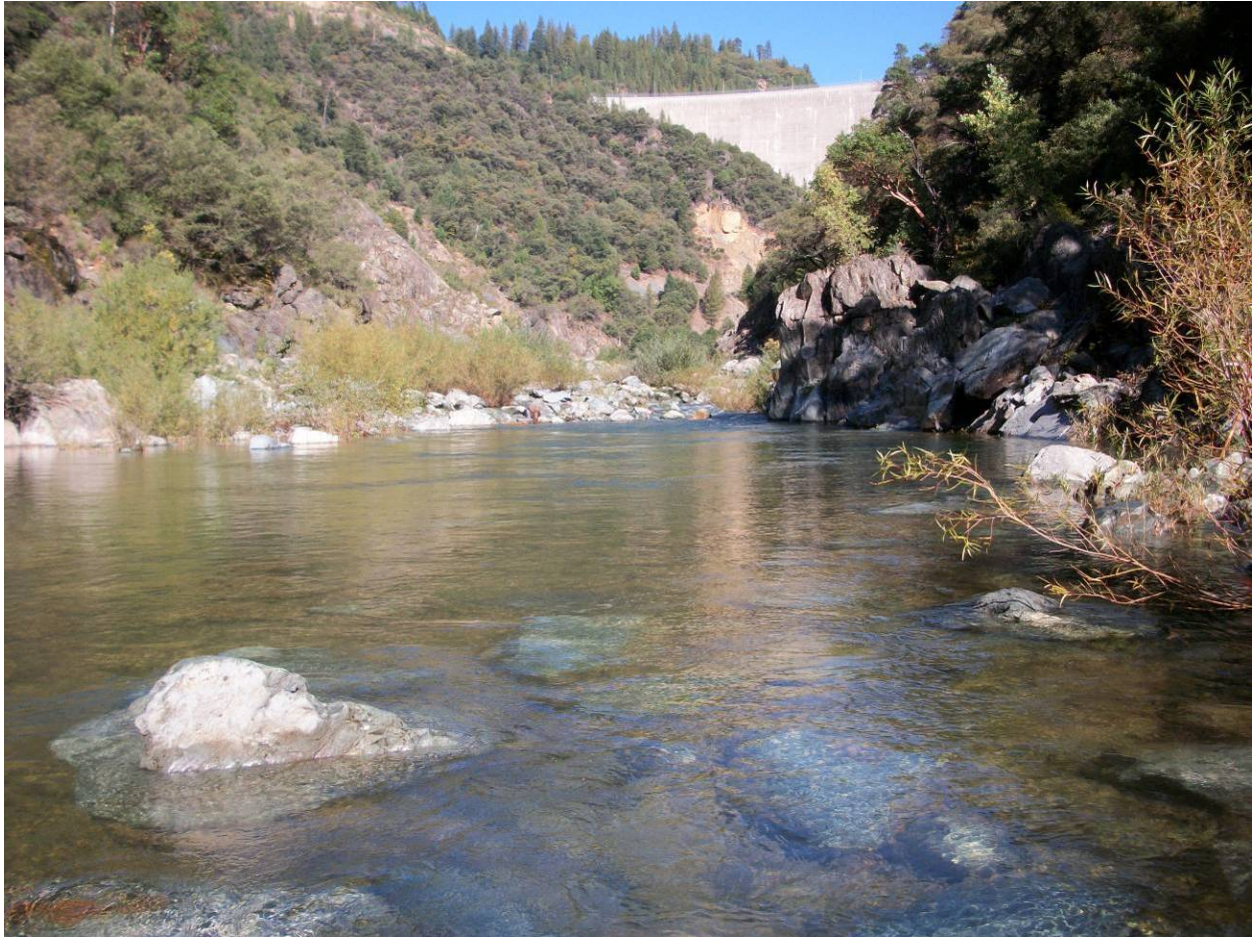
**Figure 2.0-30. North Yuba River NBBDR, Section 3 near RM 1.7, mid-channel pool with boulder-dominant substrate, looking upstream October 17, 2009.**

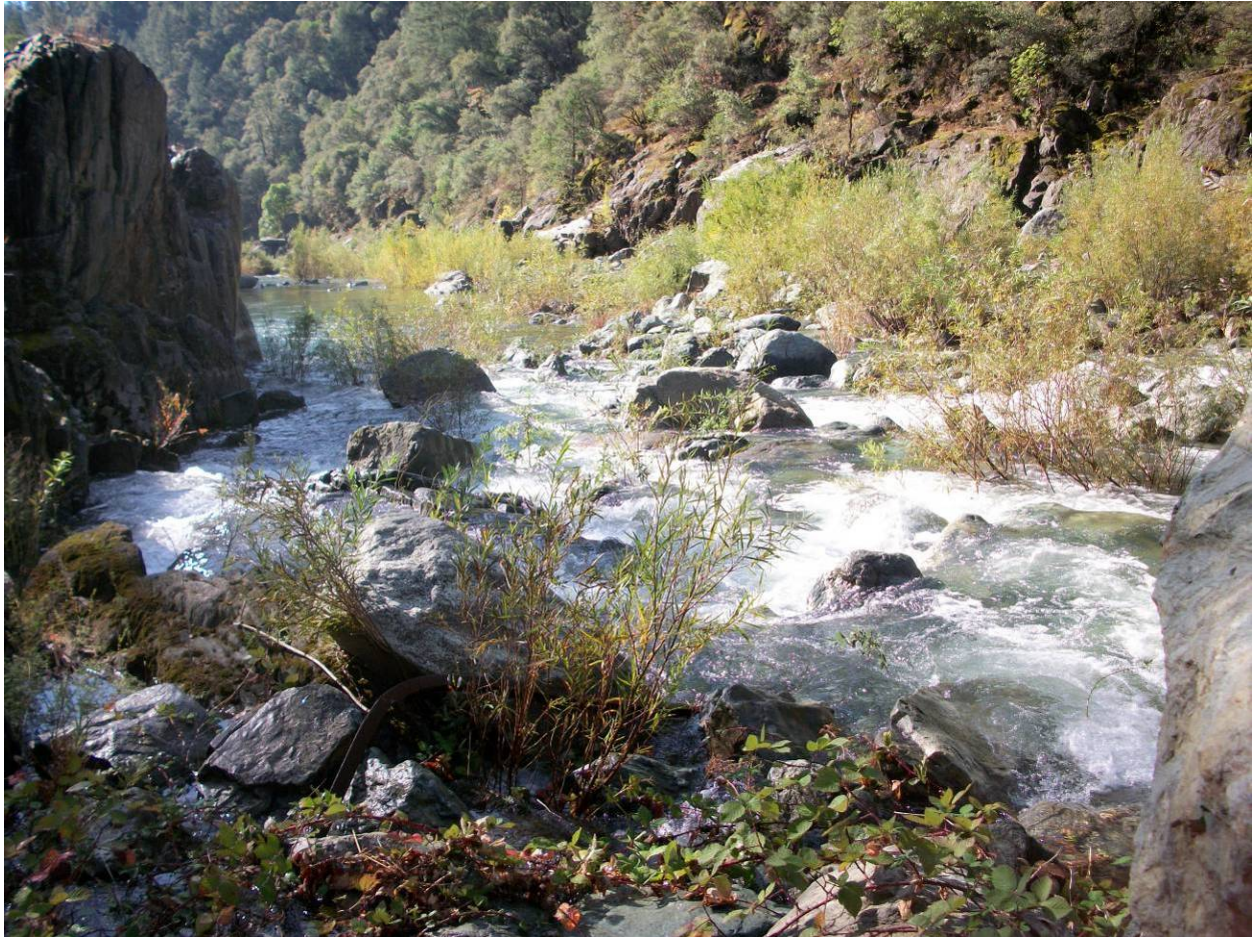
**Figure 2.0-31. North Yuba River NBBDR, Section 3 near RM 1.8, high-gradient riffle with boulder-dominant substrate, looking downstream October 17, 2009.**

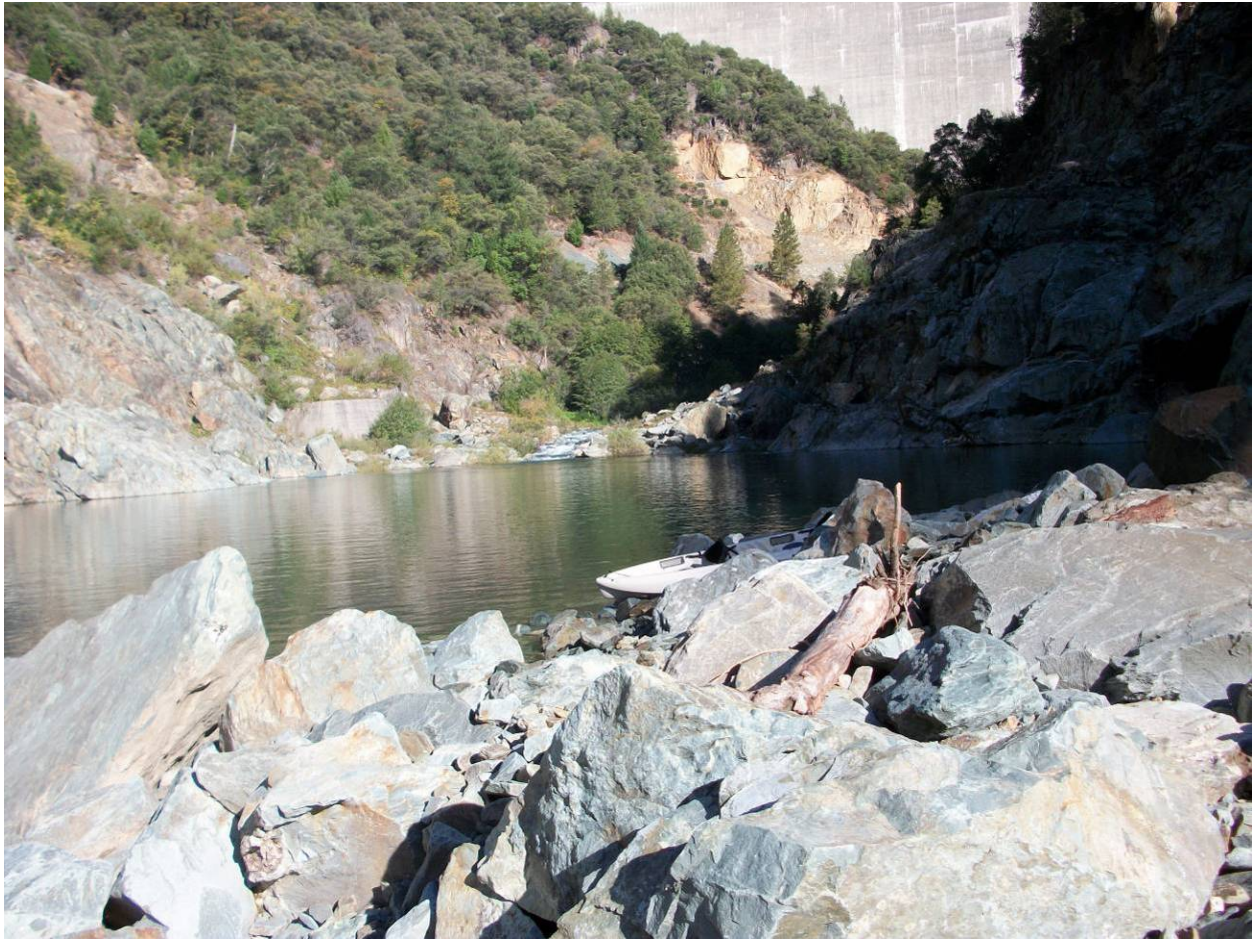
**Figure 2.0-32. North Yuba River NBBDR, Section 3 near RM 1.9, mid-channel pool with boulder-dominant substrate (bedrock mainly found on banks), looking upstream October 17, 2009. Spillway pool requires boat to cross.**
