## 2.0 North Yuba River – New Bullards Bar Dam Reach

New Bullards Bar Dam Reach of the North Yuba River is 2.3 miles in length and extends from the confluence of the North Yuba River with the Middle Yuba River to New Bullards Bar Dam. Information used to evaluate conditions on this reach and investigate accessibility included a field reconnaissance on March 7 and 9, 2011. Additional information was collected in September and October 2009 as part of the Habitat Mapping Report (YCWA 2010).

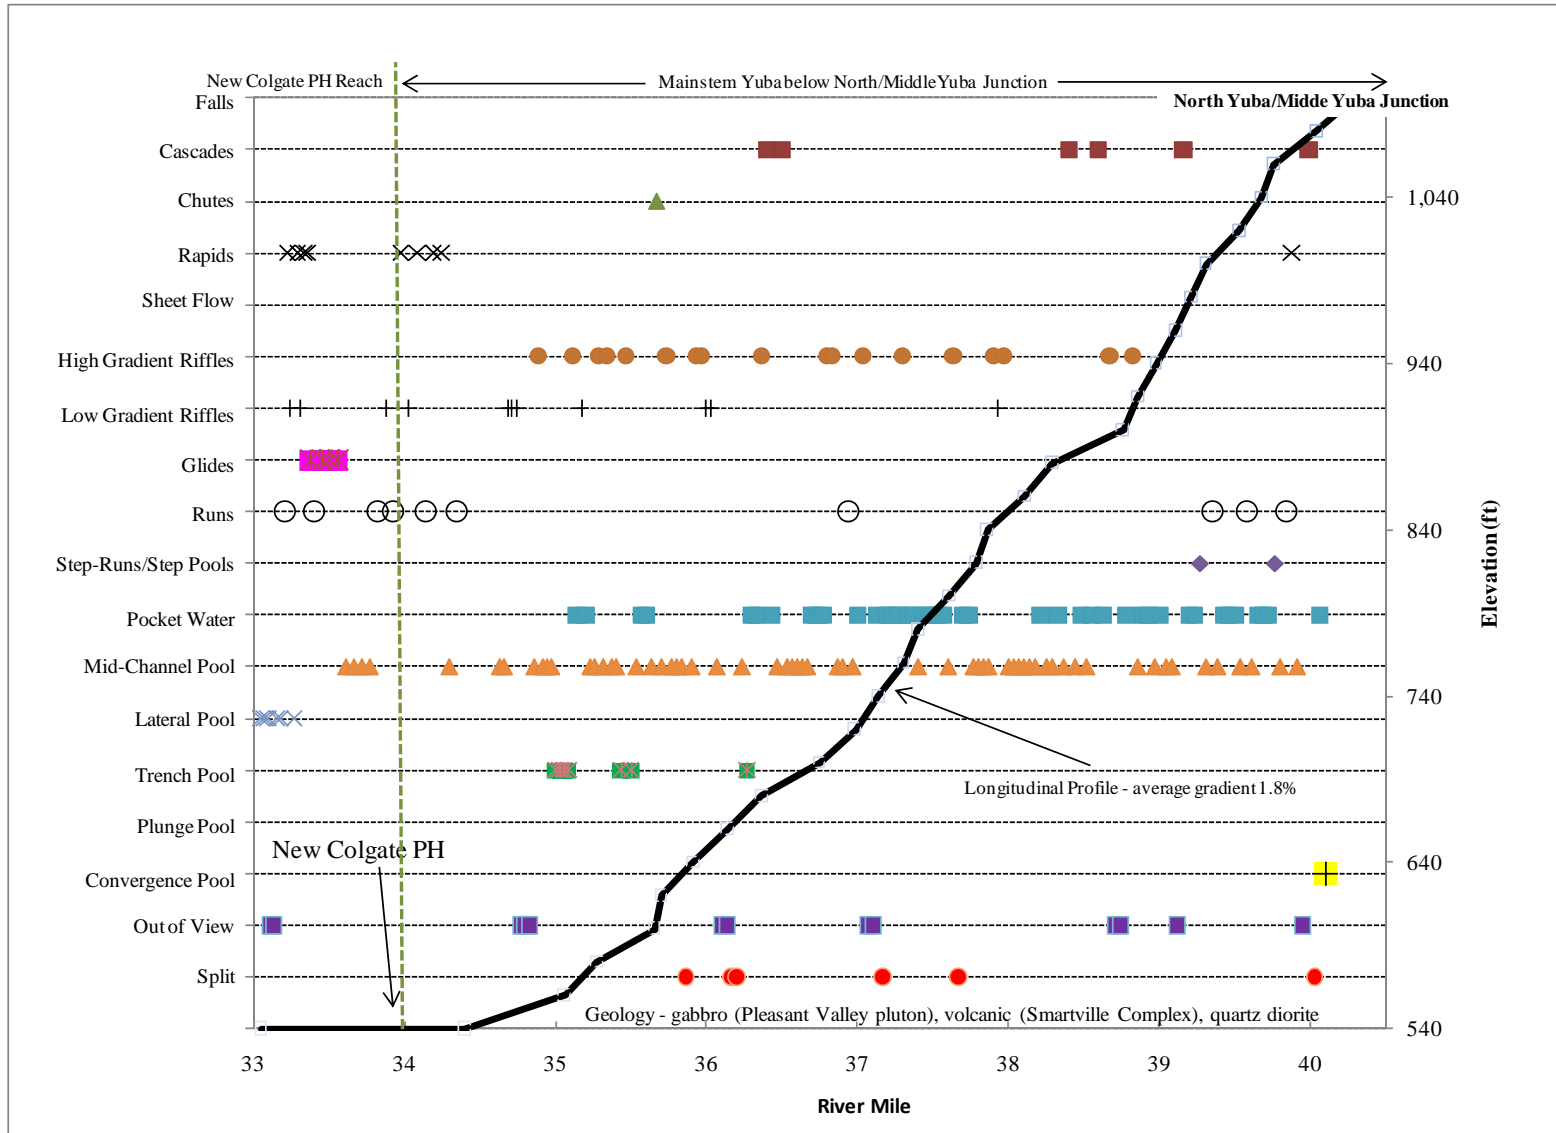
**Figure 3.0-1. Yuba River – Middle/North Yuba River Reach longitudinal profile and Habitat Mapping Units using video-mapped data (YCWA 2010).**

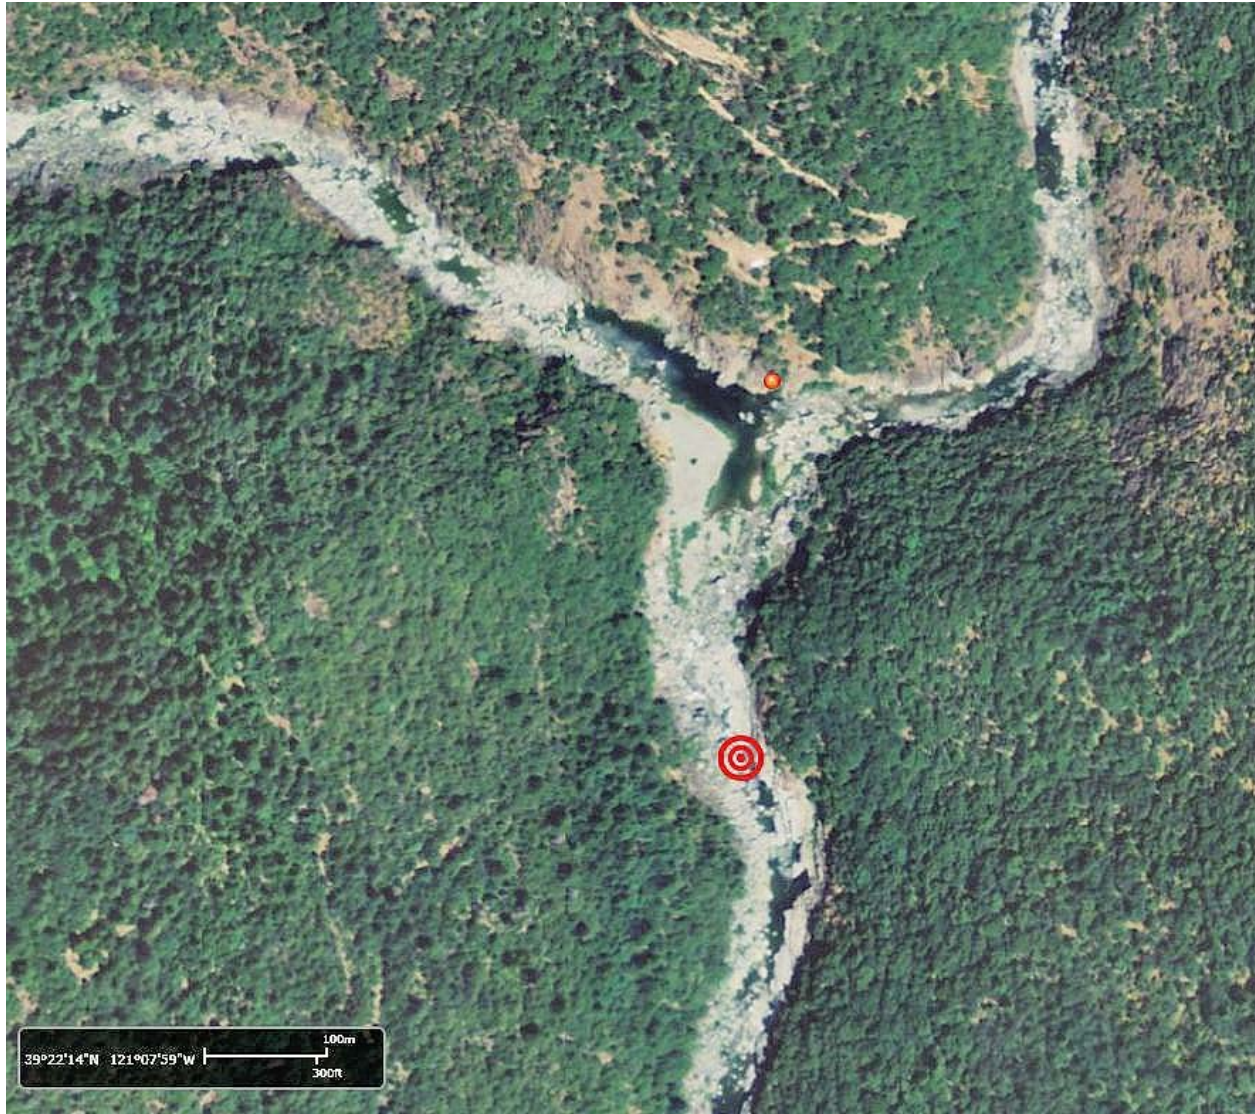
**Figure 3.0-4. Yuba River – Middle/North Yuba River Reach: aerial image of upstream section investigated in March 2011. The reach was not traversable during the March 2011 reconnaissance; investigation was limited to visual observations at the Middle/North Yuba Confluence only. Concentric red circles indicate approximate limit of accessible section of reach (with boat and at low flows).**

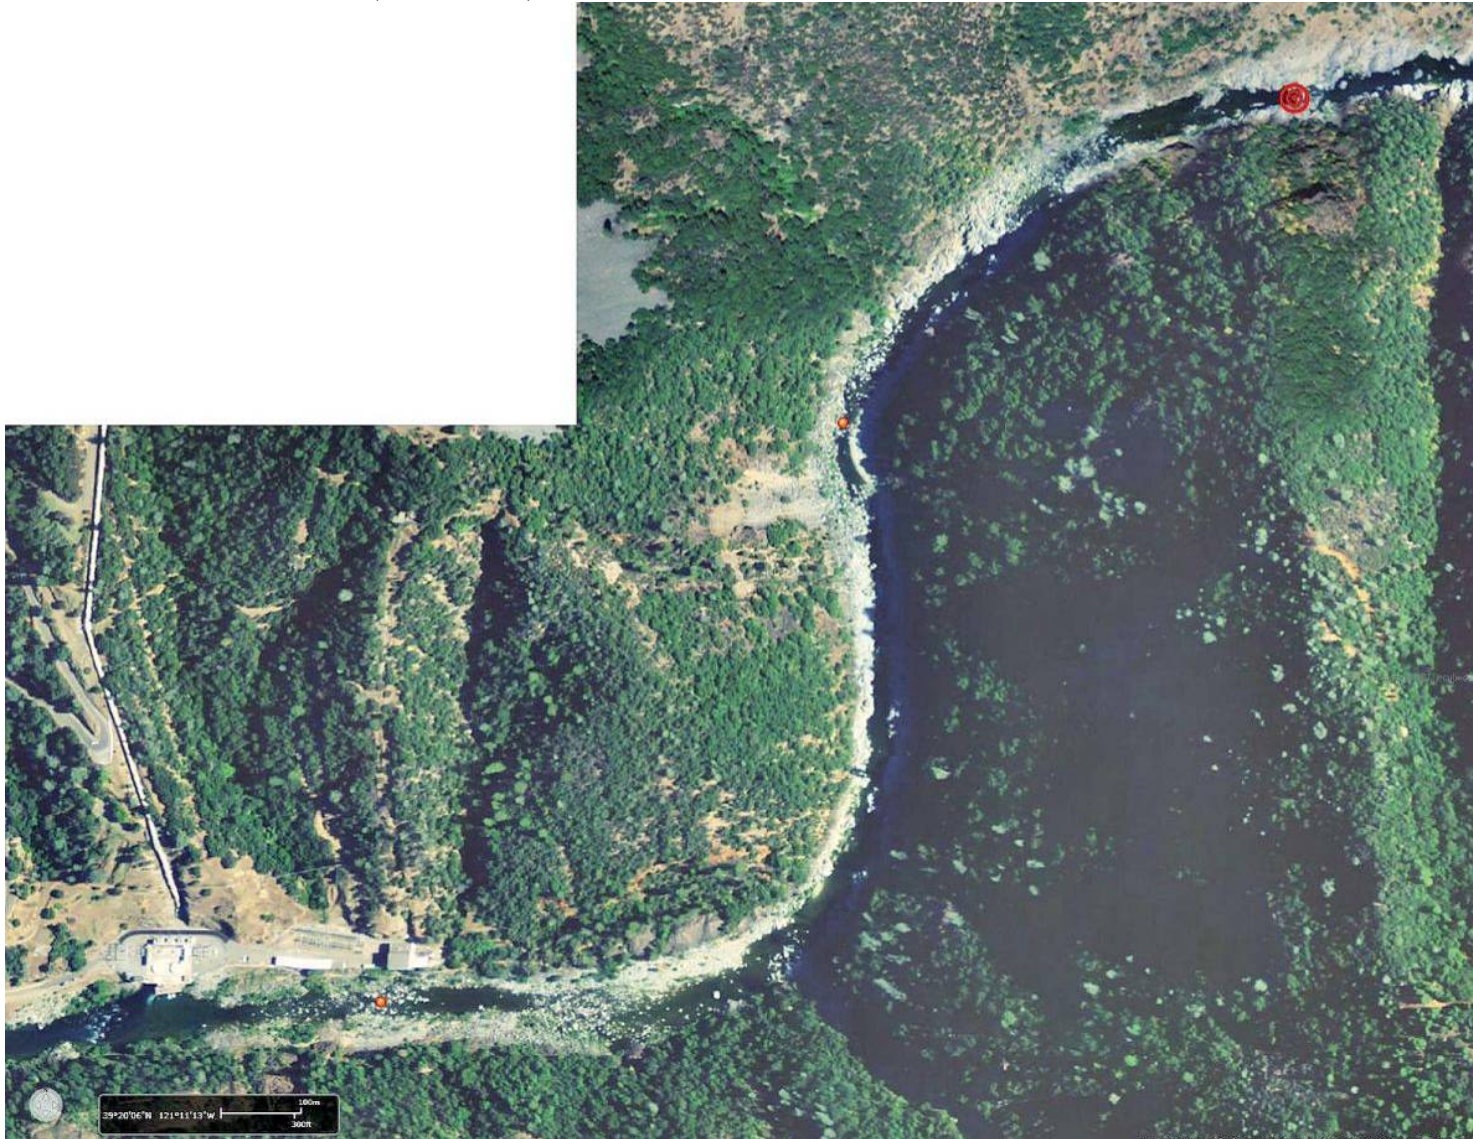
**Figure 3.0-5. Yuba River – Middle/North Yuba River Reach: aerial image of downstream section investigated in March 2011. The approximate extent of the March 2011 reconnaissance area is demarcated by red dots. Concentric red circles indicate approximate limit of accessible section of reach (at low flows).**

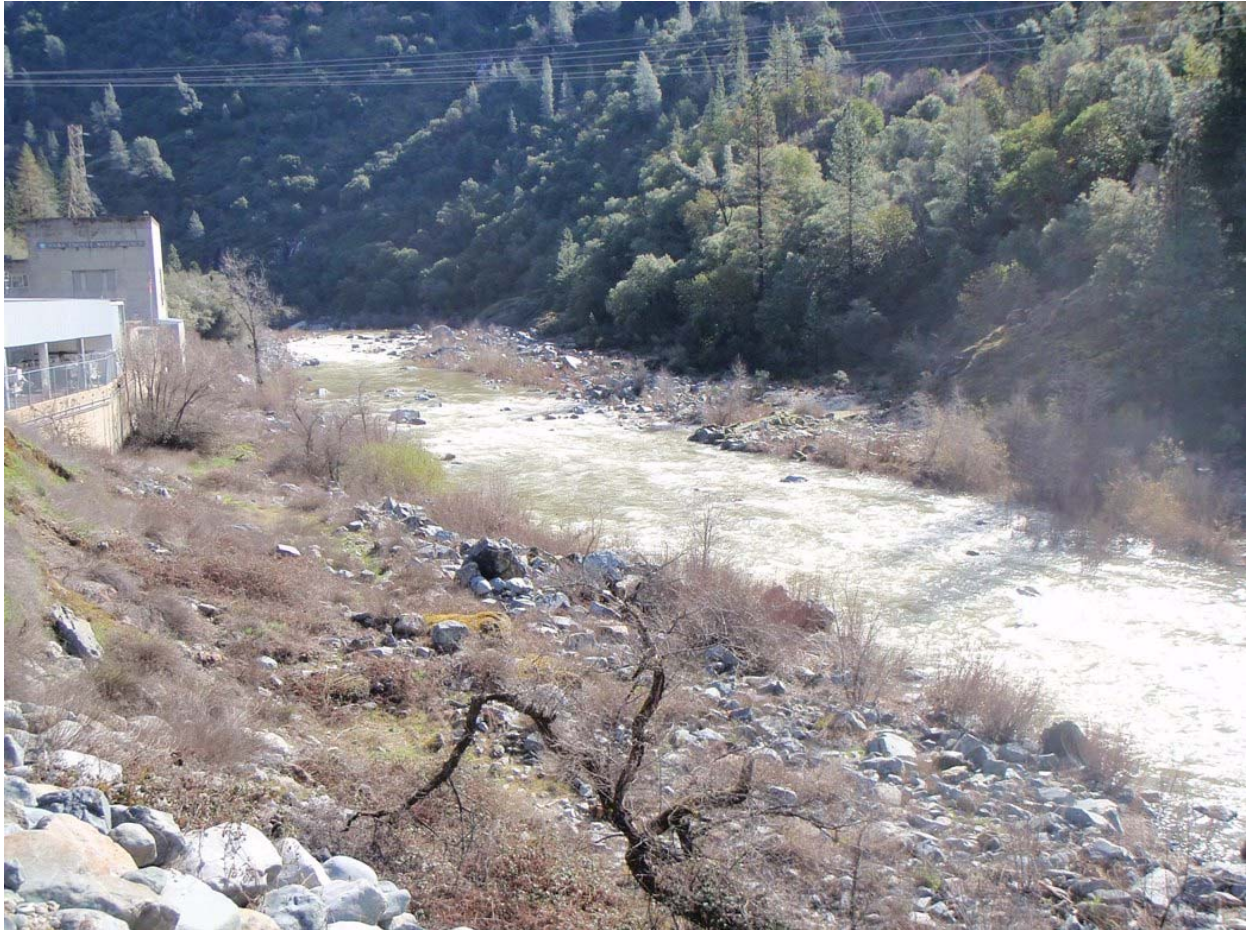
**Figure 3.0-17. Yuba River MNYRR, Section 1 at RM 34, run/mid-channel pool looking upstream from New Colgate Powerhouse, March 7, 2011.**

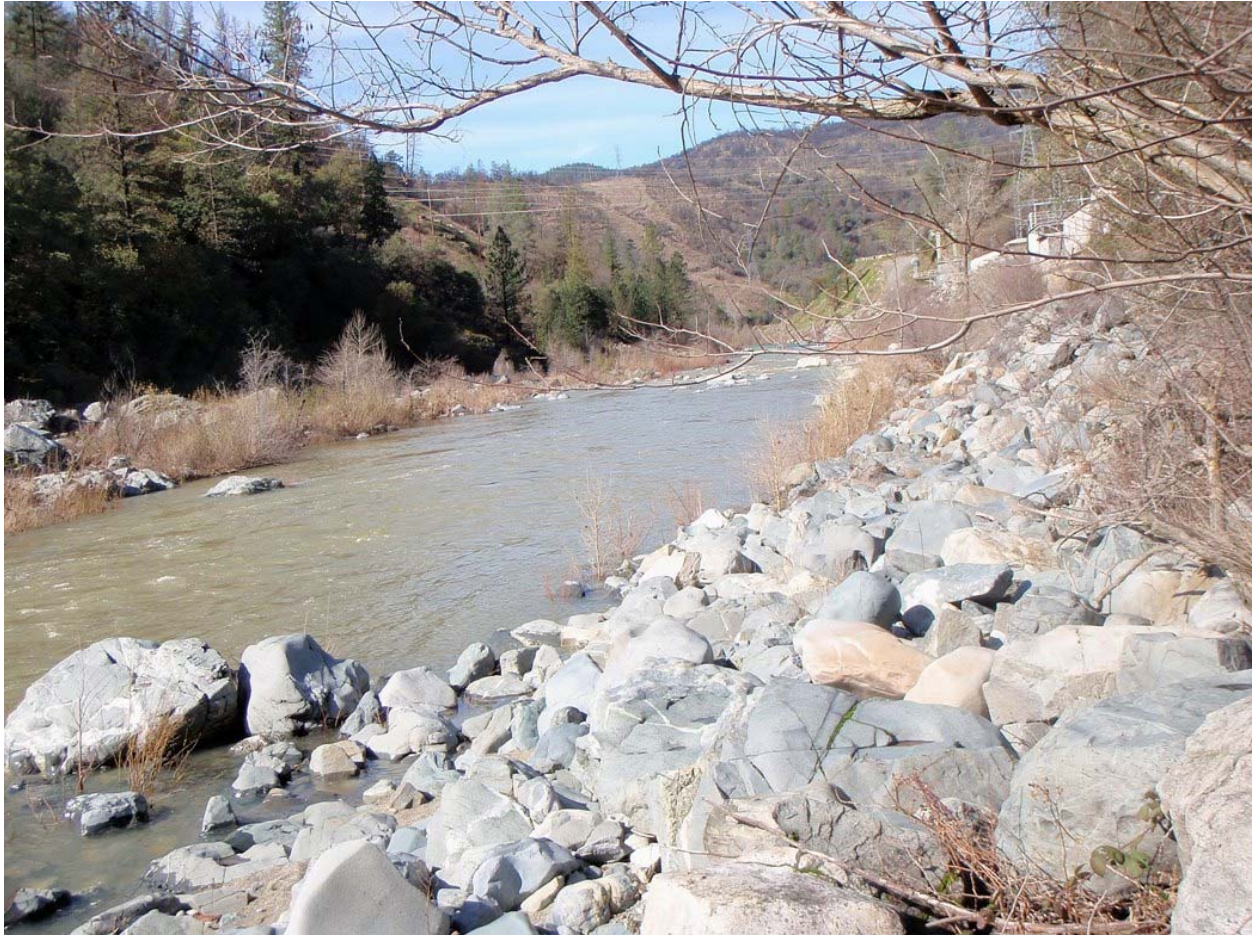
**Figure 3.0-18. Yuba River MNYRR, Section 1 at RM 34.1, low-gradient riffle looking upstream, March 7, 2011.**

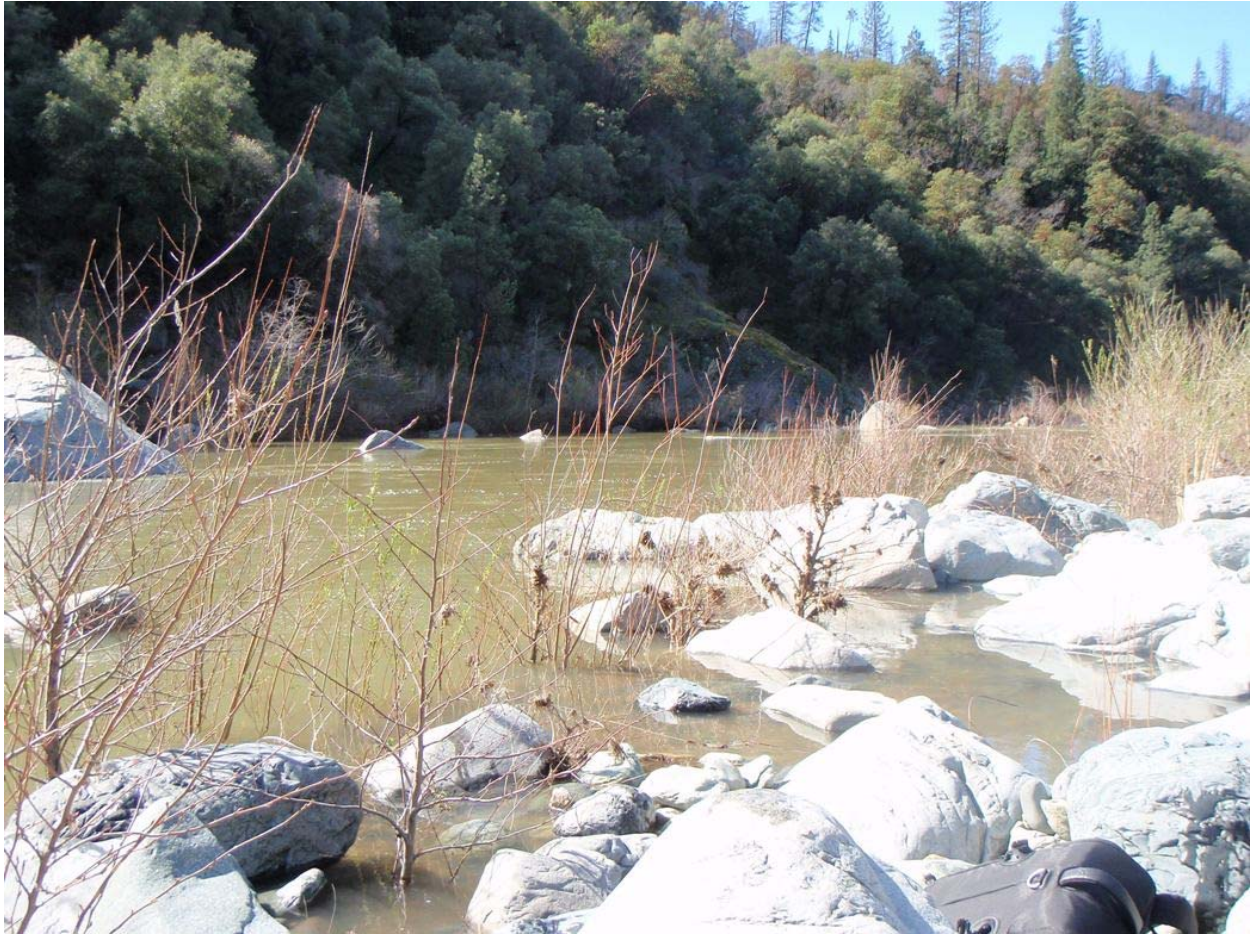
**Figure 3.0-19. Yuba River MNYRR, Section 1 at RM 34.3, mid-channel pool looking upstream, March 7, 2011.**

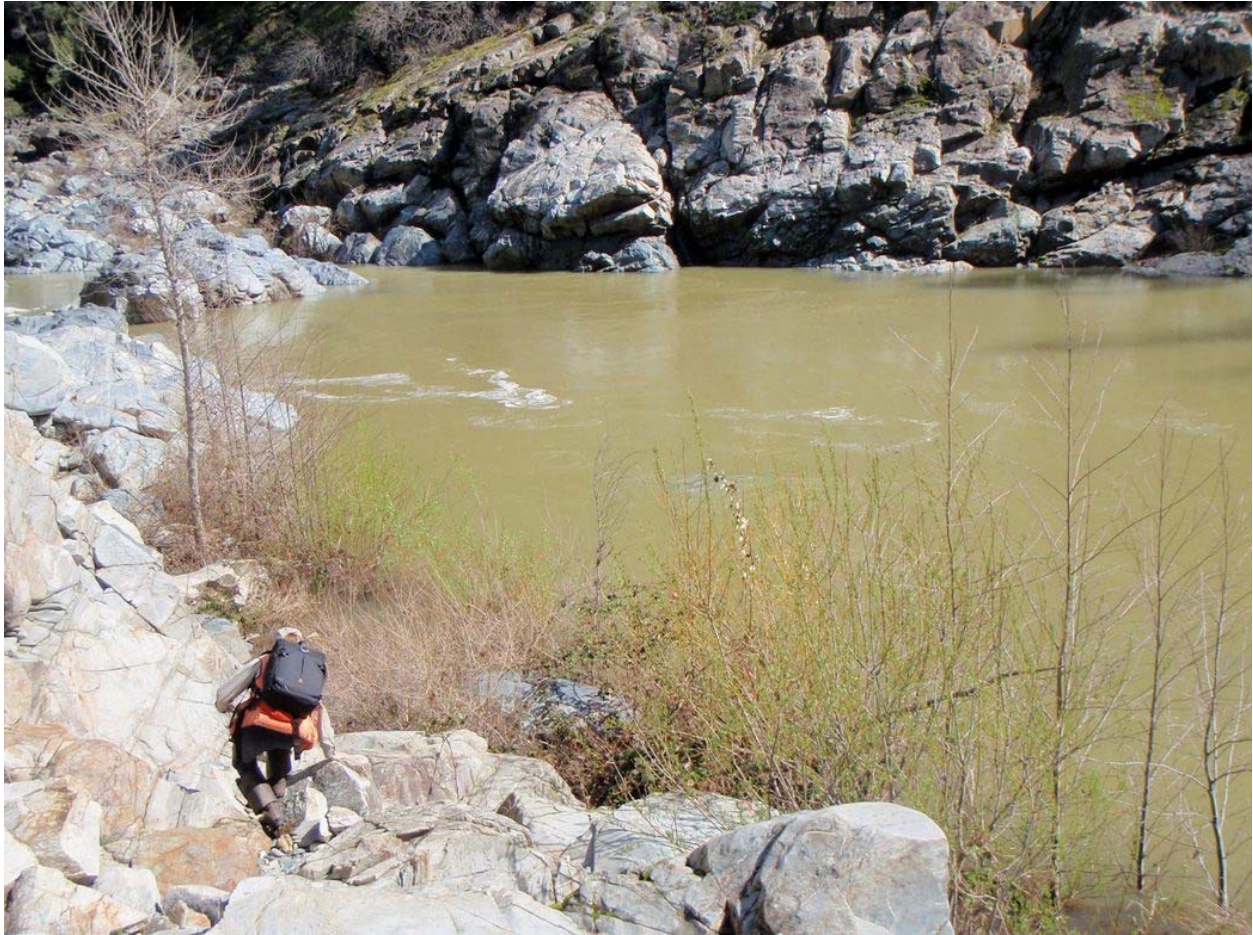
**Figure 3.0-20. Yuba River MNYRR, Section 1 at RM 34.4, trench pool looking upstream, March 7, 2011.**

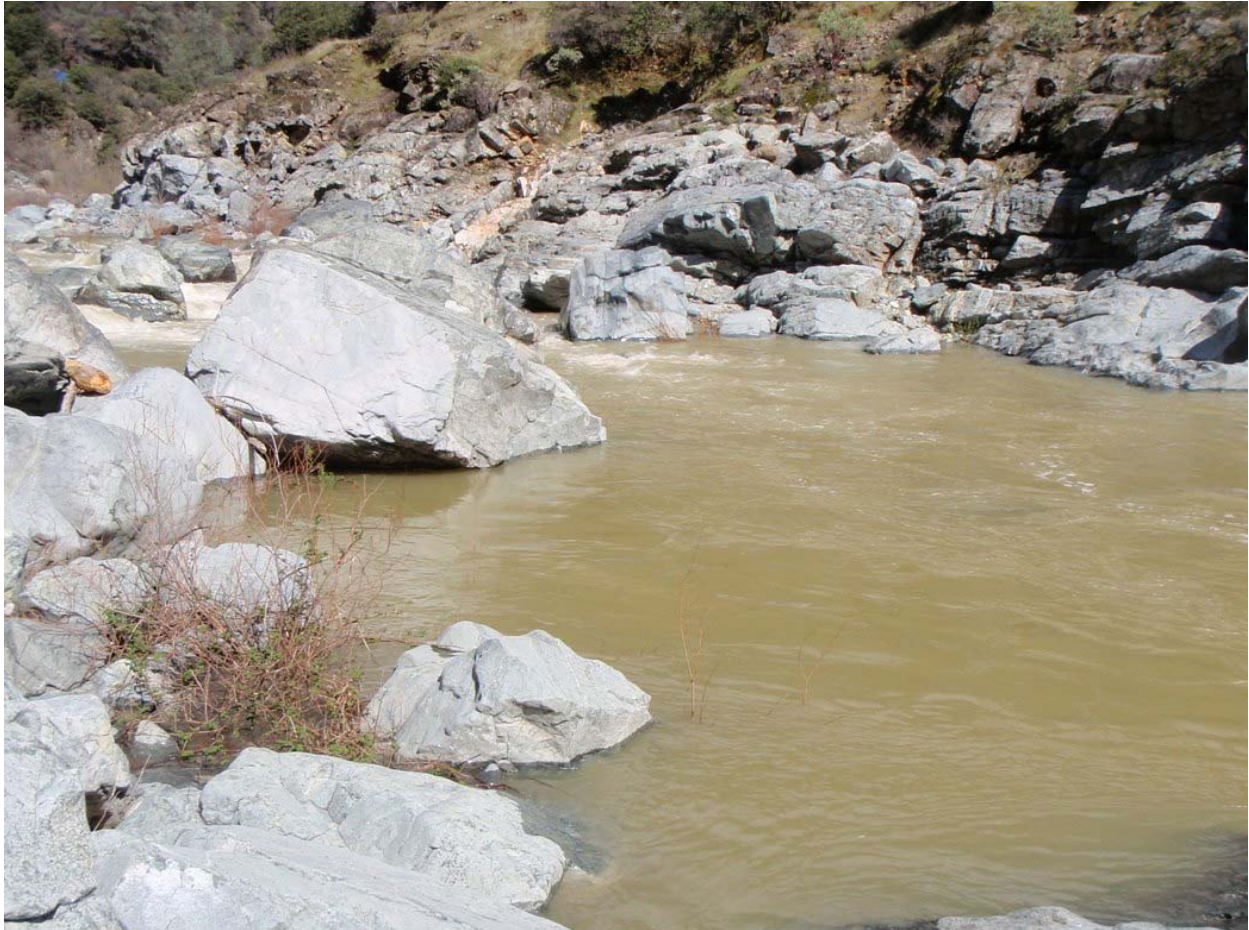
**Figure 3.0-21. Yuba River MNYRR, Section 1 at RM 34.5, edgewater habitat near high gradient riffle, looking upstream, March 7, 2011.**

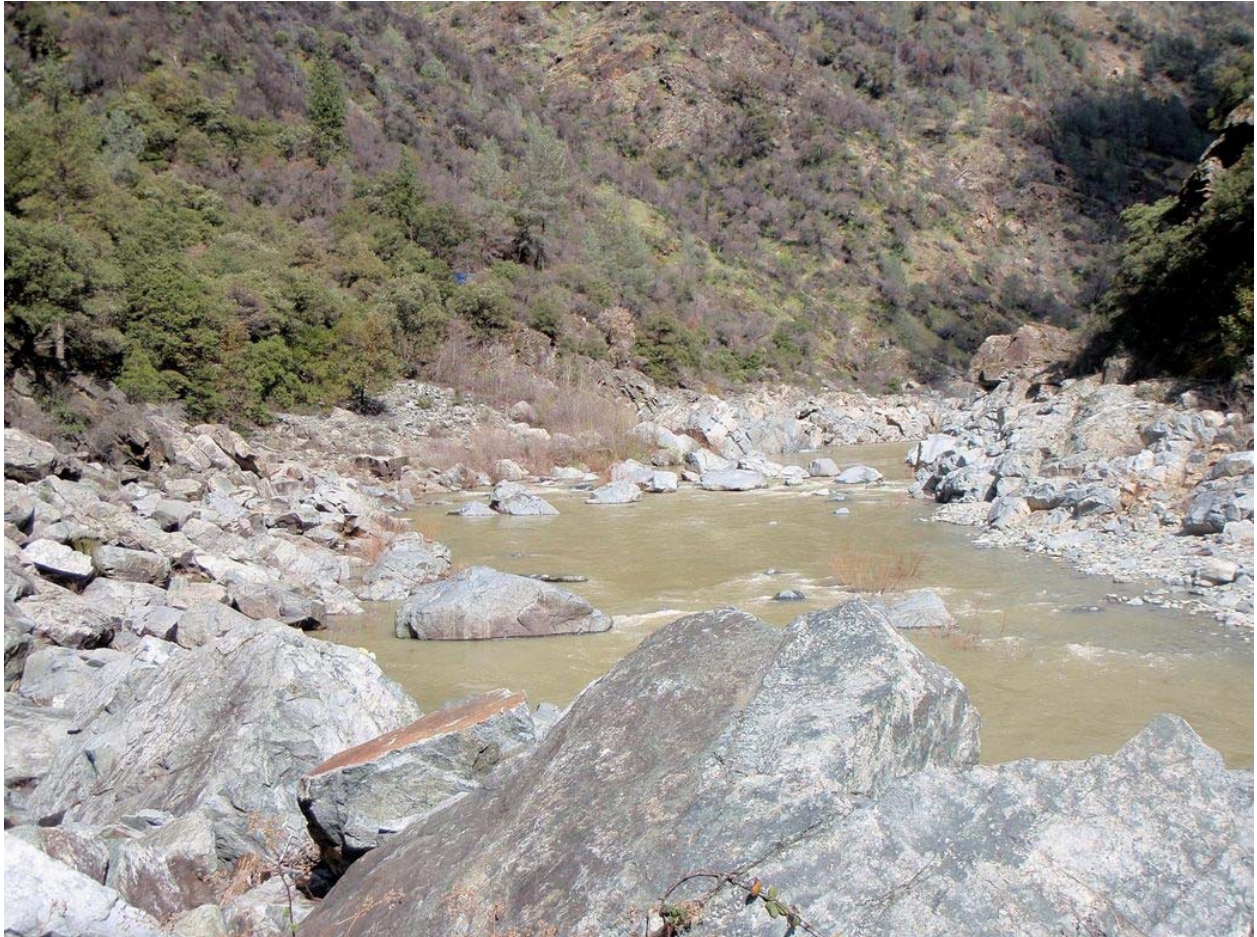
**Figure 3.0-22. Yuba River MNYRR, Section 1 at RM 34.7, low-gradient riffle, looking upstream, March 7, 2011.**

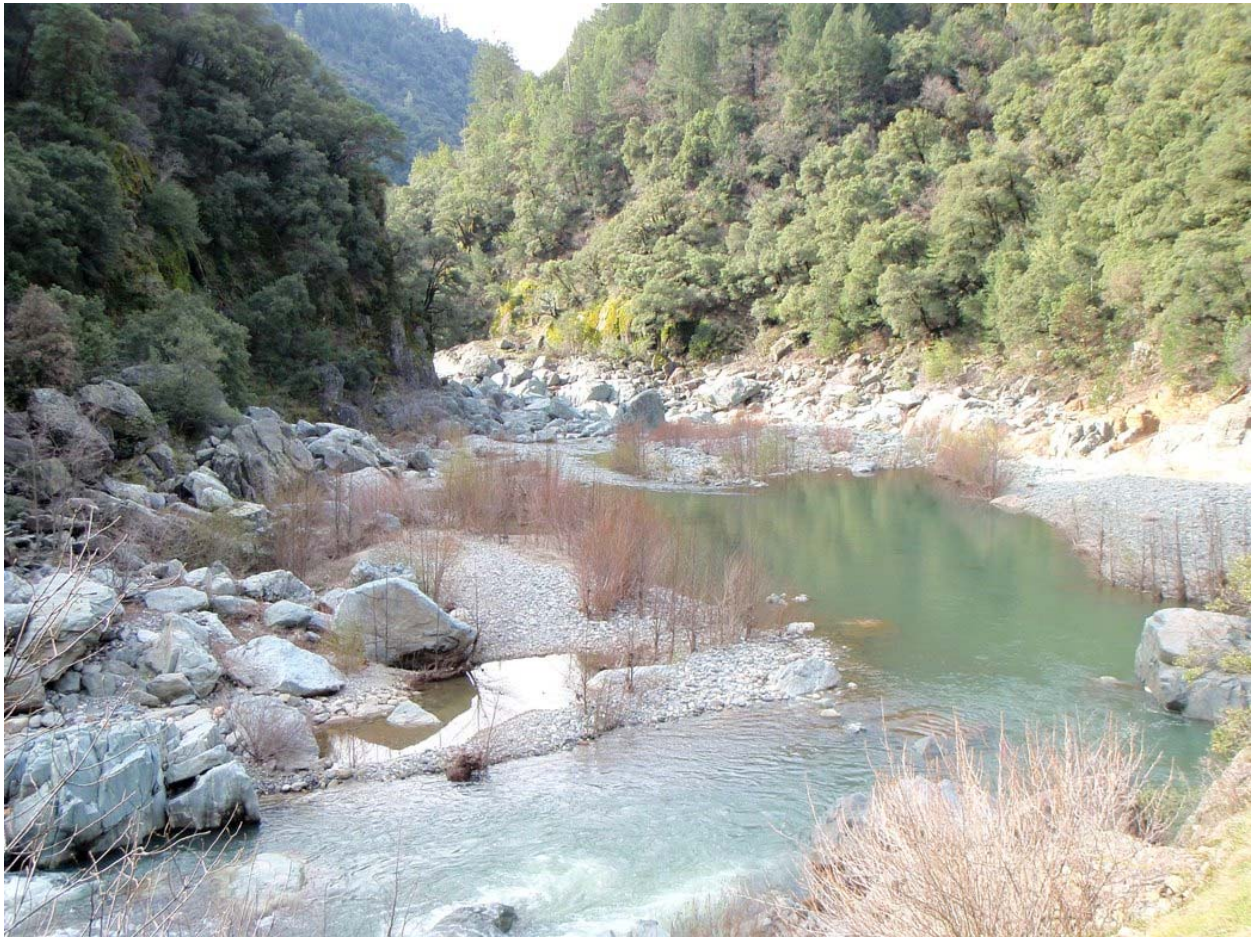
**Figure 3.0-23. Yuba River MNYRR, Section 3 at RM 39.6, confluence of Middle/North Yuba, looking downstream, March 9, 2011.**
