**North Yuba River
Habitat Mapping Data**

**Yuba County Water Agency Hydroelectric Project
FERC 2246**

Stream: North Yuba
Reach: > MY jntn and < Bullards Bar

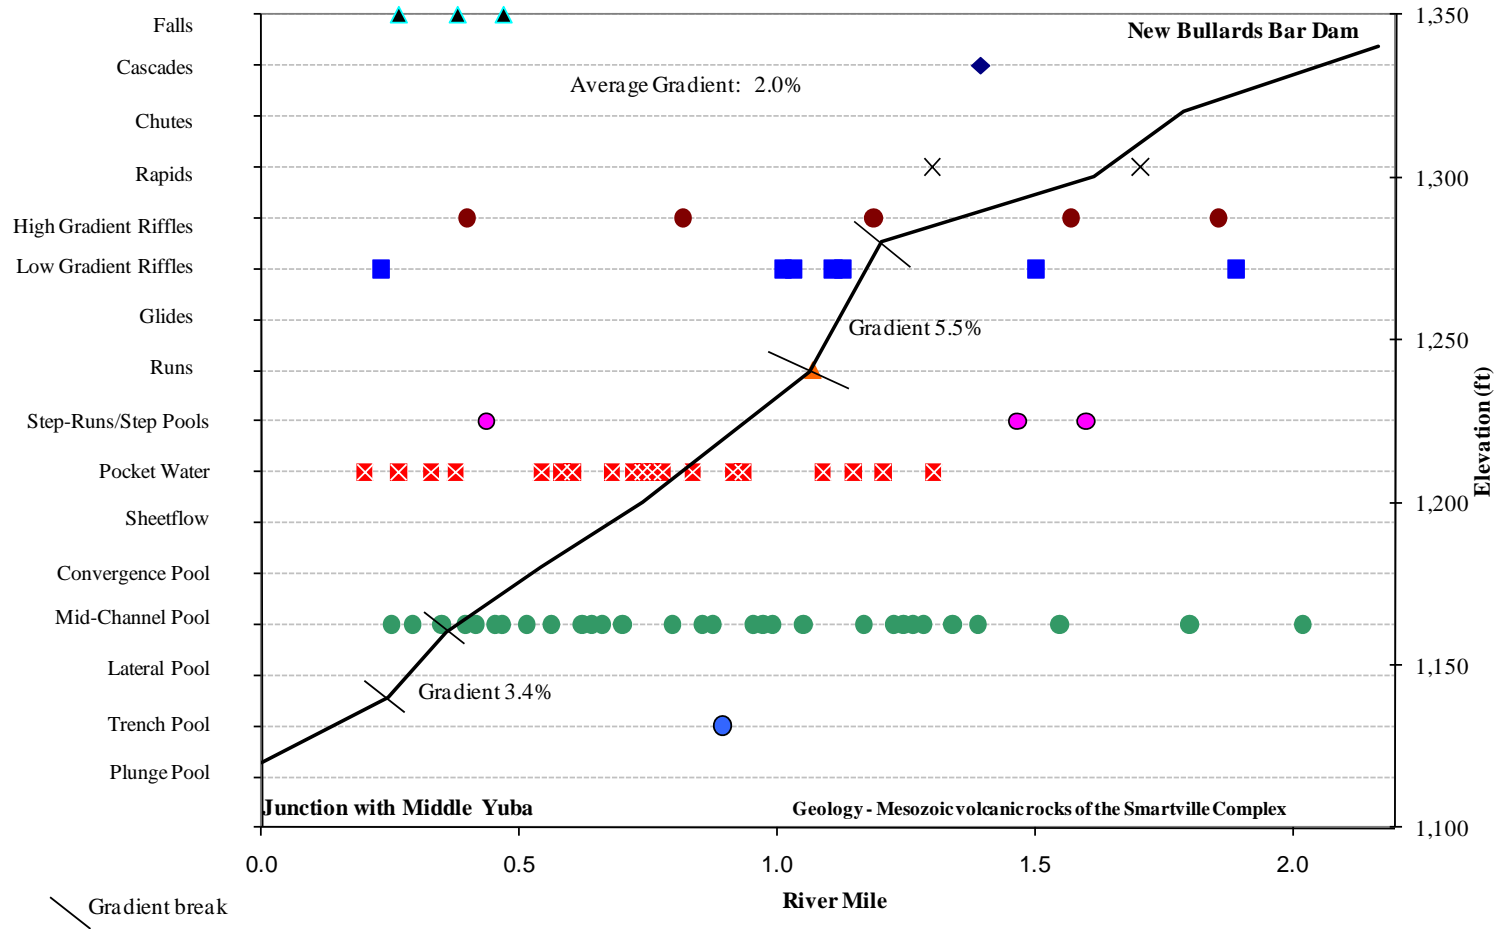
North Yuba River – Habitat Mapping Units using ground-based and video-mapped data and longitudinal profile.
