Technical Memorandum 6-2
Riparian Habitat Downstream of Englebright Dam

Attachment 6-2F
Representative Photographs

Yuba River Development Project
FERC Project No. 2246

June 2013

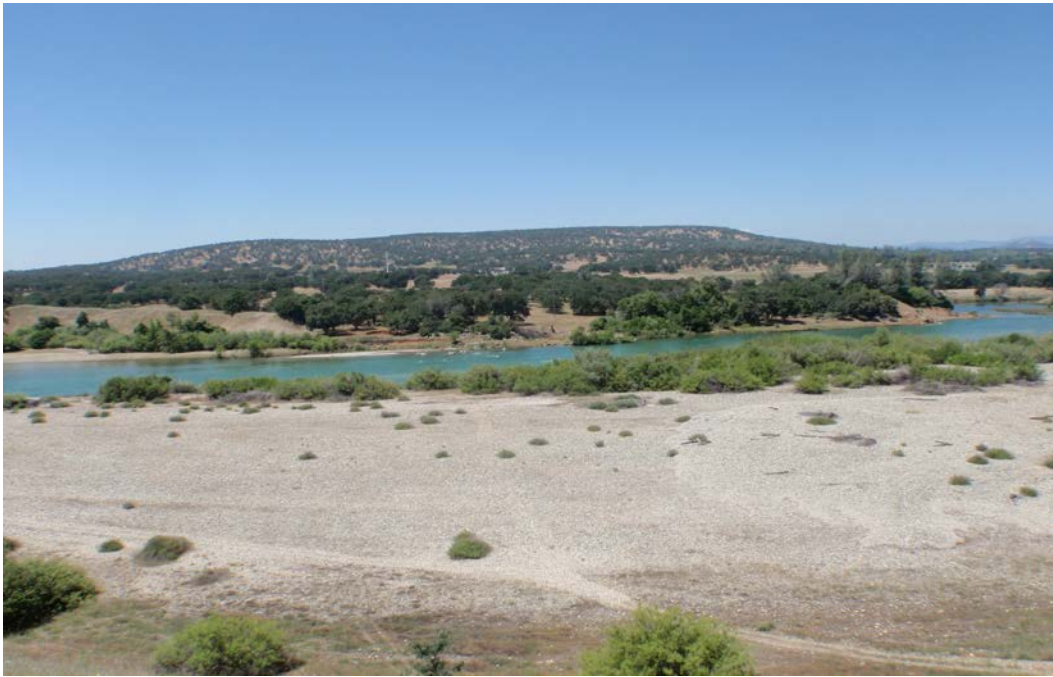
Figure 1. Floodplains in the lower Yuba River (LYR) are dominated by various species of willows (*Salix* spp.) and Fremont's cottonwood (*Populus fremontii*) (cottonwood) along with California brickellbush (*Brickellia californica*). This photograph overlooks Parks Bar from the south bank.

| Figure No. | List of Figures Description | Page No. |
|---|---|---|
| 1. | Floodplains in the lower Yuba River (LYR) are dominated by various species of willows (<i>Salix</i> spp.) and cottonwood along with California brickelbush (<i>Brickellia californica</i>) (small vegetation in dryer areas. This photograph overlooks Parks Bar from the south bank. | F-2 |

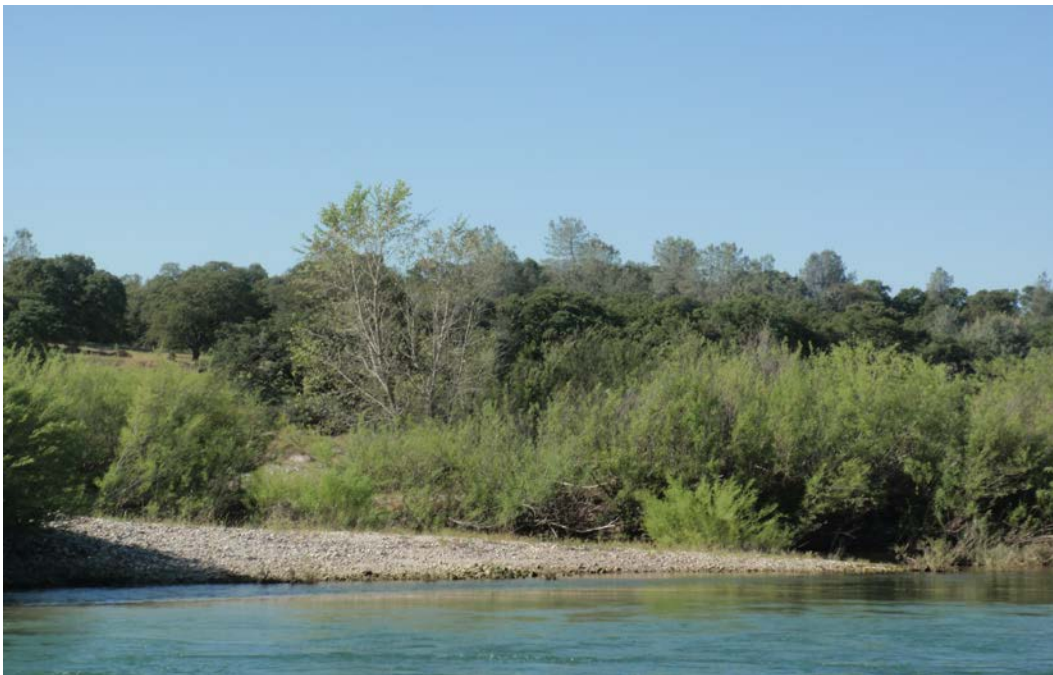
Figure 2. Various willows and cottonwoods on a lateral bar in the Parks Bar study site, with oak (*Quercus* spp.) grasslands and grey pines (*Pinus sabiniana*) in the upland areas.

| Figure No. | List of Figures Description | Page No. |
|---|---|---|
| 2. | Various willows and cottonwoods on a lateral bar in the Parks Bar study site, with oak grasslands and grey pines in the upland areas. | F-2 |

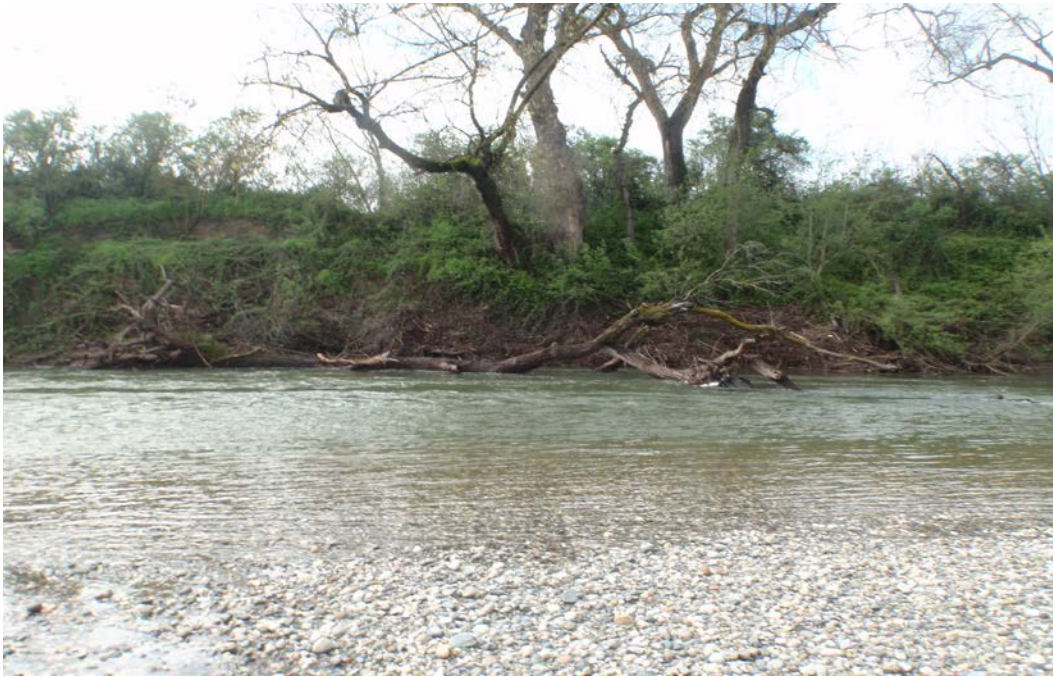
Figure 3. Large cottonwoods are present in abundance on levee walls and at the top of terreces. Photograph taken in the Hallwood reach.

| Figure No. | List of Figures Description | Page No. |
|---|---|---|
| 3. | Large cottonwoods are present in abundance on levee walls and at the top of terreces. Photograph taken in the Hallwood reach. | F-3 |

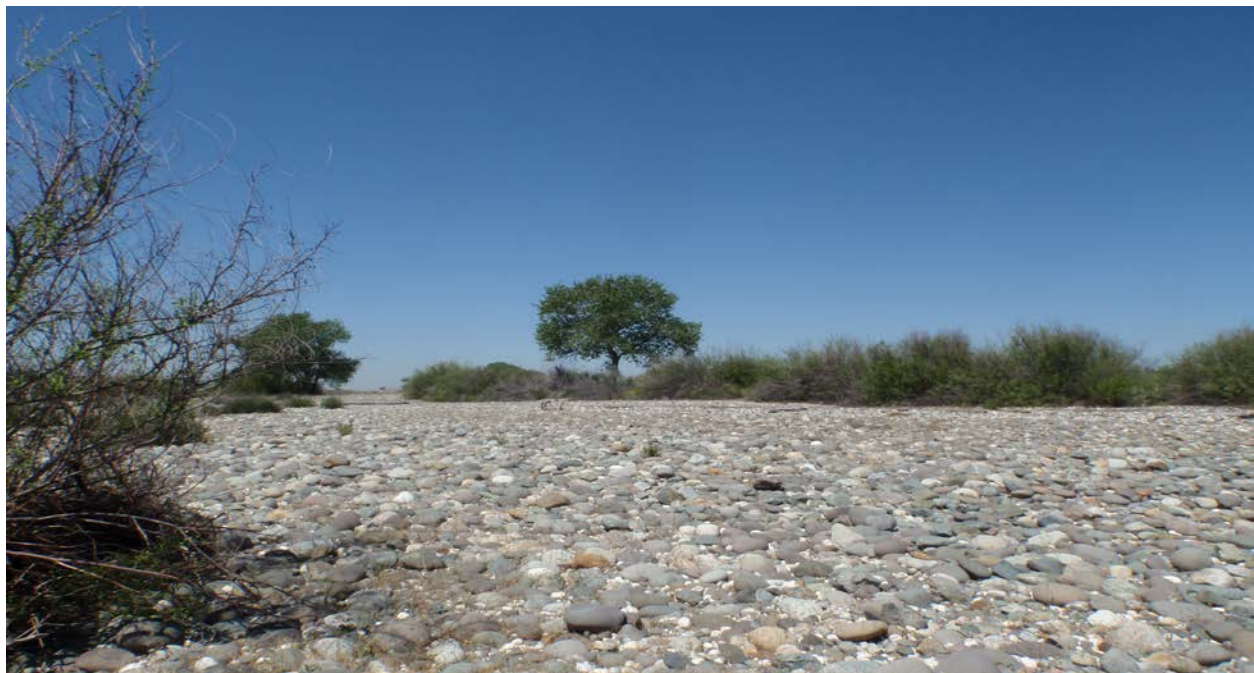
Figure 4. Cottonwoods are located across the full width of the LYR valley. Two mature cottonwoods are pictured here on a lateral bar in the Parks Bar study site.

| Figure No. | List of Figures Description | Page No. |
|---|---|---|
| 4. | Cottonwoods are located across the full width of the LYR valley. Two mature cottonwoods are pictured here on a lateral bar in the Parks Bar study site. | F-3 |

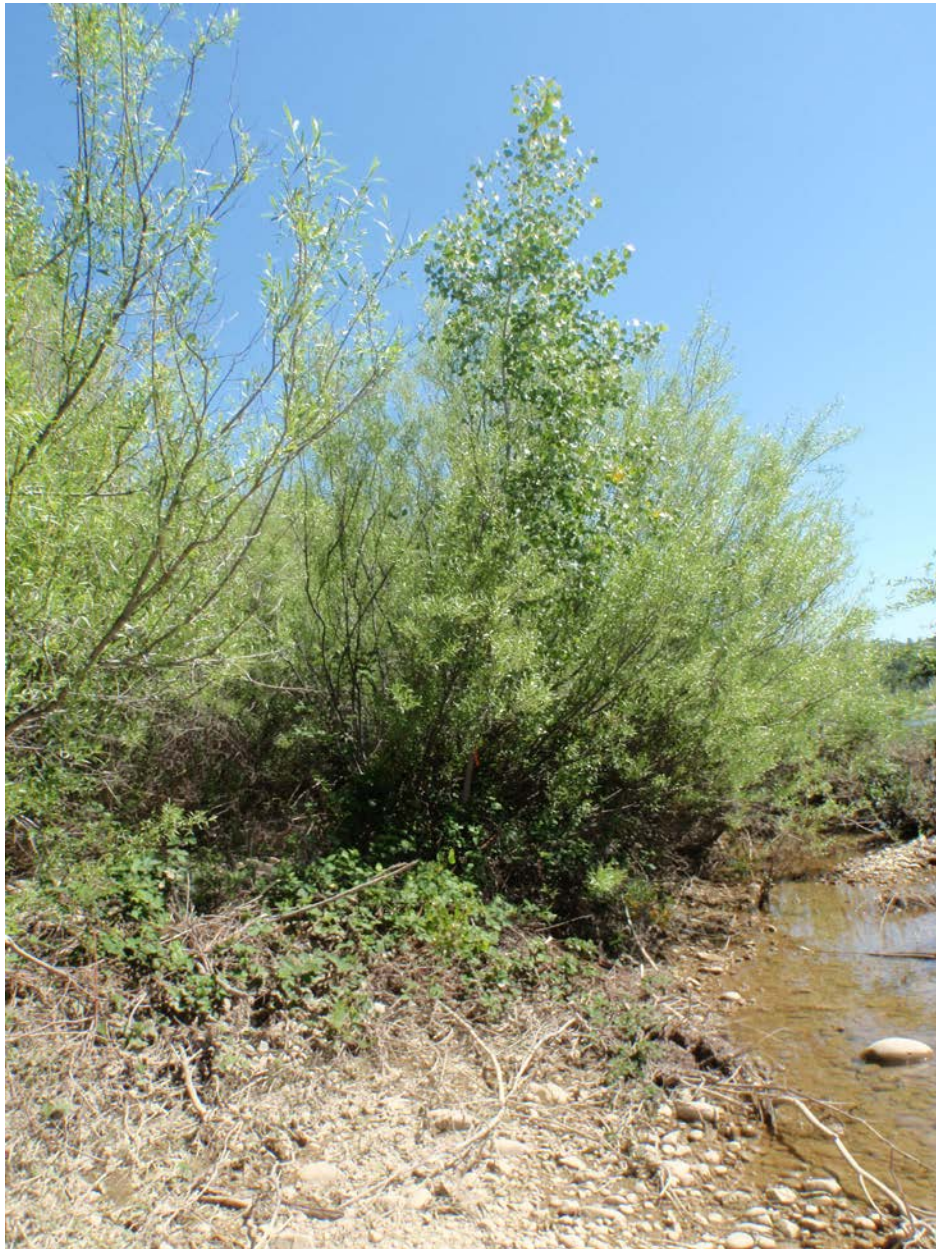
Figure 5. Small trees (recruits) tended to be intermixed with willow patches on the flood plains and in backwater areas.

| Figure No. | List of Figures Description | Page No. |
|---|---|---|
| 5. | small trees (recruits) tended to be intermixed with willow patches on the flood plains where woody debris was not accumulated and in backwater areas. | F-4 |

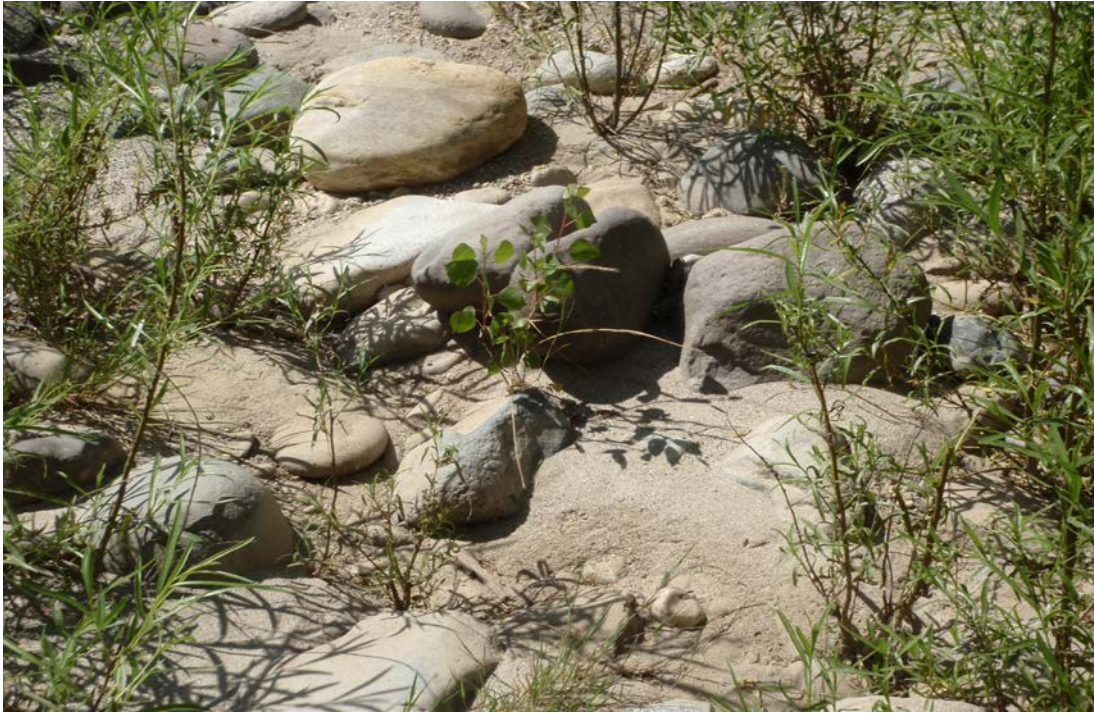
Figure 6. Seedlings are present along unvegetated or sparsely vegetated banks, and were generally within about 50 feet of the wetted edge during the time of the surveys. Photograph taken in the Timbuctoo Bend study site.

| Figure No. | List of Figures Description | Page No. |
|---|---|---|
| 6. | Seedlings are present along unvegetated or sparsely vegetated banks, and were generally within about 50 feet of the wetted edge during the time of the surveys. Photograph taken in the Timbuctoo Bend study site. | F-5 |

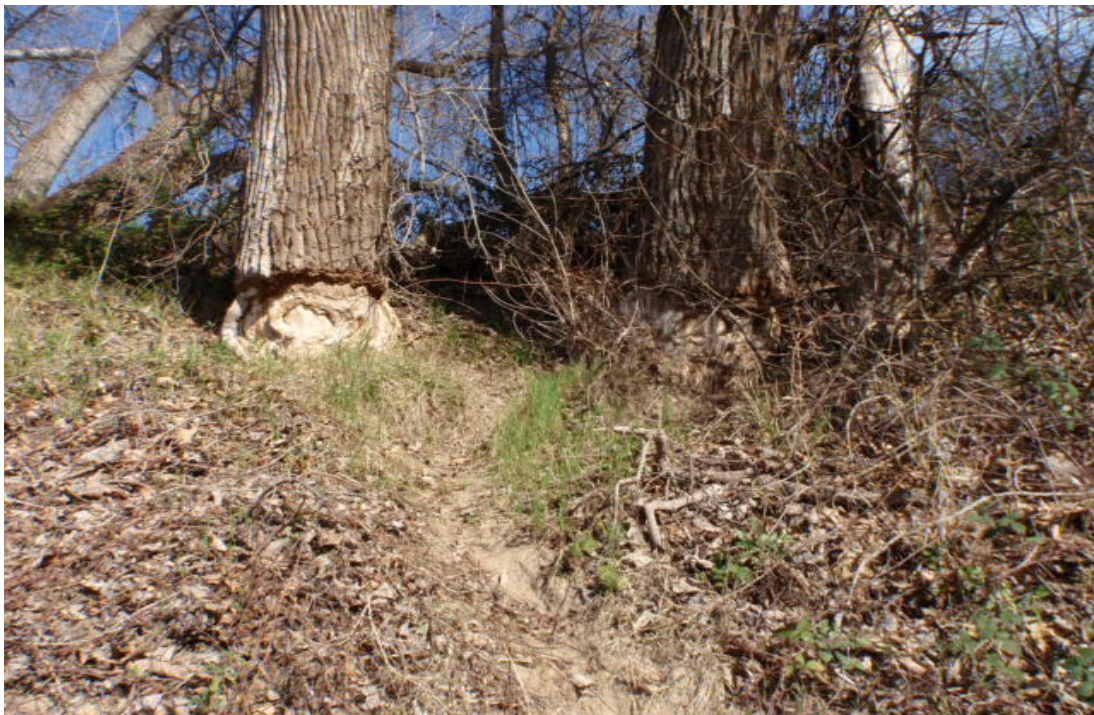
Figure 7. In the Marysville reach, large, standing trees had wedges chewed from the base of the cottonwoods, although many of these had scared over and the trees appeared healthy.

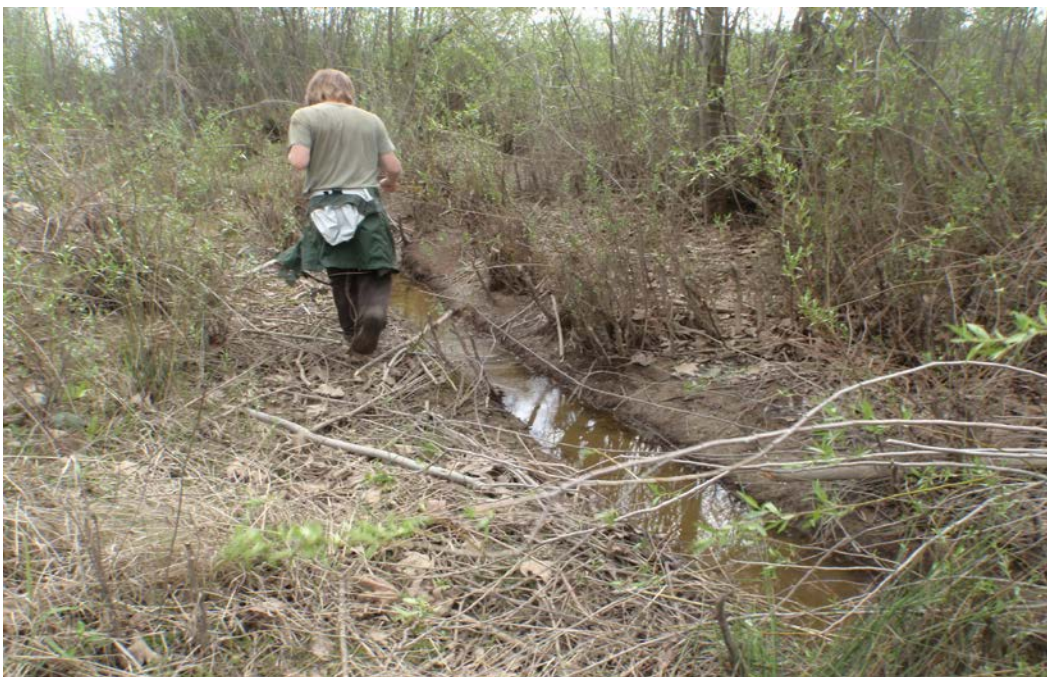
Figure 8. Beaver water-trails and dammed backwater areas support young-looking (smaller trees) riparian stands. Photograph taken on the south side of the LYR at the Hallwood reach.

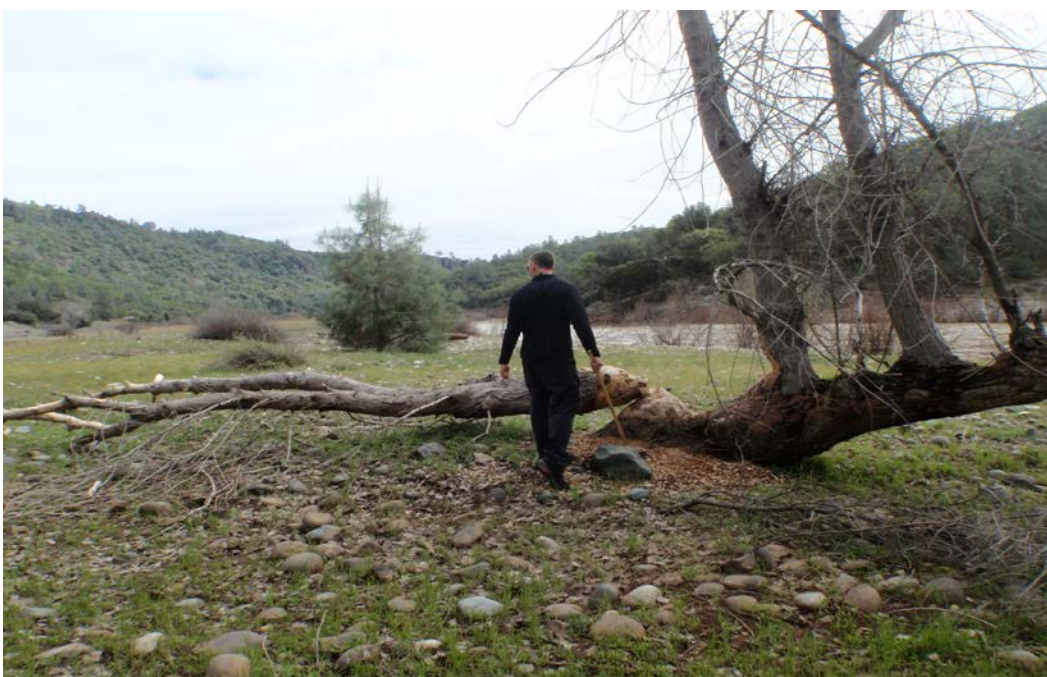
Figure 9. In the Timbuctoo and Englebright Dam reaches, backwater areas or mature riparian stands were prevalent, but many of the cottonwoods were beaver-chewed to stumps. This photograph was taken in the Timbuctoo Bend study site looking upstream.

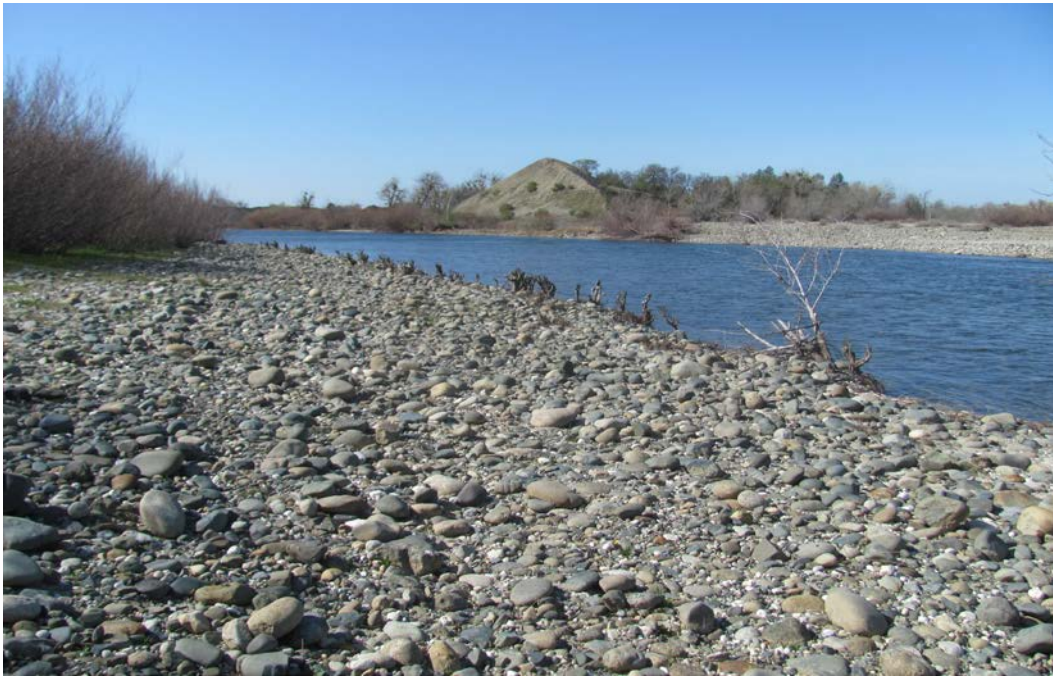
Figure 10. Willows lining the channel are frequently sheared by beavers at a consistent height. Photograph was taken in the Dry Creek study site looking downstream.

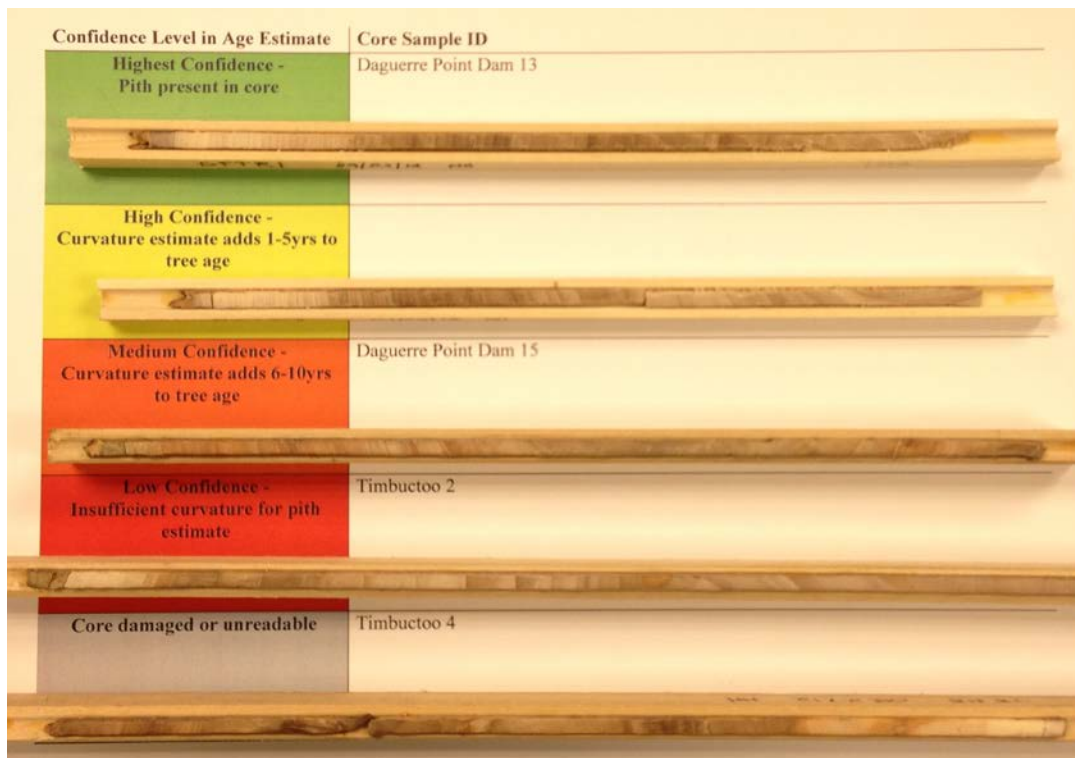
Figure 11. Example of cottonwood age-estimated cottonwood cores of various confidence levels.

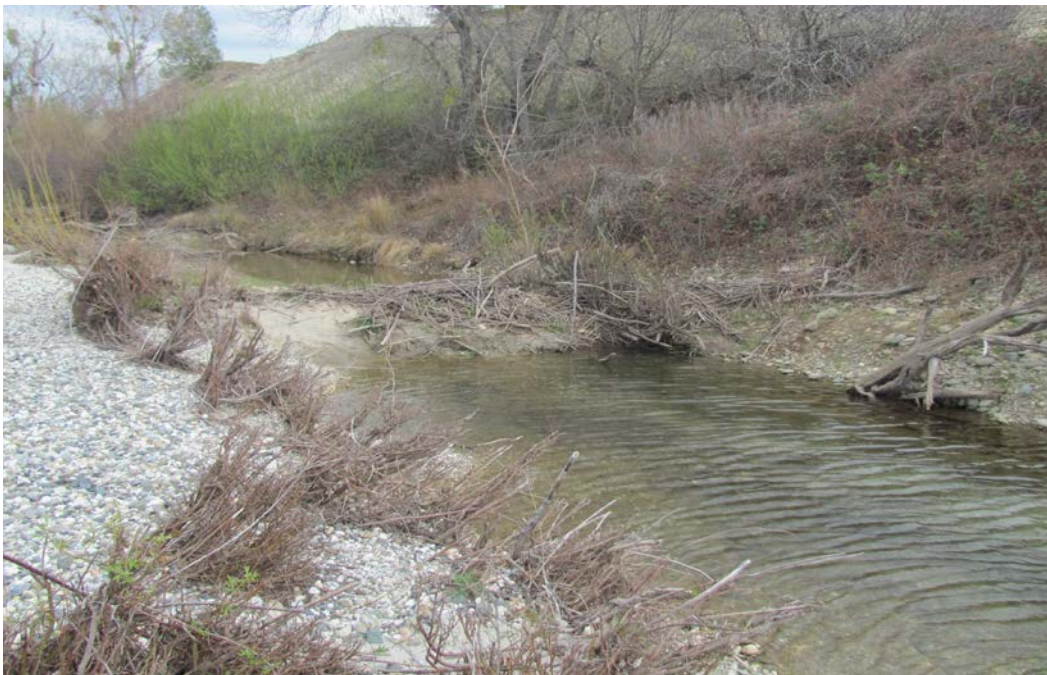
Figure 12. In the Daguerre Point Dam study site, historical aerial photographs show that the density of riparian vegetation increased dramatically over time. This area corresponds to beaver-dammed backwater ponds.

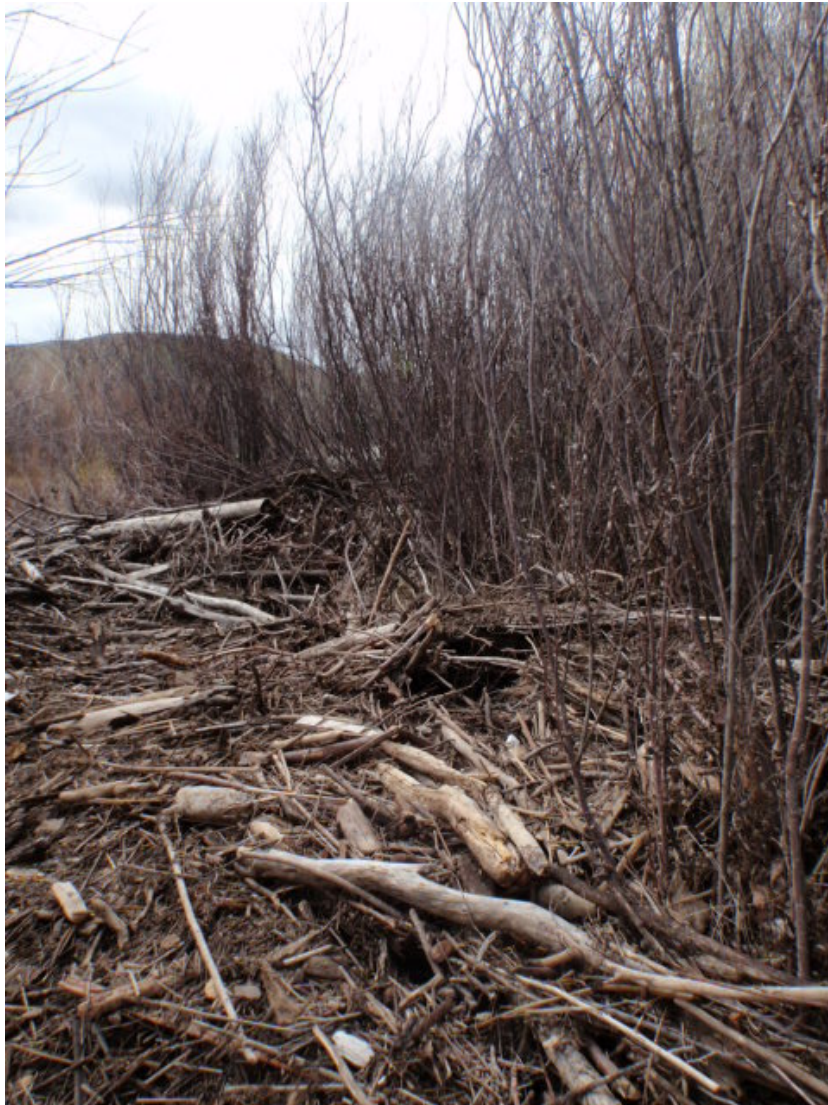
Figure 13. Bands of willow shrubs on the flood plains act as a capture point for large woody material (LWM), creating tall piles of small woody debris and LWM against the upstream side of the vegetation or around the base of the shrubs.

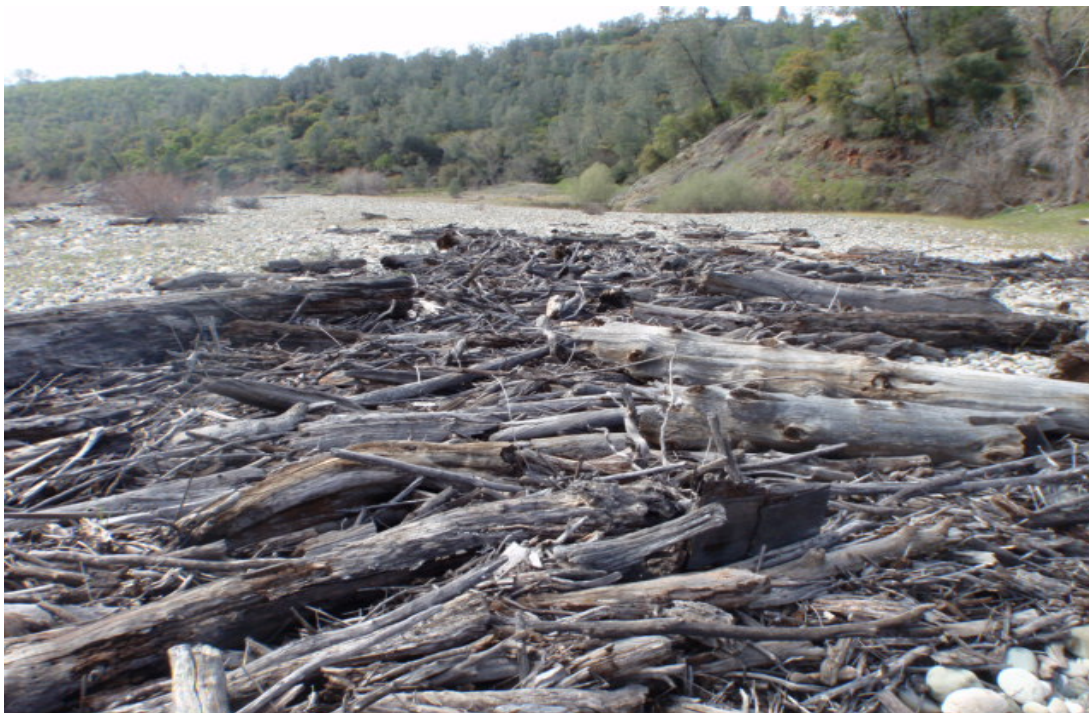
Figure 14. On the open cobbles of the bars in the alluvial reaches, LWM and smaller woody debris was deposited at a high flow line; this distribution comprised the smallest number of LWM pieces. This photograph was taken at the Timbuctoo Bend study site, looking downstream on the south side of the river.

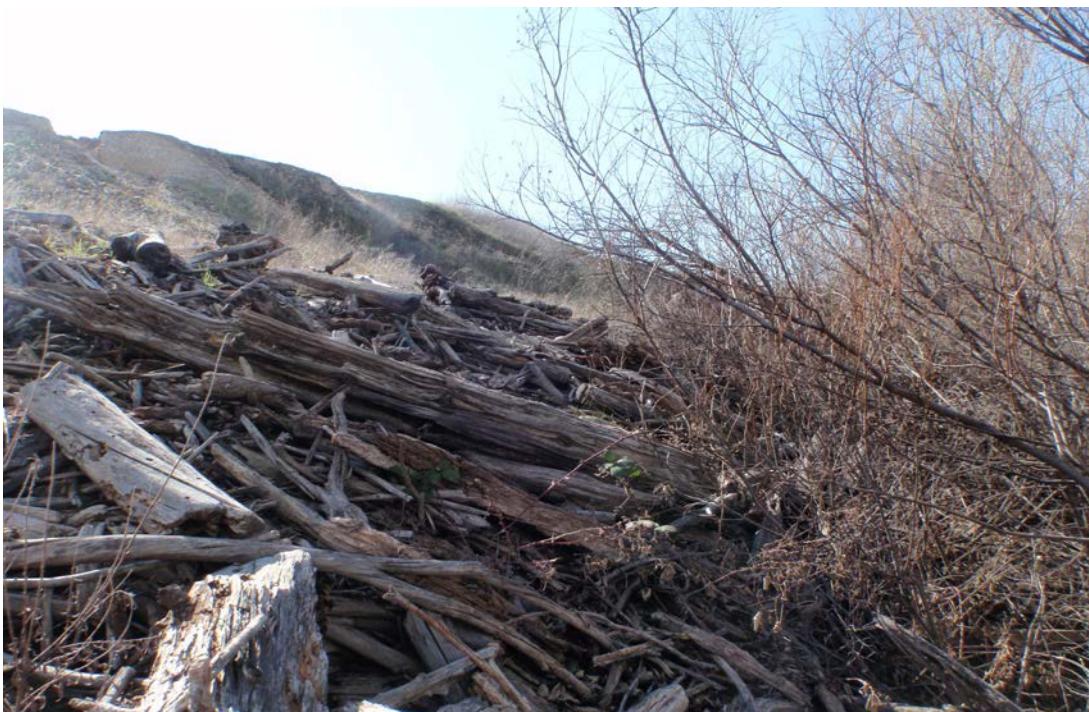
Figure 15. Large woody material accumulated against the lower portion of the training walls that line the north side of the river in Dry Creek study site at flood flow levels.

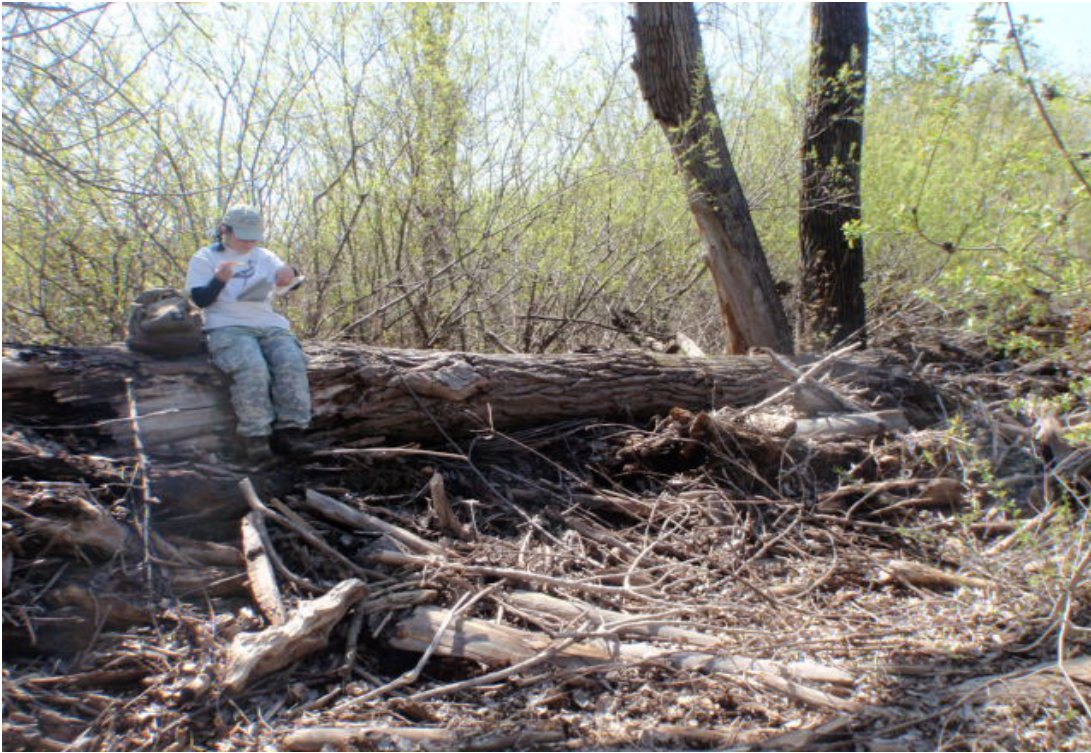
Figure 16. A great deal of LWM was located at flood heights far from the wetted channel in stands of riparian forests. This photograph was taken at the Daguerre Point Dam study site on the south side of the river.

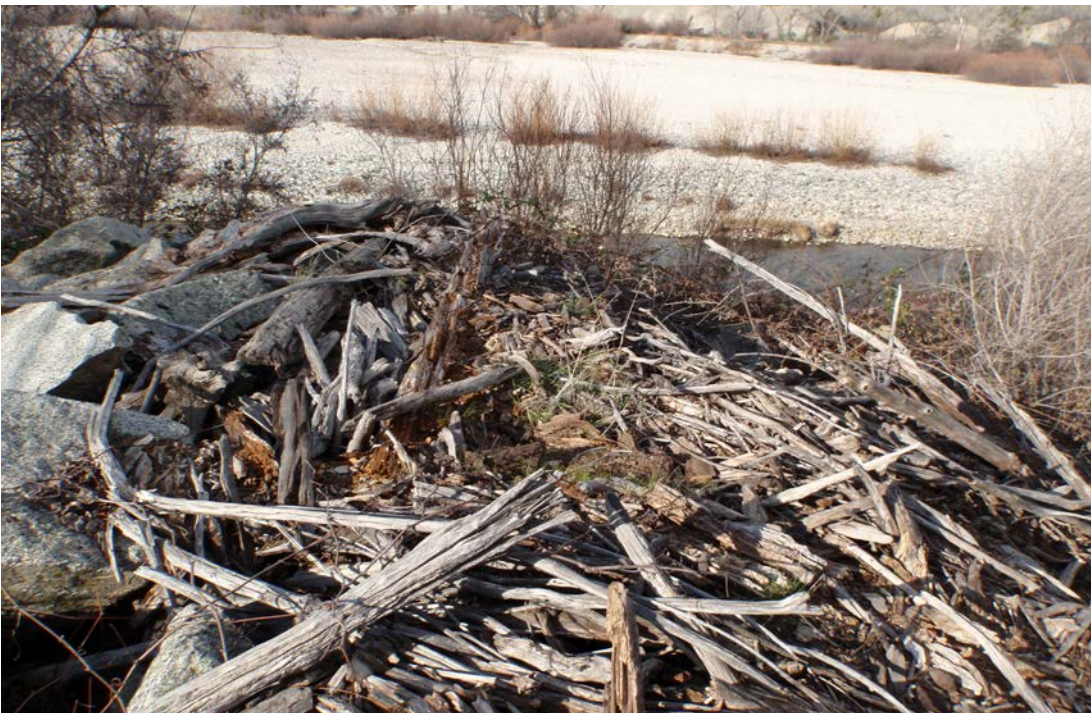
Figure 17. This photograph shows LWM and smaller woody debris accumulated on rip-rap at flood flow heights at the Parks Bar study site.

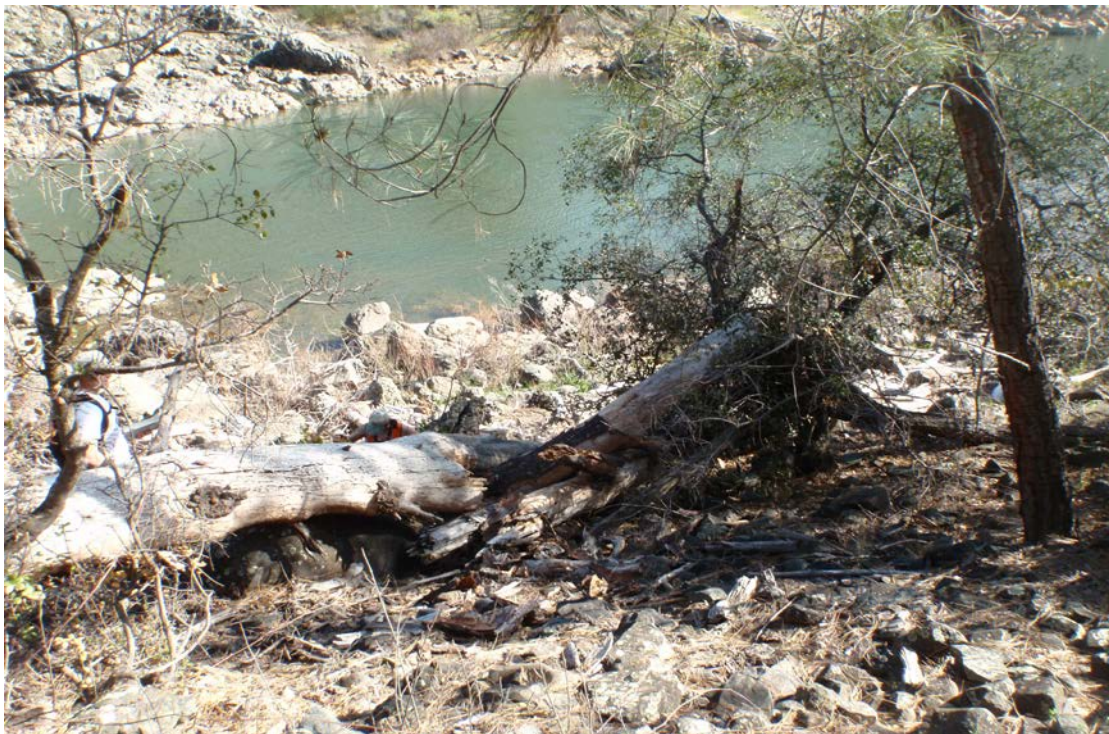
Figure 18. Many LWM pieces were found to be upland trees that fell downslope into the riparian are, as pictured above in the Englebright Dam study site.

| Figure No. | Description | Page No. |
|---|---|---|
| 18. | Many LWM pieces were found to be upland trees that fell downslope into the riparian are, as pictured above in the Englebright Dam study site..... | F-12 |

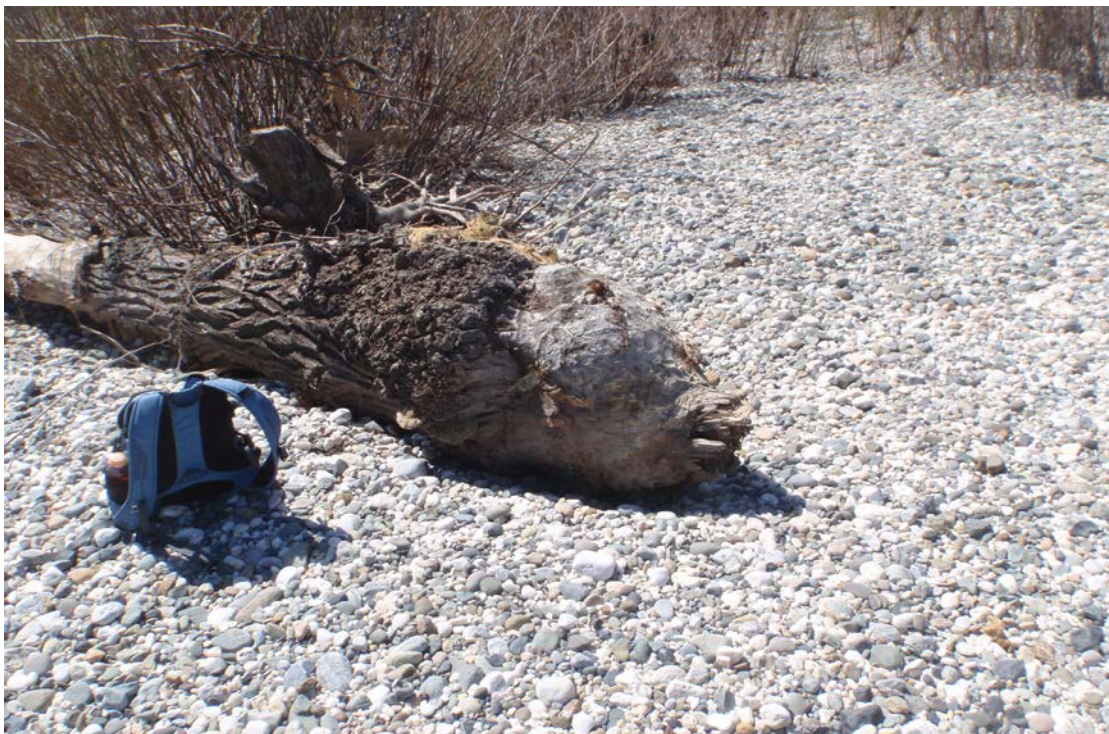
Figure 19. Some key pieces of LWM were in the active channel; these pieces frequently showed signs of beaver activity. This photograph was taken in the Dry Creek study site.

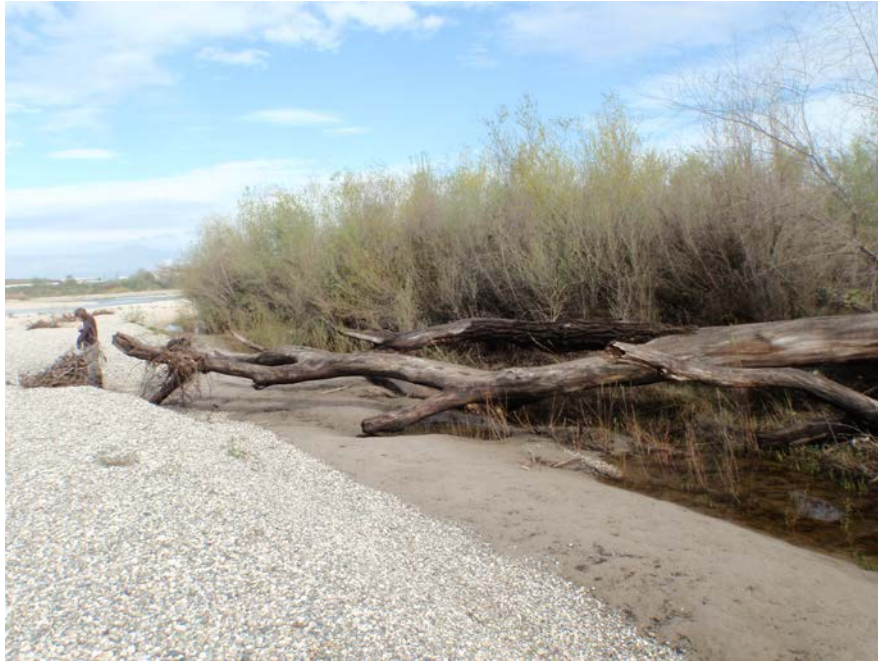
Figure 20. Most pieces of LWM were found to be mobile (not stabilized to resist high flows) and few pieces were observed to have an impact on the geomorphology (greater than one square meter) or capture woody debris. This photograph was taken at a mid-channel bar looking downstream at the Hallwood study site.

| Figure No. | Description | Page No. |
|---|---|---|
| 20. | Most pieces of LWM were found to be mobile (not stabilized to resist high flows) and few pieces were observed to have an impact on the geomorphology (greater than one square meter) or capture woody debris. This photograph was taken at a mid-channel bar looking downstream at the Hallwood study site..... | F-13 |

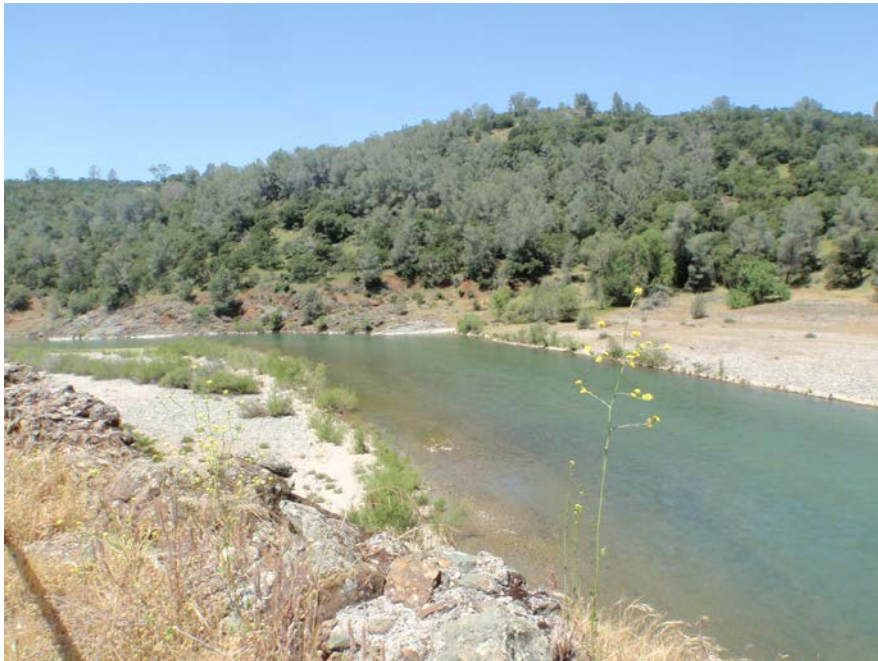
Figure 21. The cobble-dominated banks support dense bands of willows occurring in lines following various flow heights along the banks at or near the wetted channel. This photograph was taken on the south side of the river looking downstream in the Timbuctoo Bend study site.

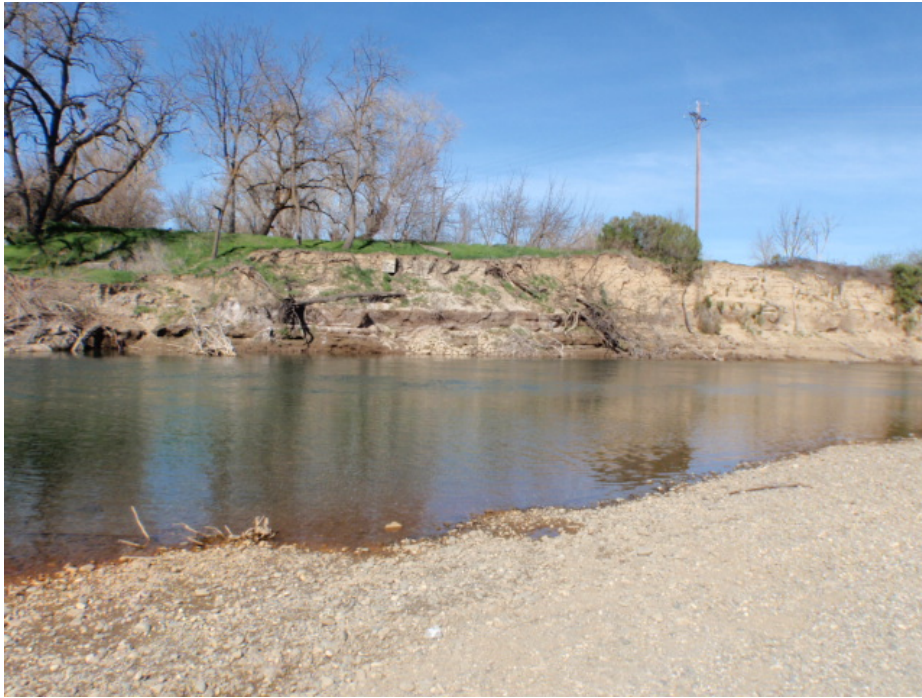
Figure 22. Scarps are steeply sloping banks or cliffs formed by slumping banks, characterized by exposed, soil-faced cliffs generally ranging in height from 15 to 30 ft, often with fallen, rooted trees lying against the banks. This photograph was taken in the Marysville study site looking toward the north bank.

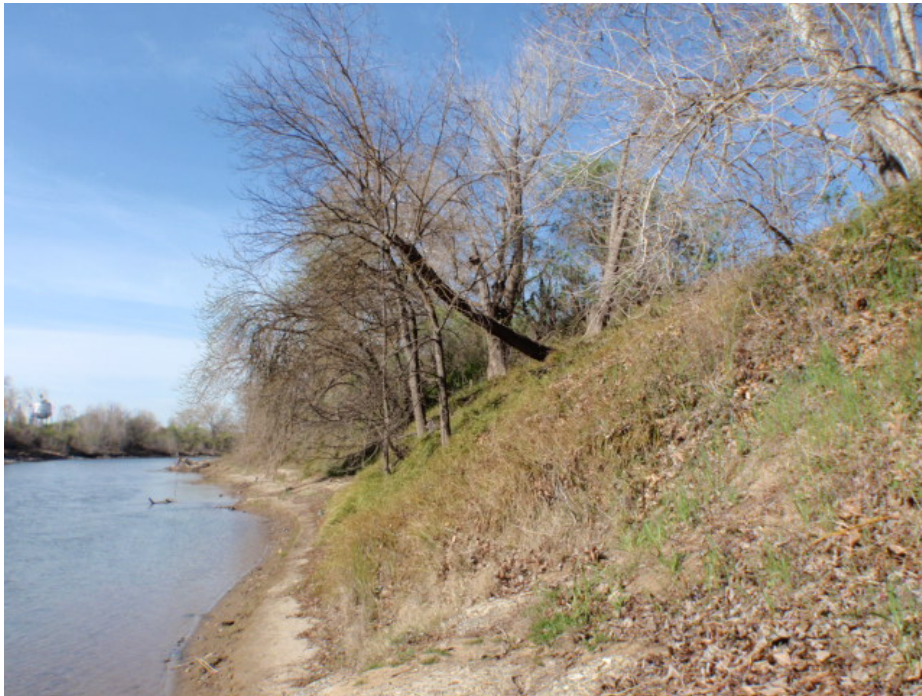
Figure 23. Levee banks have slightly gentler slopes than scarps (around 45 degrees) and support simple vegetation communities, characterized by either grassy banks or Himalayan blackberry thickets and mature cottonwood trees. This photograph was taken on the south side of the river looking upstream in the Marysville study site.

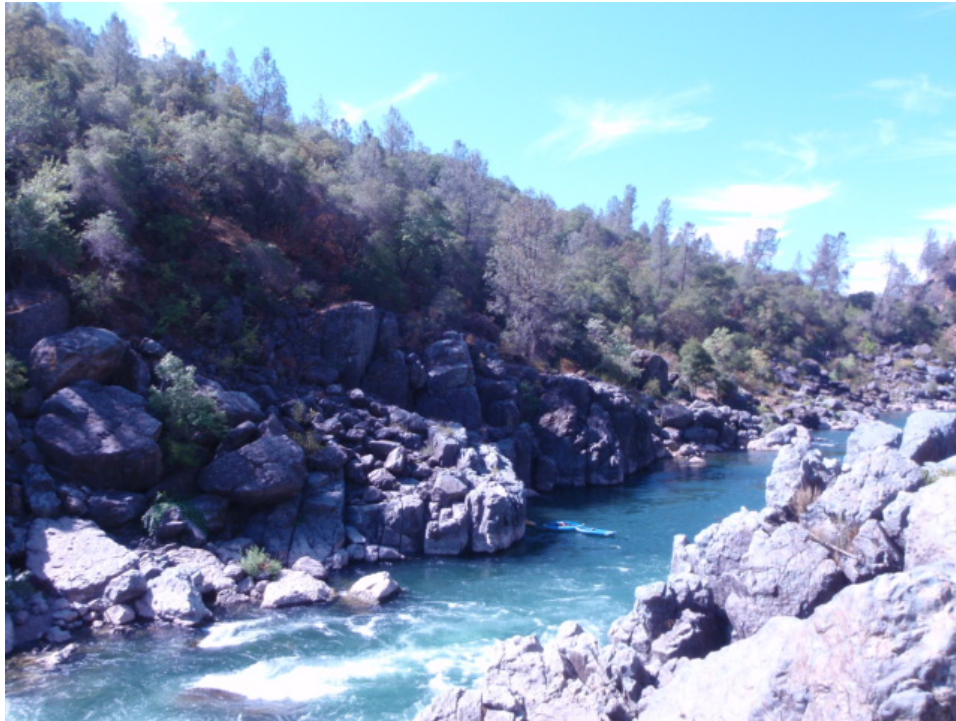
Figure 24. The Narrows reach has very large, car-sized boulders stacked against the steep canyon walls. This photograph was taken just downstream of the “Ground-chuck” rapid on the north side of the river looking downstream.

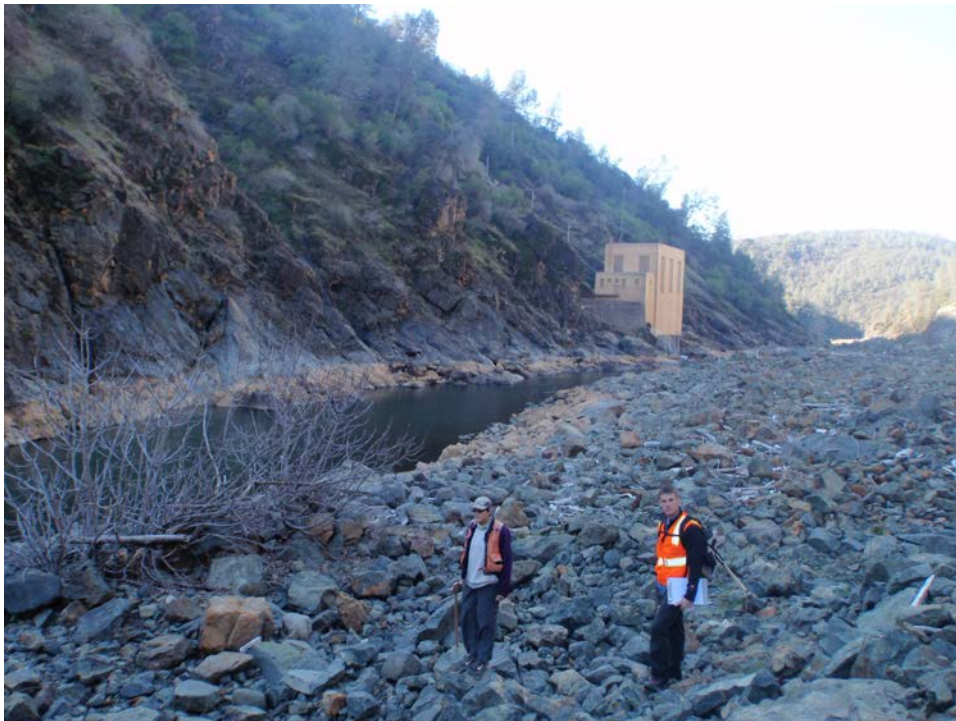
Figure 25. The Englebright Dam reach is slightly less narrow than the Narrows reach, with moderately sized boulders. This photograph was taken on the north side of the river looking downstream.

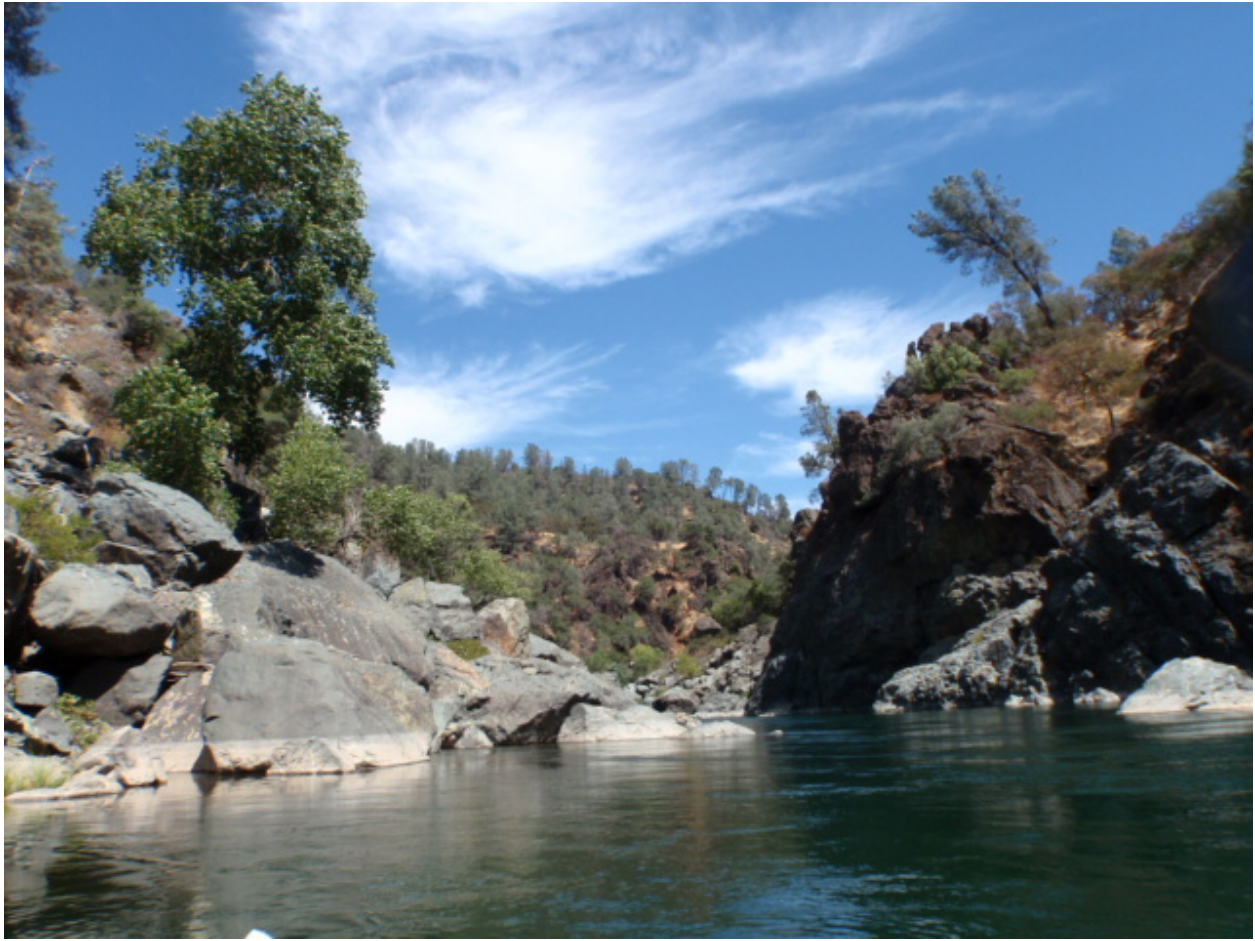
Figure 26. In the Narrows and Englebright Dam reaches, the cottonwoods are more prevalent near the scour-line, with the mature trees primarily populating the upper-most areas of the riparian zone, although smaller, scattered trees are present throughout. This photograph was taken looking upstream in the Narrows study site.
