Technical Memorandum 6-2
Riparian Habitat Downstream of Englebright Dam

Attachment 6-2F
Representative Photographs

Yuba River Development Project
FERC Project No. 2246

June 2013

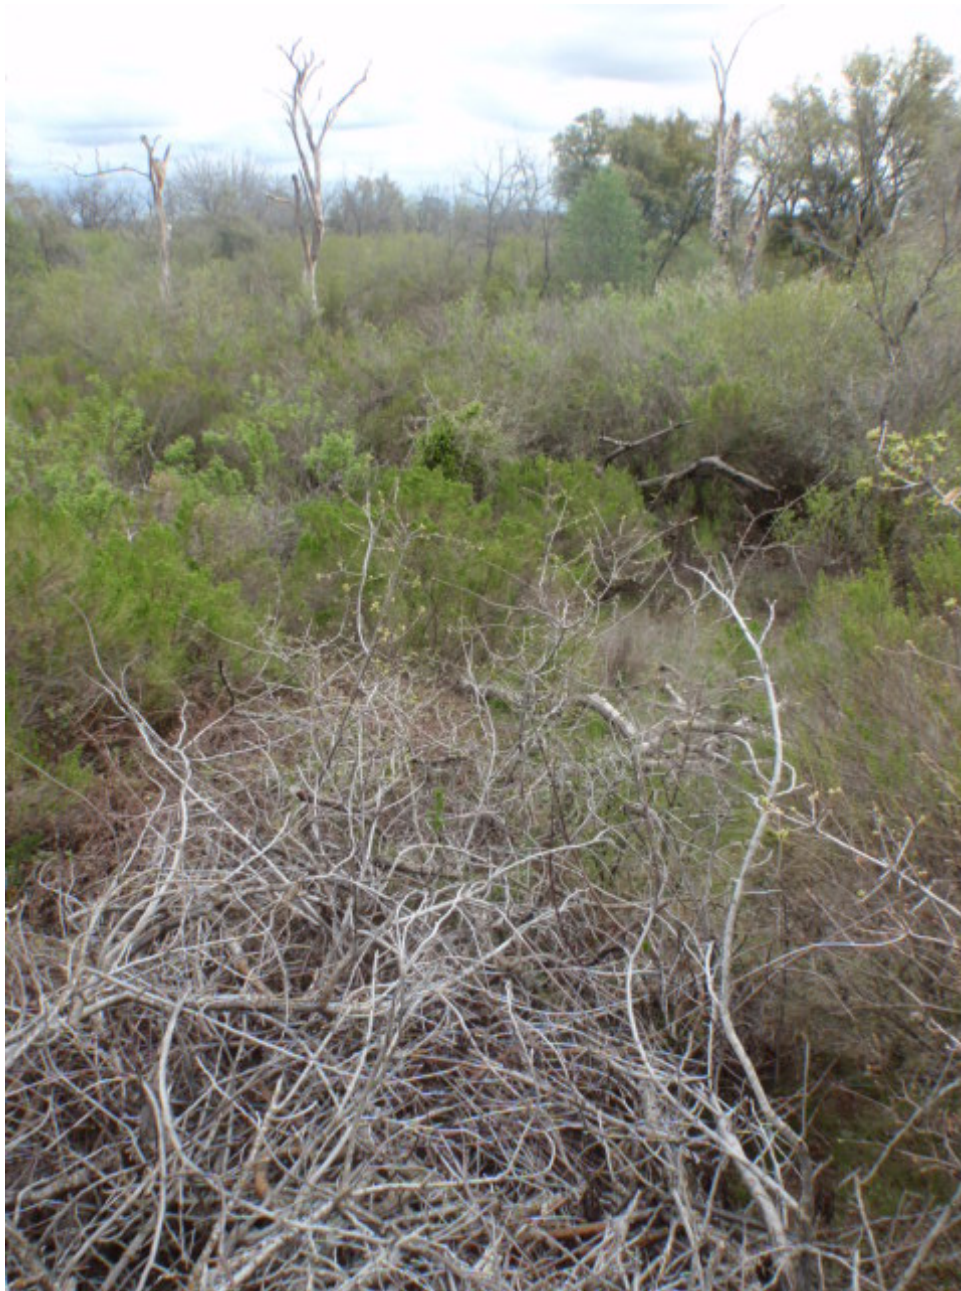
Figure 27. The vegetation on the terrace of the north side of the river in the Hallwood study site is primarily upland, but supports a virtual “orchard” of cottonwood trees. In this photograph, most of the cottonwoods have not yet leafed-out; they stand out among the coyote brush and poison oak.

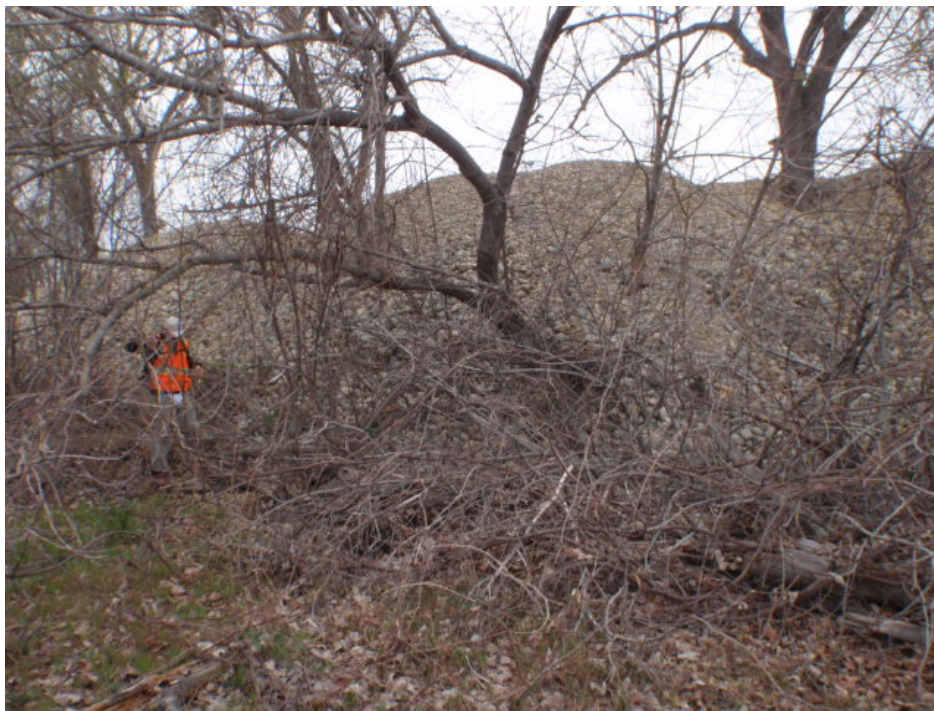
Figure 28. At the downstream end of the Parks Bar study site on the north side of the river, gravel from the adjacent property continues to bury a mature cottonwood stand; this stand can be seen in photographs as early as 1937.

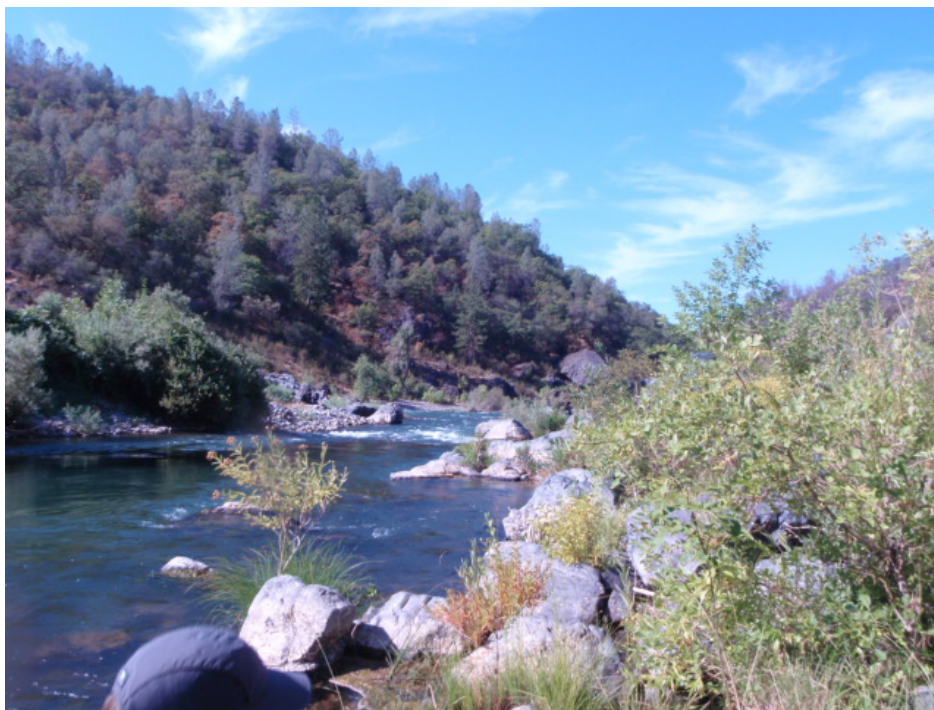
Figure 29. Small remnant lateral bars in the upstream portion of the Narrows reach support vigorous cottonwoods, willows, and sedges.

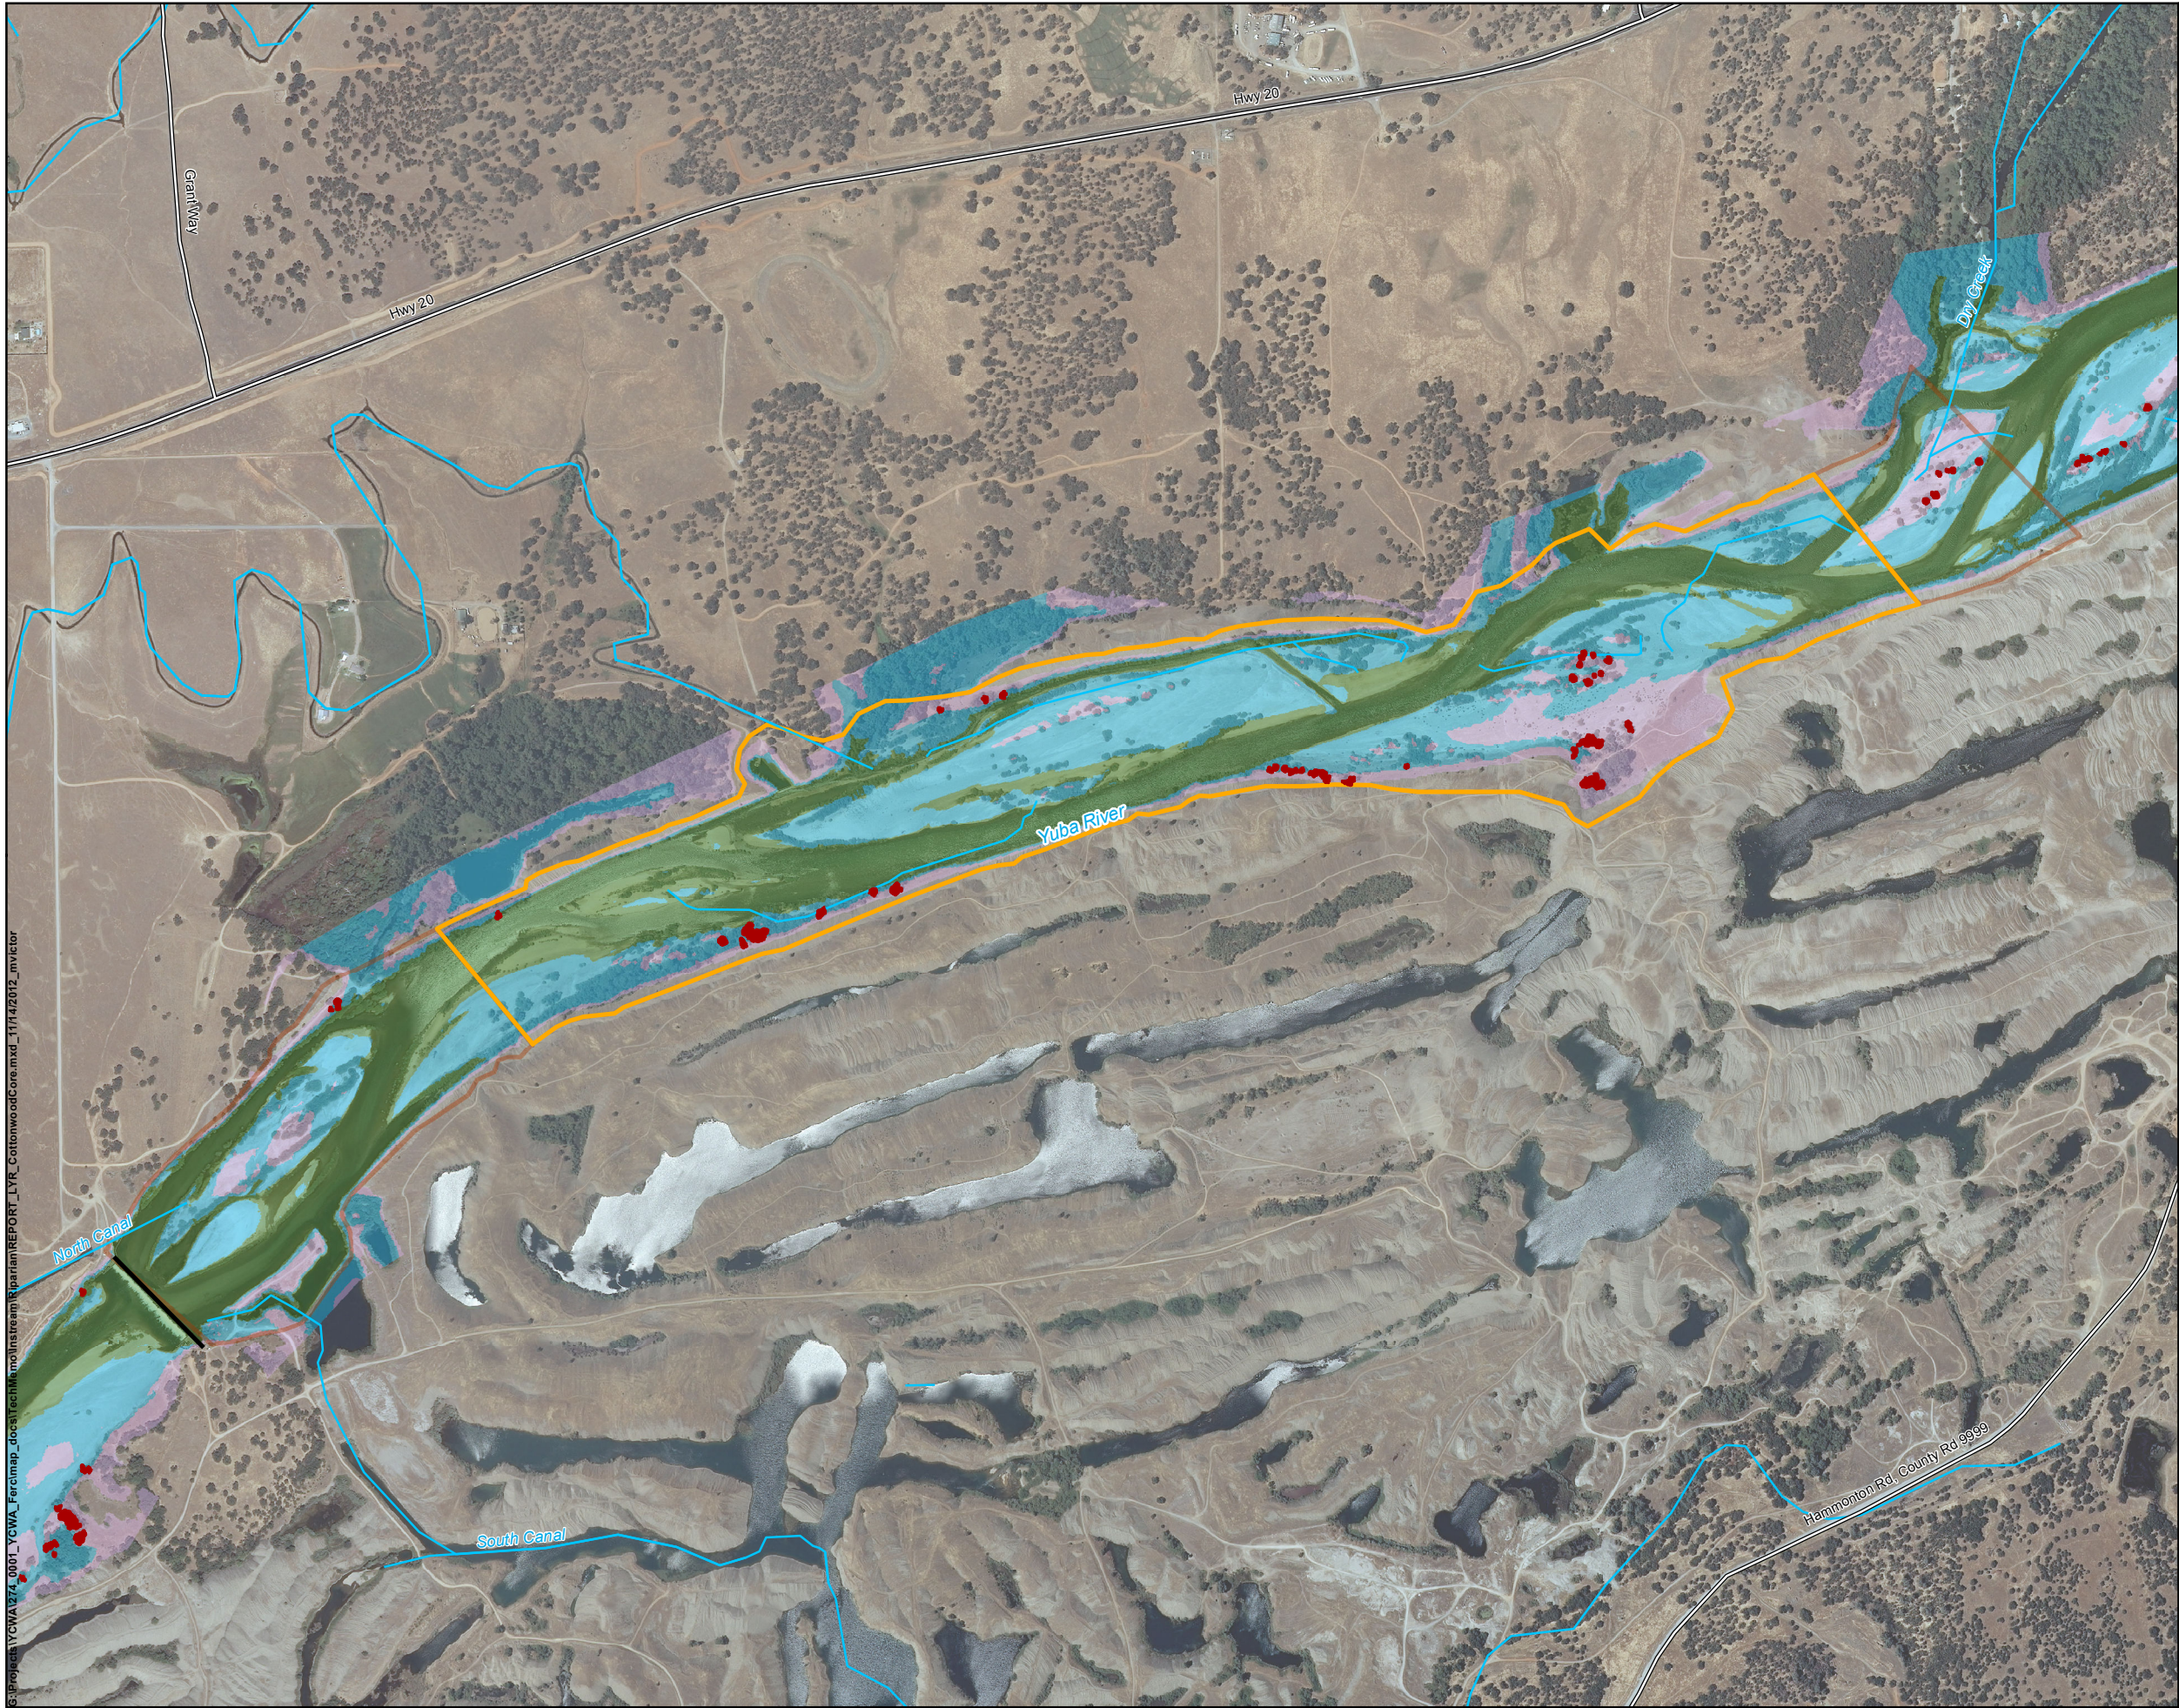
- < 5,000 cfs (Bankfull)
- 5,000 cfs - 21,100 cfs (Floodway)
- 21,100 cfs - 84,400 cfs (Valley Floor)

| Figure No. | List of Figures Description | Page No. |
|---|---|---|
| 4. | Dry Creek Reach page 4 of 7..... | G-4 |

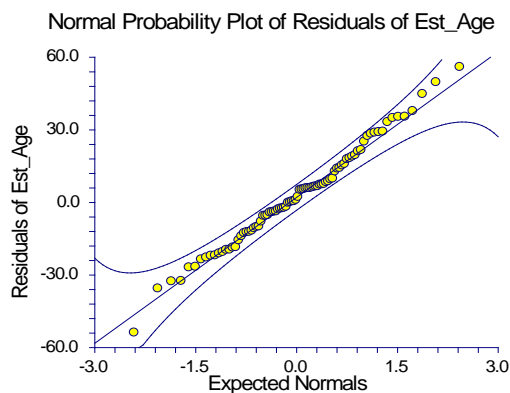
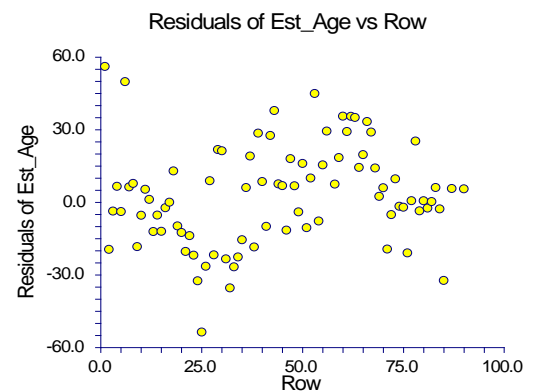
Plots Section

1.0 Model 1 Regression

| Independent Variable | Regression Coefficient b(i) | Standard Error Sb(i) | T-Value to test H0:B(i)=0 | Prob Level | Reject H0 at 5%? | Power of Test at 5% |
|---|---|---|---|---|---|---|
| Canopy_Height | 0.7054 | 0.0362 | 19.464 | 0.0000 | Yes | 1.0000 |

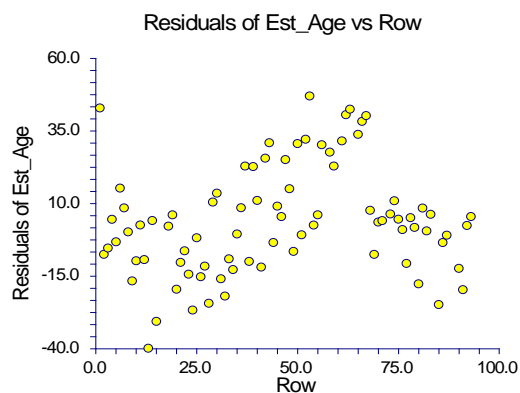
Plots Section

2.0 Model 2 Regression

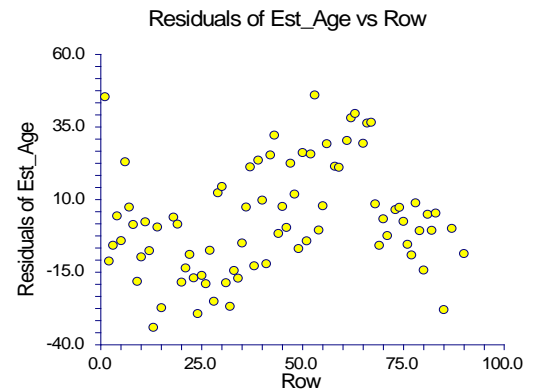
Plots Section

3.0 Model 3 Regression
