**ATTACHMENT 1  
TO  
CHANNEL MORPHOLOGY DOWNSTREAM OF  
ENGLEBRIGHT DAM STUDY PROPOSAL  
EXISTING INFORMATION SUMMARY**

**Dr. Gregory B. Pasternack  
September 2010**

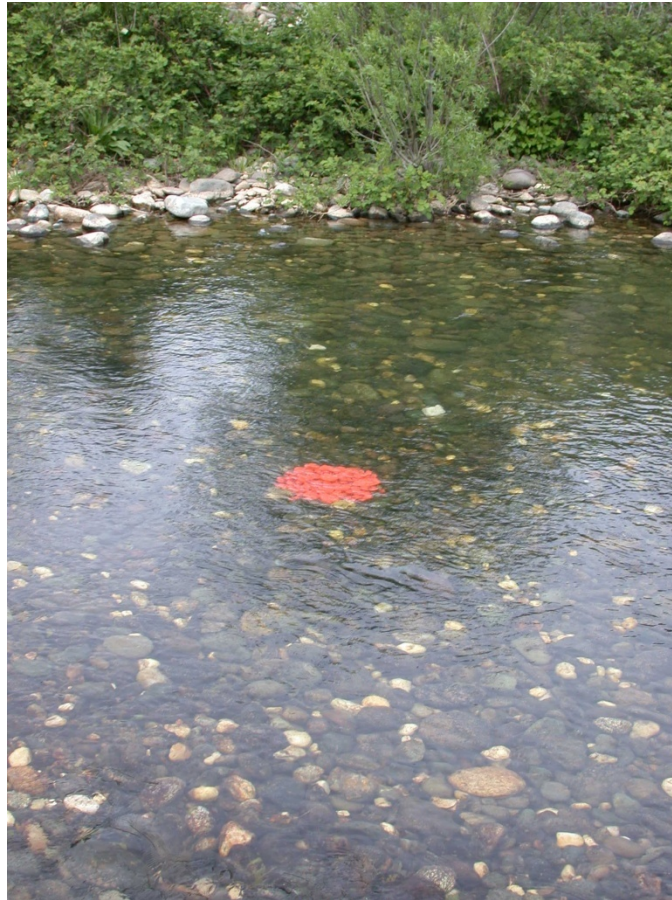
(red painted tracers for sediment transport study in the lower Yuba River)

In November 2005, Moir and Pasternack placed 4 rows of painted, numbered tracer stones (366 stones total) with powerful imbedded neodymium magnets in them across the LYR at the Timbuctoo Bend Apex Riffle site. The tracers ranged in size class from 22.6 – 32 mm to 128 – 256 mm and in mass from 0.04 to 4.22 kg. A month later there was the enormous New Years 2006 flood that yielded a major reconfiguration to the river. When the flows finally receded enough in the summer to look for stones, 3 were found very close to the original locations and all the rest were gone with no hope of finding them down the next 20 miles of riverbed and floodplains.
