SUBJECT: Yuba River Development Project
FERC Project No. 2246-058
Yuba Salmon Forum Fish Passage Study Report

YUBA SALMON FORUM

FISH PASSAGE STUDY REPORT

February 2012

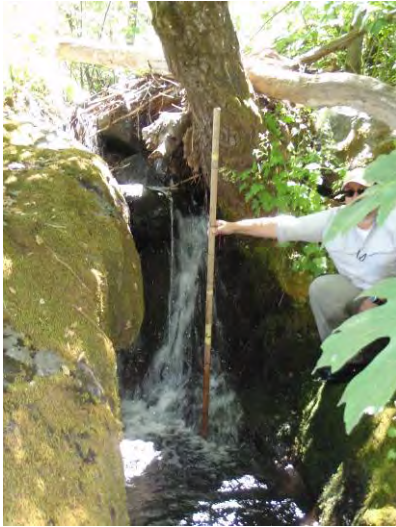
Photo 42. Devils Canyon barrier 1

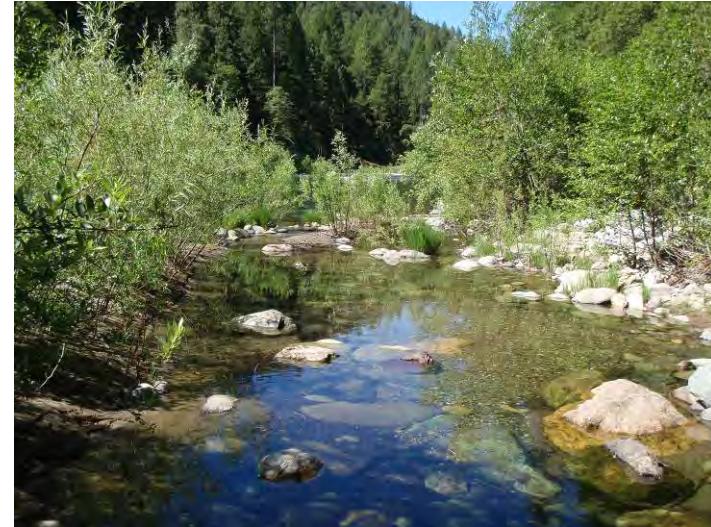
Photo 43. Ramshorn Cr. looking downstream at confluence

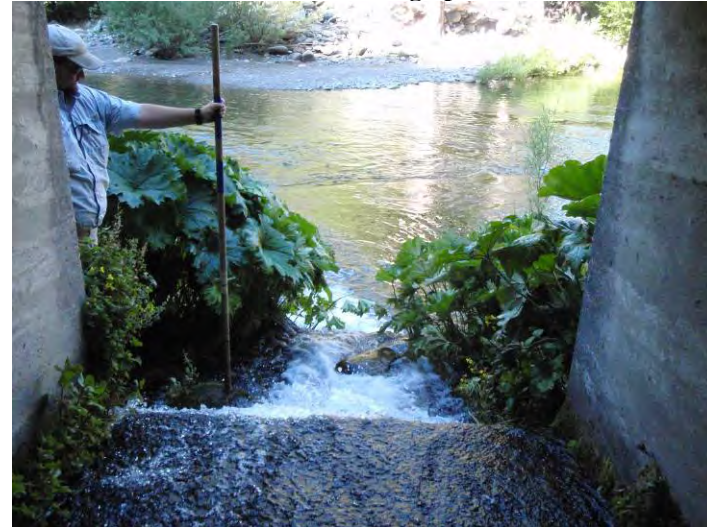
Photo 52. Slate Castle Cr. barrier 1

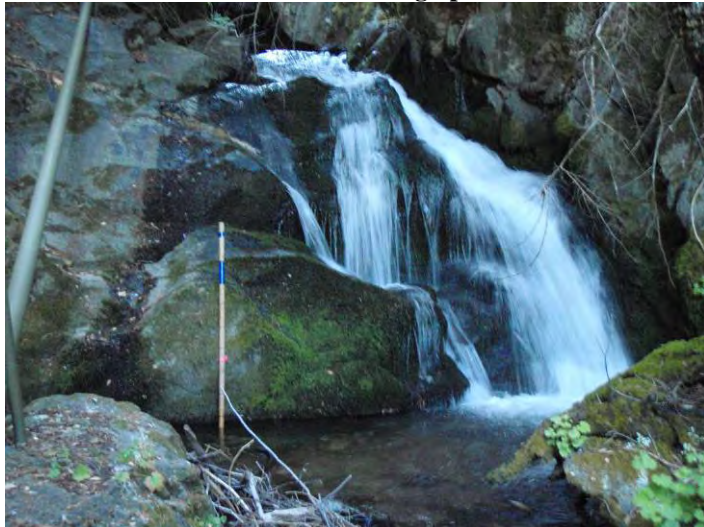
Photo 55. New York Ravine at falls 1

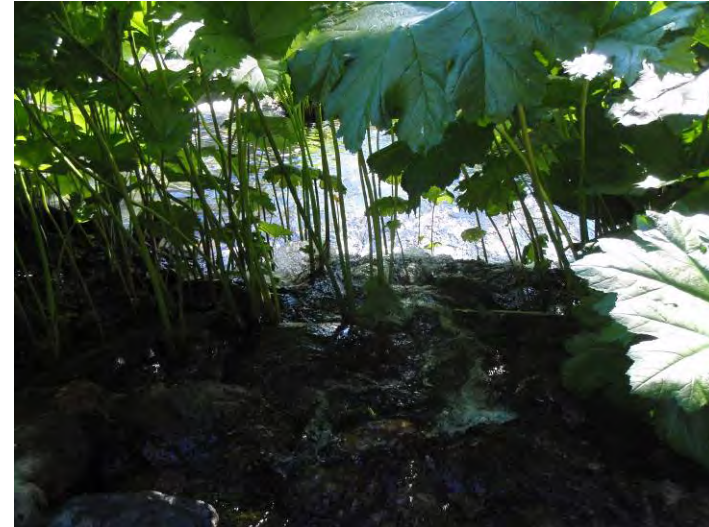
Photo 56. New York Ravine at falls 2

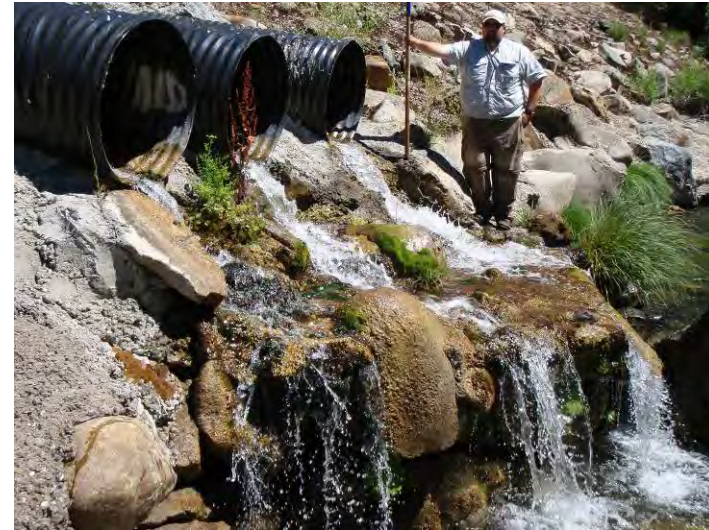
Photo 58. Secret Canyon barrier 1

Secret Canyon				
Stream/ Tributary: N. Yuba / Secret Canyon		Crew: RA, CV	Temp (C°): 10.4	Date : 8/18/11
Estimated Discharge (cfs): 3.0		UTM Start/Description: 0690788 E / 4380361 N	UTM End/Description: 0690788 E / 4380361 N	
Comments: Additional falls that qualify as barriers were observed 200 ft. upstream of Point ID 1.

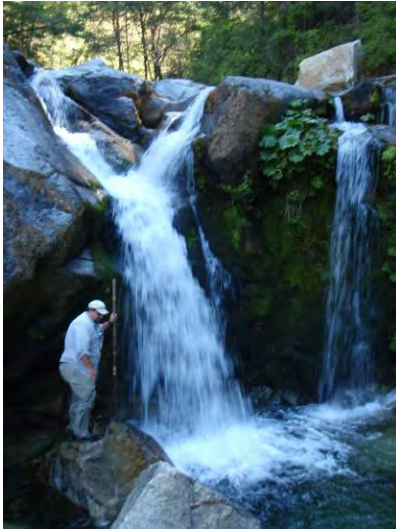
Photo 78. Fiddle Cr. barrier 1a

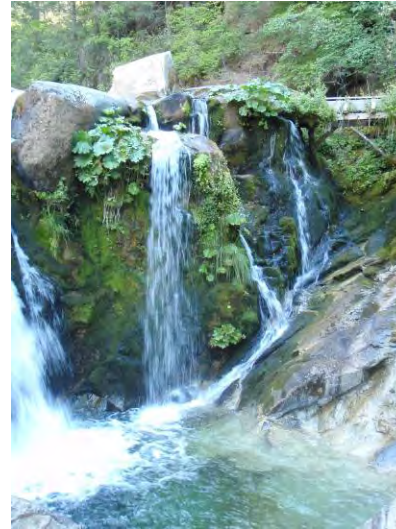
Photo 79. Fiddle Cr. barrier 1b

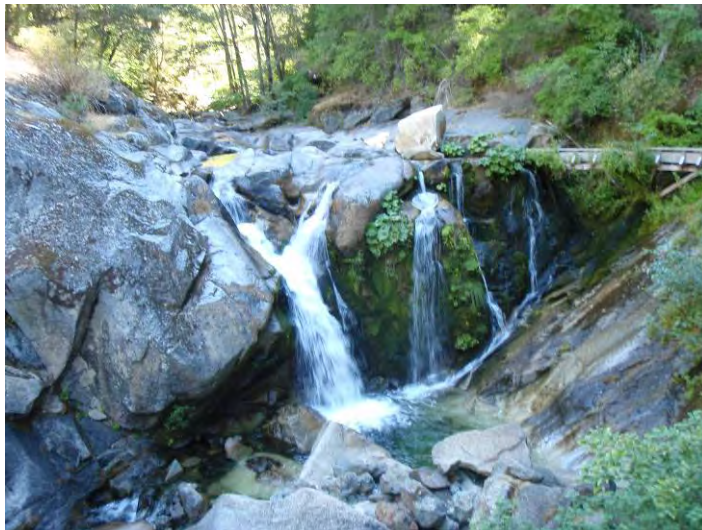
Photo 80. Fiddle Cr. barrier 1c

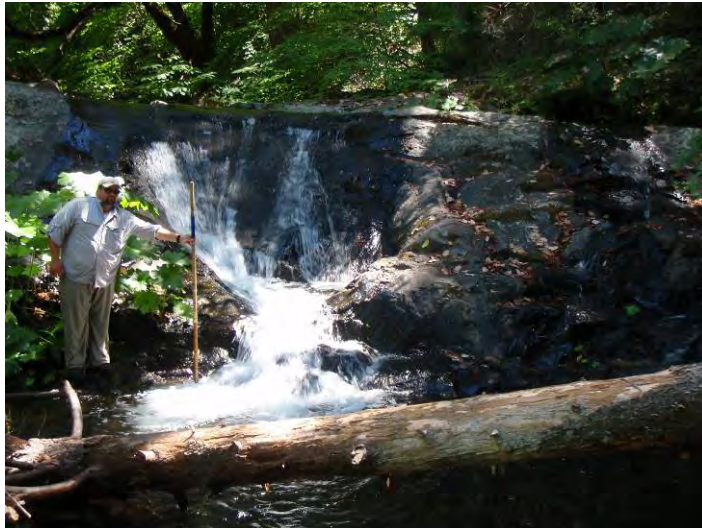
Photo 82. Humbug Cr. barrier 1

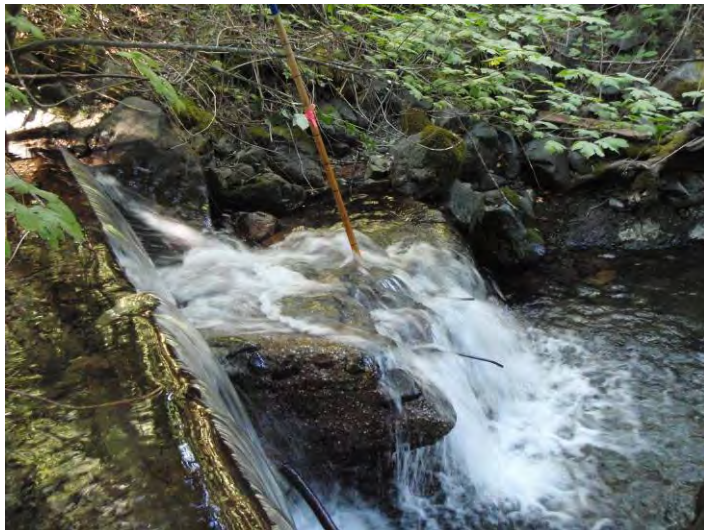
Photo 88. Woodruff Cr. barrier 1b looking at left bank

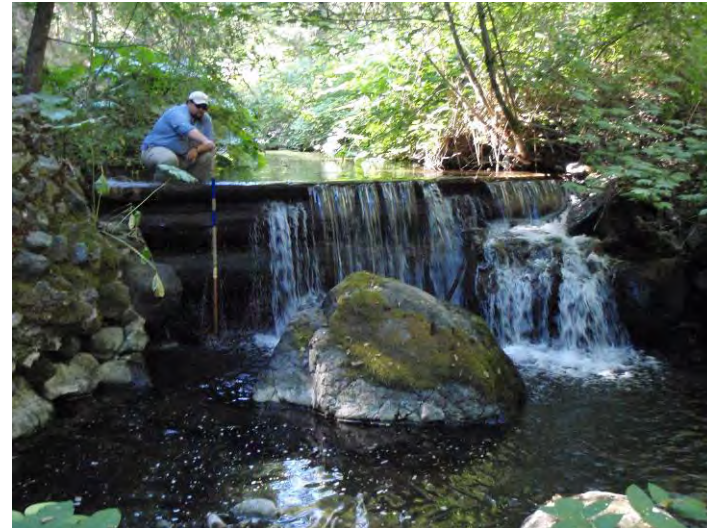
Photo 87. Woodruff Cr. barrier 1a

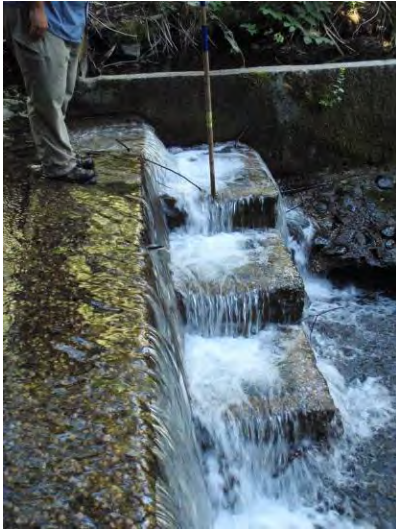
Photo 90. Woodruff Cr. barrier 2b looking at left bank

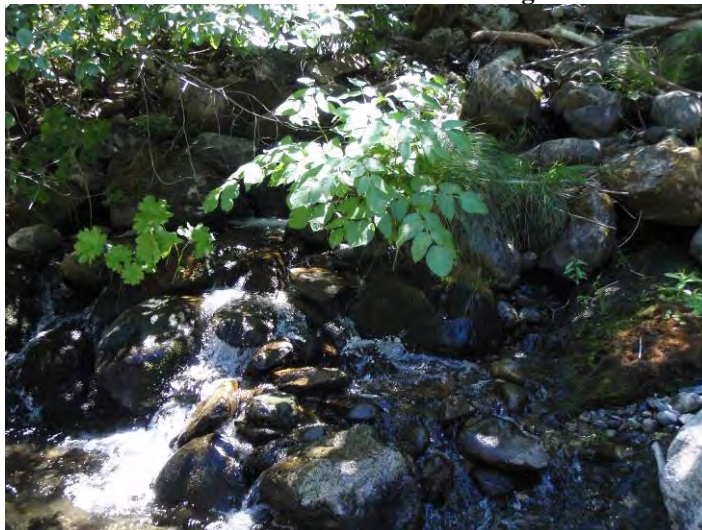
Photo 92. Slug Canyon at confluence looking upstream

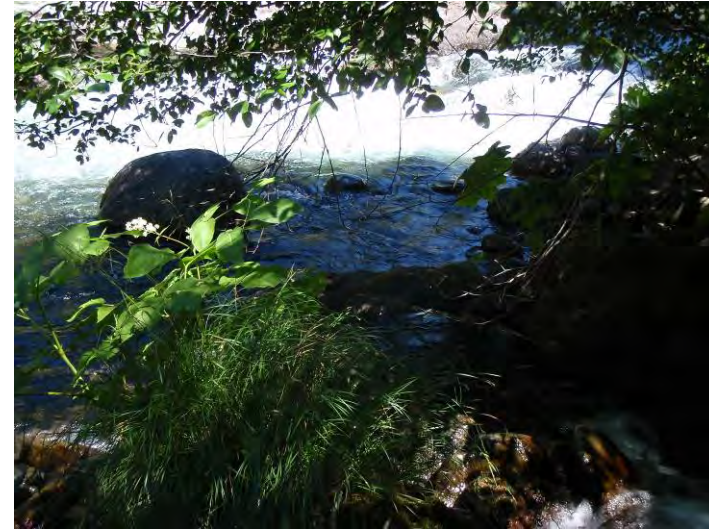
Photo 91. Slug Canyon at confluence looking downstream

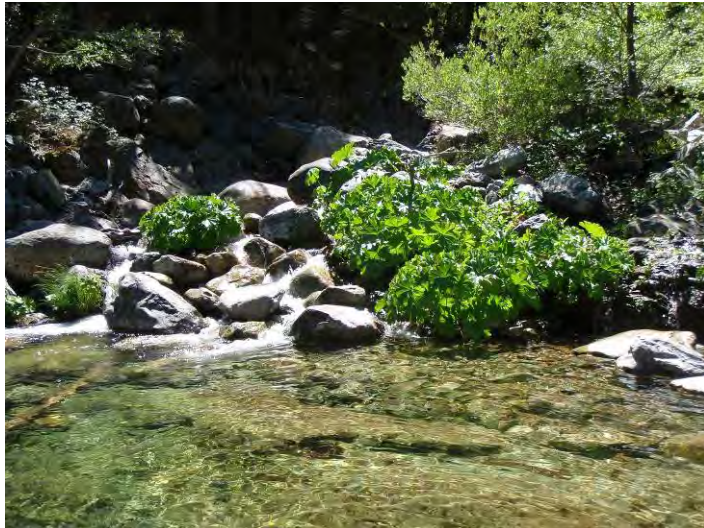
Photo 94. Negro Canyon looking upstream at confluence

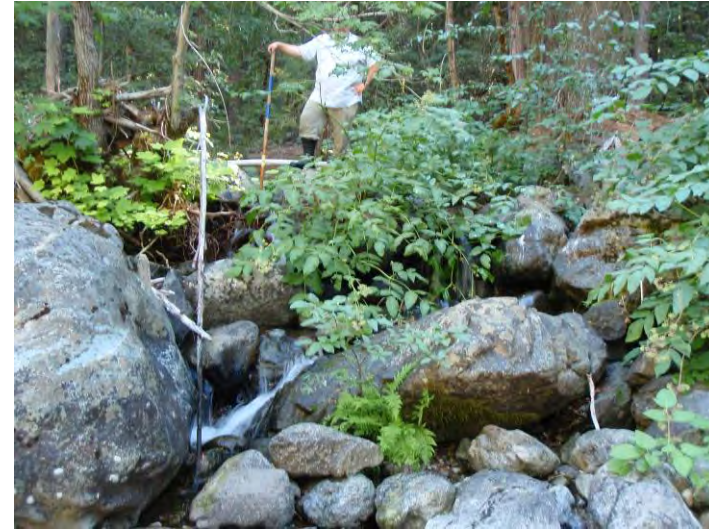
Photo 99. Hackmans Ravine looking upstream at confluence

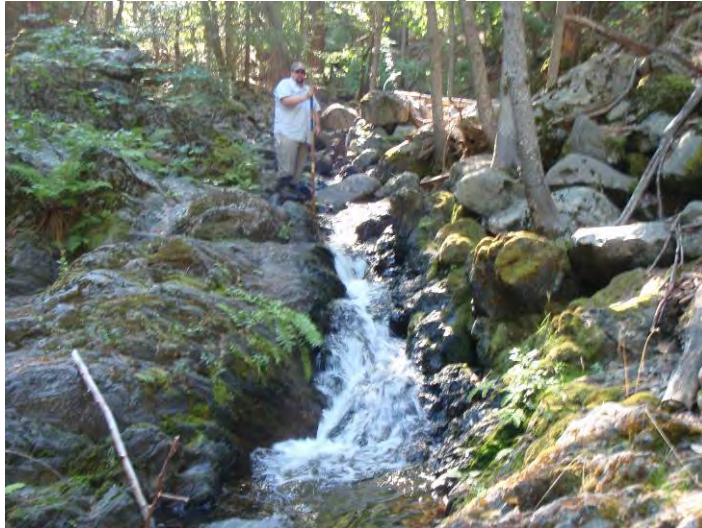
Photo 100. Hackmans Ravine barrier 1

Stream/ Tributary: N. Yuba / Hackmans Ravine	Crew: RA, CV	Temp (C°): 10.6	Date: 9/23/11
Estimated Discharge (cfs): 1.5	UTM Start/Description: 0703640 E / 4382125 N	UTM End/Description: 0703749 E / 4382000 N	
Comments: Boulder delta disperses flow and would block passage at current flow. At current flow no anadromous habitat due to numerous low flow leaping barriers and overall high gradient. Average 4% near confluence and picks up to 8-10% after Point ID #1. Overall, no good habitat due to low flow and high gradient. Fry observed below Point ID #1.

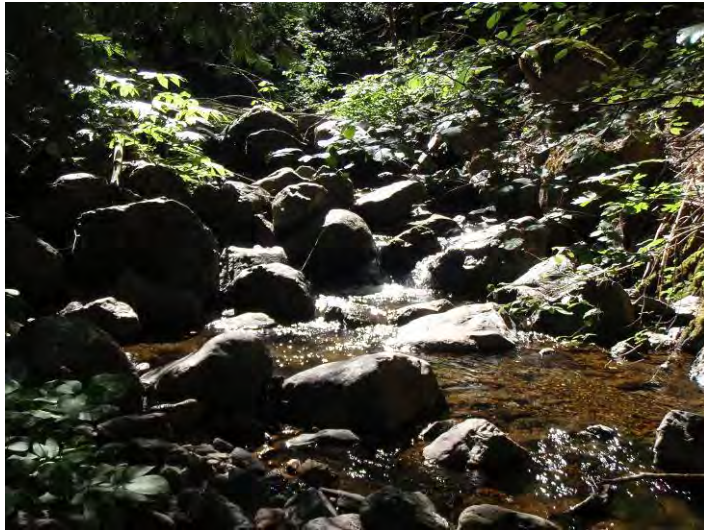
Photo 102. Hackman Ravine typical habitat looking upstream

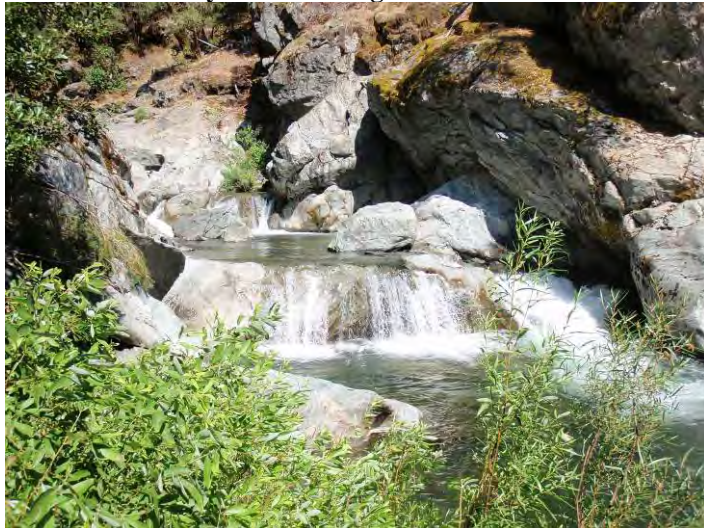
Photo 105. Canyon Cr. barrier 1

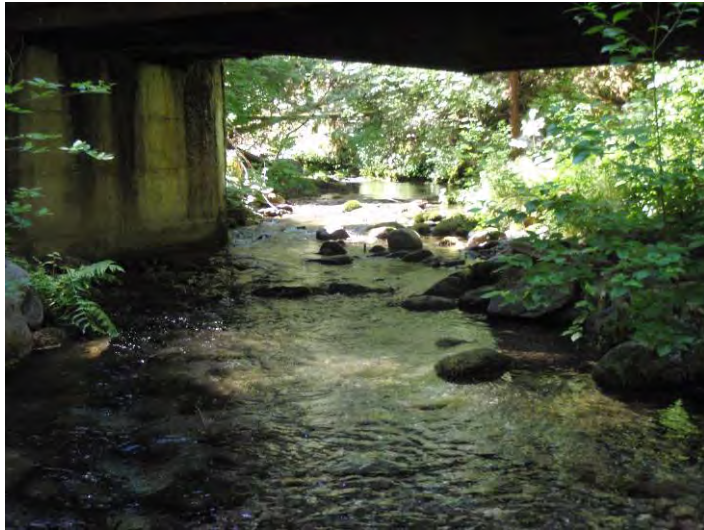
Photo 111. San Juan Cr. Looking upstream at end point

Stream/ Tributary: San Juan / N. Yuba	Crew: RA, CV	Temp (C°): 9.6 upstream of Jim Crow	Date : 8/18/11
Estimated Discharge (cfs): 4 upstream of Jim Crow Creek	UTM Start/Description: 0690519 E / 4379993 N at confluence with Jim Crow Creek	UTM End/Description: 0690472 E / 4379916 N 500' short of 0.5 mile point	
Comments: Private property postings occur 500ft downstream of 0.5 mile point so end survey short. No barriers were observed. Good habitat for fish.

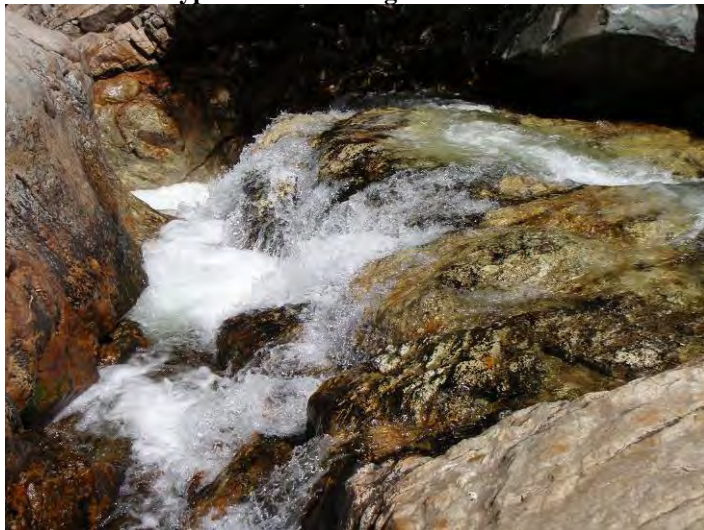
Photo 128. Haypress Cr. barrier 1b at step in falls
